Miloslav Kopecký\*, Luboš Hruštinec\*, Martin Ondrášik\*, Jana Frankovská\*

## DEFORMATION OF UNSTABLE SLOPE AT THE RESERVOIR DAM NOVÁ BYSTRICA\*\*

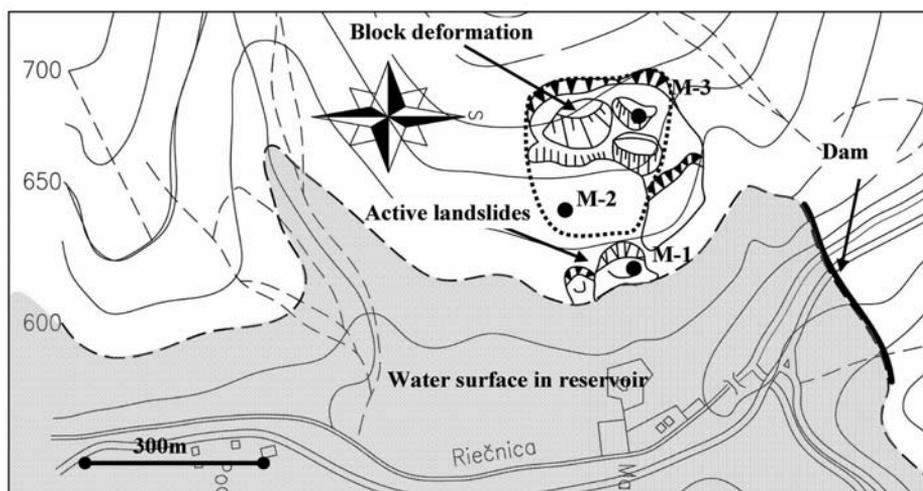
Two slope deformations of varying activity can be allocated on the slope. In the area between the reservoir shoreline and the forest road there are active landslides with overall area about  $120 \times 60$  m (fig. 2). The landslides were probably caused by improper interference during building of the forest road. Active landslides are bound only to the slope debris containing coarse fragments from 40 to 80% and the shear surfaces were detected by the inclinometric measurements at depths from 3,5 to 5,0 m.

Fig. 2. Scheme of the landslides in the slope located on the dam left-hand side

In the higher part of the slope (in the range of about 630–690 m above sea level) there is a block deformation (fig. 2). Based on initial investigation works [1] its dimensions were predicted to approximately  $100 \times 140$  m. According to our latest knowledge, this could be up to  $220 \times 140$  m (dotted line in fig. 2). Block deformation is result of gravitational movement of relatively rigid sandstones over the surface of plastic siltstones, and during the movement from the main slope zone the sandstones were disintegrated to individual blocks. The maximum depth of the shear surfaces was detected by inclinometric measurements at a depth of 34,0 m below the around surface.

Borehole M-2 (fig. 2) was situated on morphological platform about 60 meters above the forest road, and it was assumed [1], that the platform was not the result of the slope movement. However, subsequently realized inclinometric measurements showed quite a clear movement on the contact between sandstone and claystone (13.0 meters below the surface). The total resultant movement in this depth is almost 63 mm for 13 years. These findings lead us to an opinion that the area and depth extent of the block deformation is greater than it was originally anticipated.

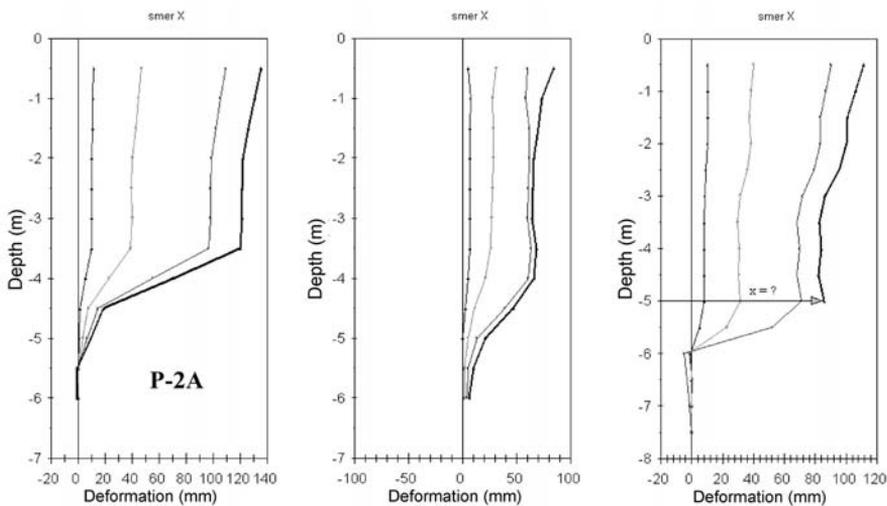
In the landslide area with the forest road it has been confirmed that the activity of the movement still persist. The maximum deformation observed from 1993 to 2006 is 300 mm (sum of deformations from two inclinometers). The movement is probably not a continuous and uniform, it occurs only under extreme climatic conditions (rainfall and snow melting).

Fig. 3. Movements in the inclinometer located in the active landslide on the forest road

The depth of the shear surface of the active landslide on the forest road was found 3.0–5.5 m below the surface (fig. 3).

It is obvious that, if no remediation works will be made on the active landslide area with the forest road [2], in some time there will be an absolute destruction of the slope and sliding of the diluvia sediments to its lower part and partially into the water reservoir. About 55 000 m<sup>3</sup> of debris can get into the movement. However we assume, that in this process there is no threat to the inflow waterworks facility remote about 150 m from the accumulation of the active landslides. On the other hand, removal of rock masses from this area can cause acceleration of movements of the block deformation situated above the forest road.

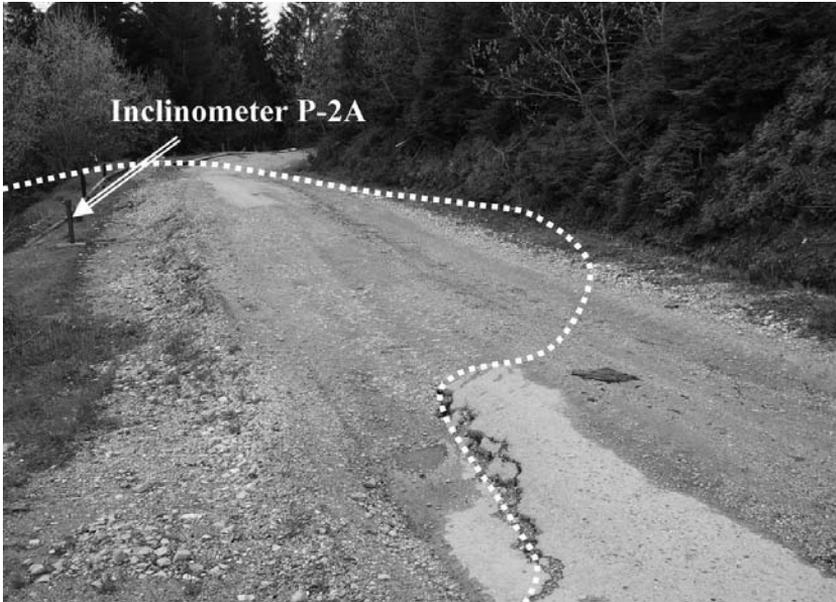
Based on the analysis of the inclinometric measurements in 2 inclinometric boreholes located outside the presumed area of the landslide active in 1993, it was found that since 1999 there was gradual expansion of the landslide and significant distortion of the forest road (fig. 4).

Fig. 4. Main slope area of the active landslide in the body of the forest road

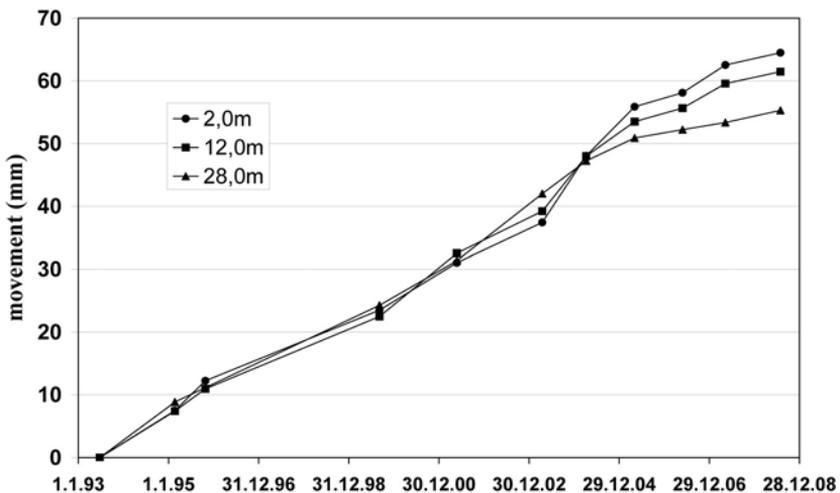
The block deformation, which is situated in the slope above the forest road, there is a gravitational movement of relatively rigid sandstones over the surface of a plastic claystone. Inclino-metric measurements under the main scarp zone of the block deformation (borehole M-3) confirmed the existence of a relatively thick shear zone (about 7 meters), along which there is

Fig. 5. The time course of movements in different depths in the borehole M-3

a movement of the block of sandstone up to 24 meters thick. Total movement of 44 mm for 13 years was detected. However it is important that the movement at a depth of about 28.0 meters is up to now relatively uniform (fig. 5).

If there are demonstrably accelerated movements in the area of the block deformation, it will be necessary to proceed to remedial or other measures, because at certain acceleration
