Miloslav Kopecký*, Martin Ondrášik*, Darina Antolová*

UNSTABLE SLOPES ON RIGHT-SIDE END OF THE DAM BODY OF LIPTOVSKÁ MARA WATER RESERVOIR**

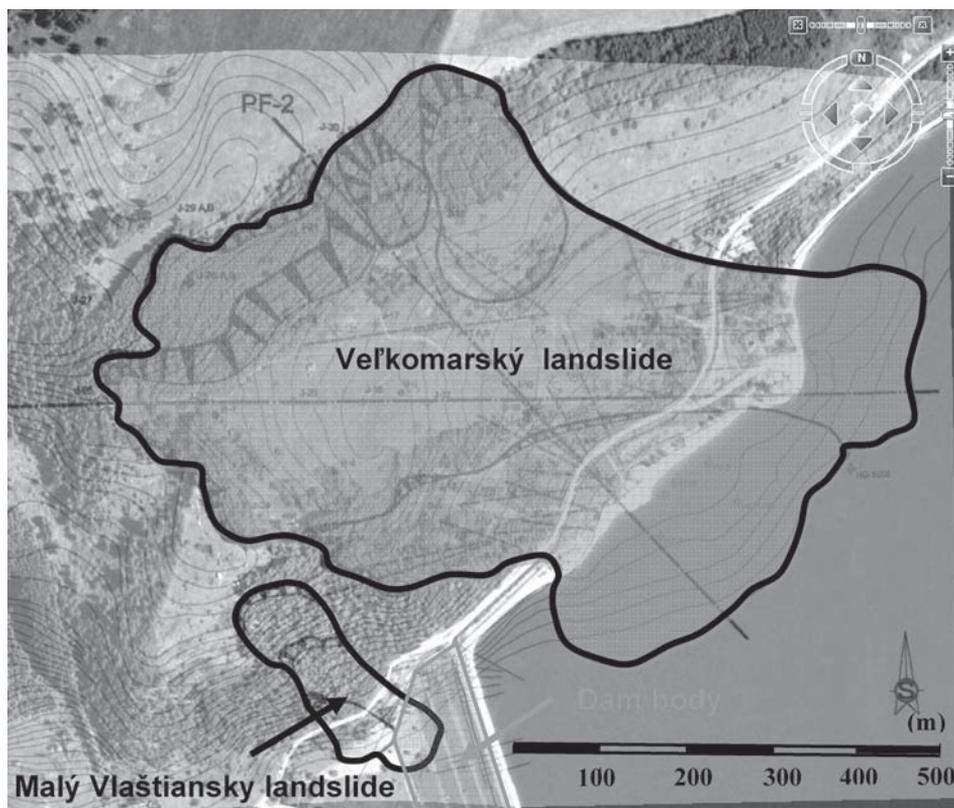
On the right-side of the dam body of WR Liptovská Mara there are located two landslides. On the water-side bank it is Veľkomarský landslide and on the downstream face of the dam it is Malý Valčianský landslide (fig. 2).

Fig. 2. Localization of the dam profile between Veľkomarský and Malý Vlačiansky landslides, (satellite photo by Google Earth)

The Malý Vlačiansky landslide is sited in close vicinity of the dam body, even part of its accumulation zone is located under drainage and stabilization foot slope of the downstream face of the dam body. The length of the landslide is approximately 320 m, width about 100 m. The landslide thickness ranges from 5 to 12 m.

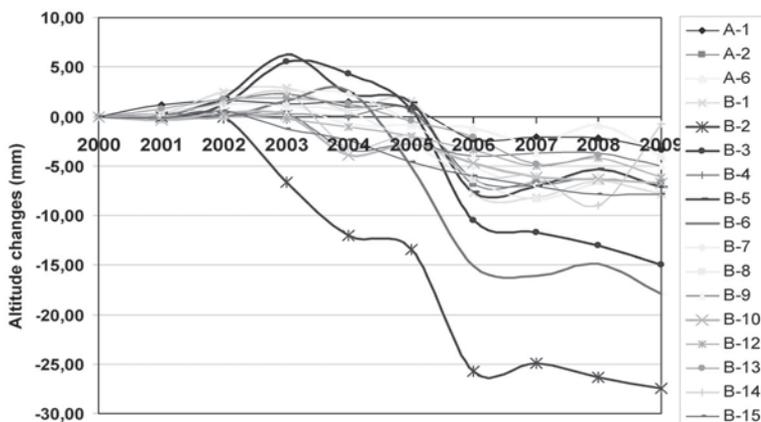
In late March 2006, the abrupt warming and rapid melting of very thick snow cover led to infiltration of water from the melted snow and to increase of groundwater levels in the sliding slope to maximum ever observed during the entire observation period. These high groundwater levels were synchronously with changes of elevation of the survey points. A significant decrease was recorded on points from B-1 to B-6, which are located in the head of the landslide area (from 6.9 to 12.2 mm — 9.8 mm in average! Fig. 3), and what indirectly points to a partial activation of the landslide area.

Fig. 3. Cumulative curves of altitude changes (mm) of fixed observation points during years 2000–2009

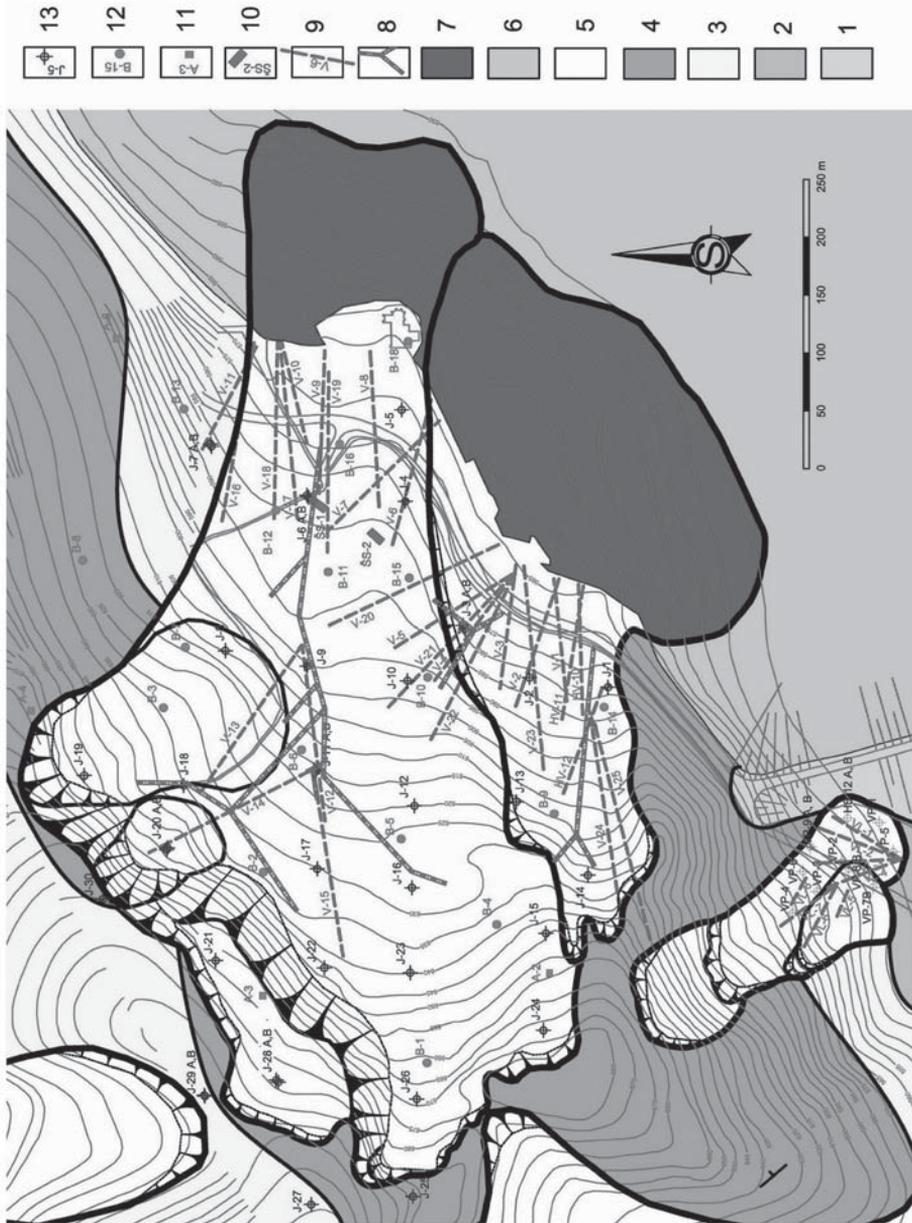
Fig. 4. Scheme of existing monitoring points and remediation measures on Vel'komarský and Malý Vlačianský landslides [2]

The monitoring network (fig. 4) of both landslides was built 35 years ago. On the Veľkomarský landslide in 1974–1975 there were built sites for observation of ground water levels (observation wells — 30 pcs). As remedial measures also 28 horizontal drainage wells with the total length of 3 800 m were built in 4 stages.

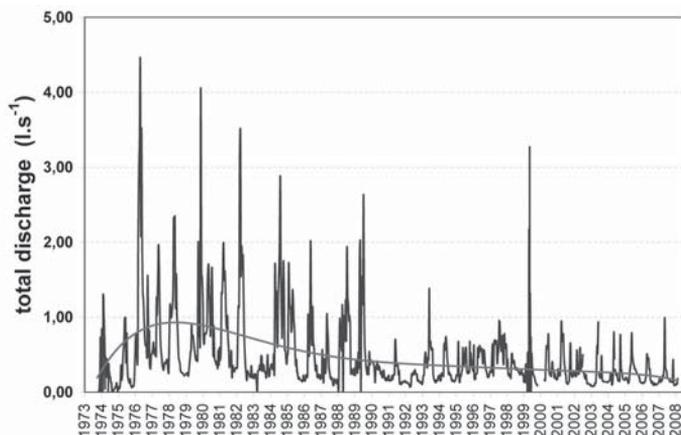
With regard to long term monitoring of the HDW discharge, it is possible to observe decrease of the total volume of the water being removed from the landslide (fig. 5).

Fig. 5. Downward trend of the total discharge from all HDW on Veľkomarský landslide

However, this overall groundwater level decline does not have to play a role in reducing of local slope stability, unless due to decrease in water discharge from HDW the groundwater level is not increased in the nearby observation wells. The negative impact of the discharge decline in HDW from V–12 to V–15 located in the landslide head area is quite obvious. In this area, in observation wells J–16, J–17 (fig. 6), J–18, J–11B, J–11A the groundwater level is increasing for long time period, in the case of J–11A the groundwater freely flows out the well as

from artesian well. People from TBD made inspection in the horizontal drainage wells with use of camera. The largest throughput was observed only up to 30 m (in 2 wells). In most cases the camera got only a few meters away from the HDW mouth. The inspection results have pointed out that the broken HDWs should be either cleaned or replaced by new HDWs.

b)	piezometer — reconstruction of approximately 11 pcs — 265 m	Reconstruction of the broken wells
	c)	horizontal drainage wells — about 2000 m	Cleaning those HDW which show long-term decline in discharge rate and those in which there is a rise of GWL (fig. 5) In the case of inefficient cleaning new HDW will be necessary to build.

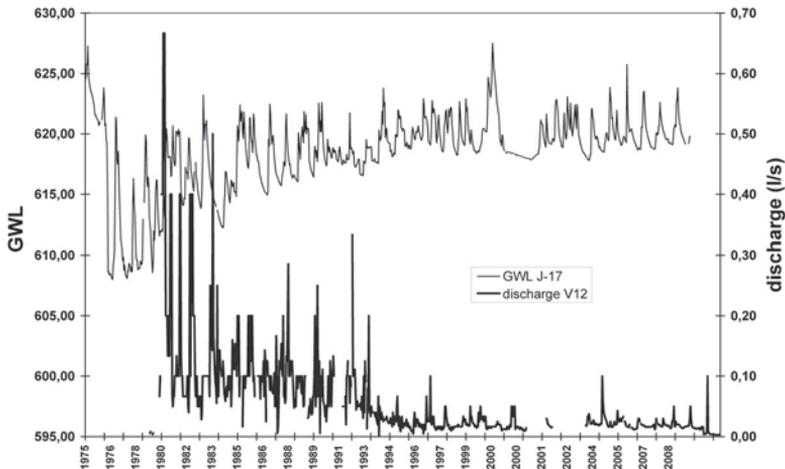
Fig. 6. Decrease of effectiveness of HDW V-12 and gradual increase of GWL in borehole J-17
