Łukasz Rakoczy, Lechosław Tuz, Krzysztof Pańcikiewicz

Hot cracking of nickel-based superalloy turbine blade

The aim of this study was to present the hot cracking behavior of a blade originating from a turbine blade segment. The crack was induced by a gas tungsten arc welding process, and the research material was a MAR-M247 nickel based superalloy. This alloy is considered to be difficult to weld because of its high tendency to crack. Light microscopy and scanning electron microscopy show the occurrence of cracking in the melted zone, heat-affected zone, and base alloy. A scanning electron microscopy investigation revealed that cracks are propagated by stresses and liquation of the low temperature constituent.

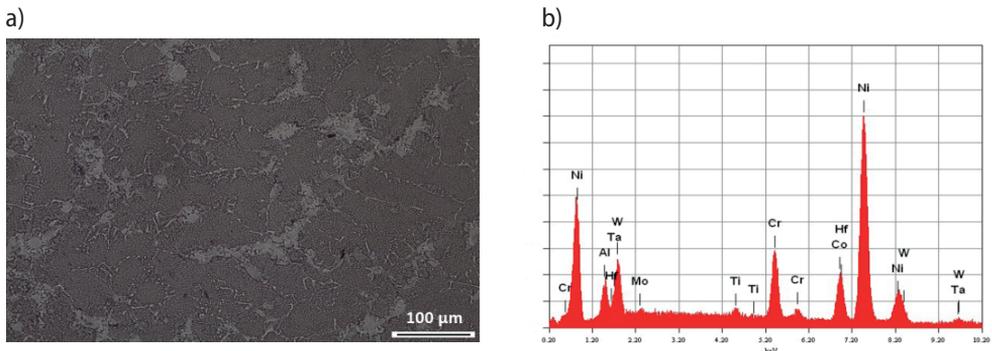
Fig. 2. Cast MAR-M247: a) microstructure; b) EDS spectrum

The microstructure revealed equiaxed grains in the blade-as-cast and after heat treatment (Fig. 2a). The obtained microstructures show that the analyzed MAR-M247 originated from a low-pressure turbine. Different methods of casting such elements allows to reach directionally solidified structure for use in the high-pressure turbine [1]. Further observations of the microstructures using a higher magnification and the EDS spectrum of carbide are presented in Figure 3.

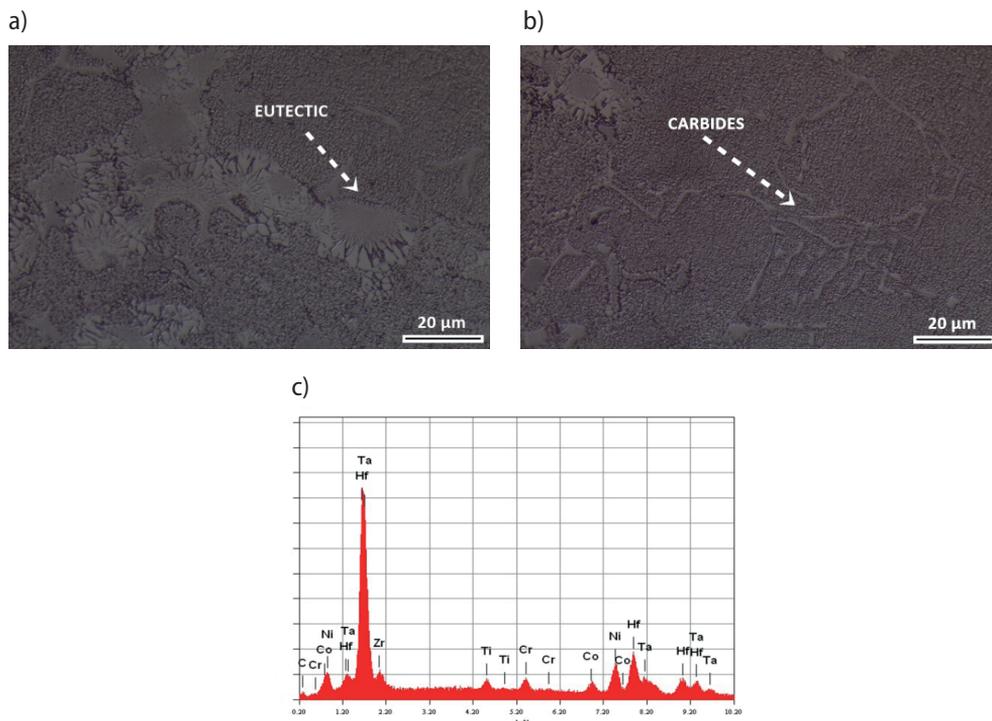
Fig. 3. Precipitation in as-received condition: a) eutectic; b) carbides; c) EDS spectrum of carbide.

It obtained that carbides as well as eutectic γ/γ' are revealed (Figs. 3a, 3b). In the microstructure, $M_{23}C_6$ -, M_6C -, and MC-type carbides can be present [2]. Evidence of an MC-type carbide (Hf, Ta)C was confirmed during energy dispersive spectroscopy (Fig. 3c).

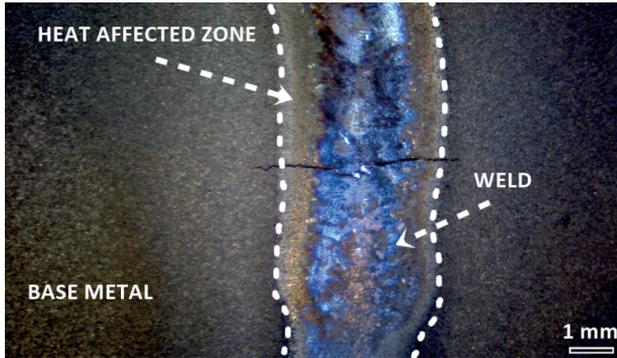
In the macrostructure (Fig. 4a), a crack was observed over the entire width of the melted region. The crack did not stop at the fusion line; as a result, liquation of the grain boundary and high stress expanded in the direction of the base material through the heat-affected zone (Figs. 4b, 4c).

Fig. 4. General location of crack obtained during repair welding

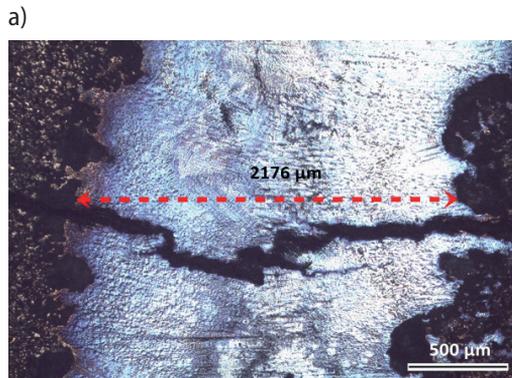
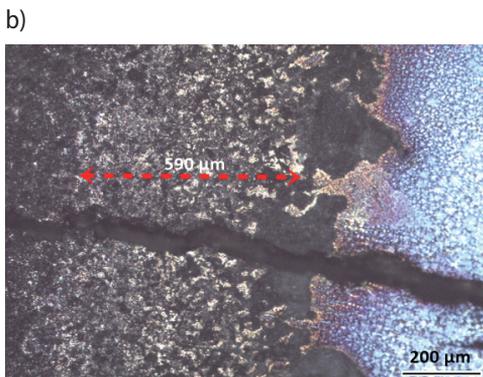
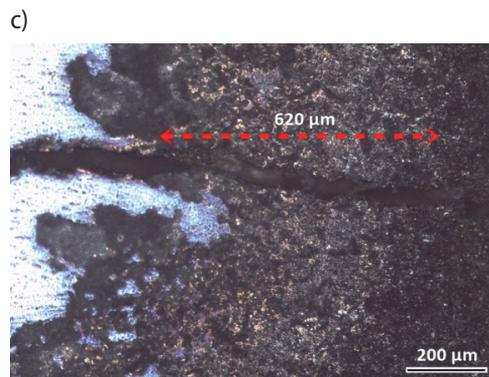
As a result of welding, the width of the melted area is just over 2 mm (Fig. 5a), while the heat-affected zones are about 600 μm (Figs. 5b, 5c). The dimension of the crack in the base metal is shown in Figure 6.

Fig. 5. Dimension of investigated regions: a) melted region; (b, c) HAZ

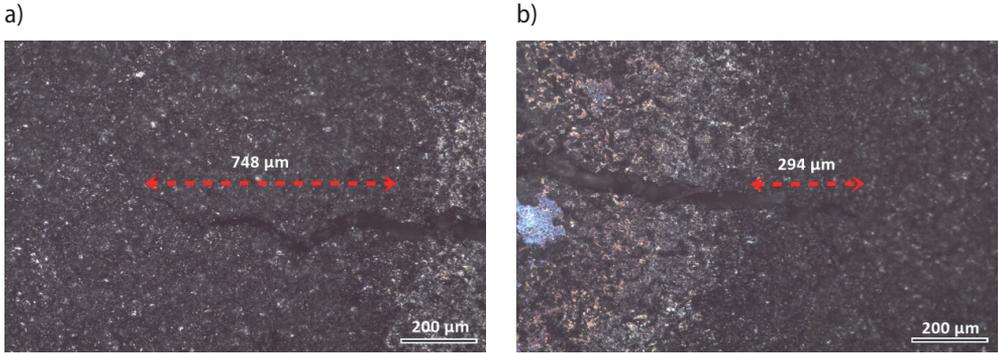
Fig. 6. Length of crack in base metal: a) left side; b) right side

On the left side, the crack developed into the base metal through 748 μm (Fig. 6a), and so the total length of the crack (HAZ and BM) on this side is about 1350 μm . On the other side, the crack is shorter – only about 915 μm (Fig. 6b). The difference in the crack’s dimensions is probably the result of different heat conductivity in the base metal near

the tip and on the opposite side. The crack on the right side is located near the leading edge, and so the higher cooling rate did not allow it to propagate a greater distance into the base metal (the thickness of the base metal near the leading edge is lower). Figures 7 and 8 illustrate more details about the microstructure of the crack.

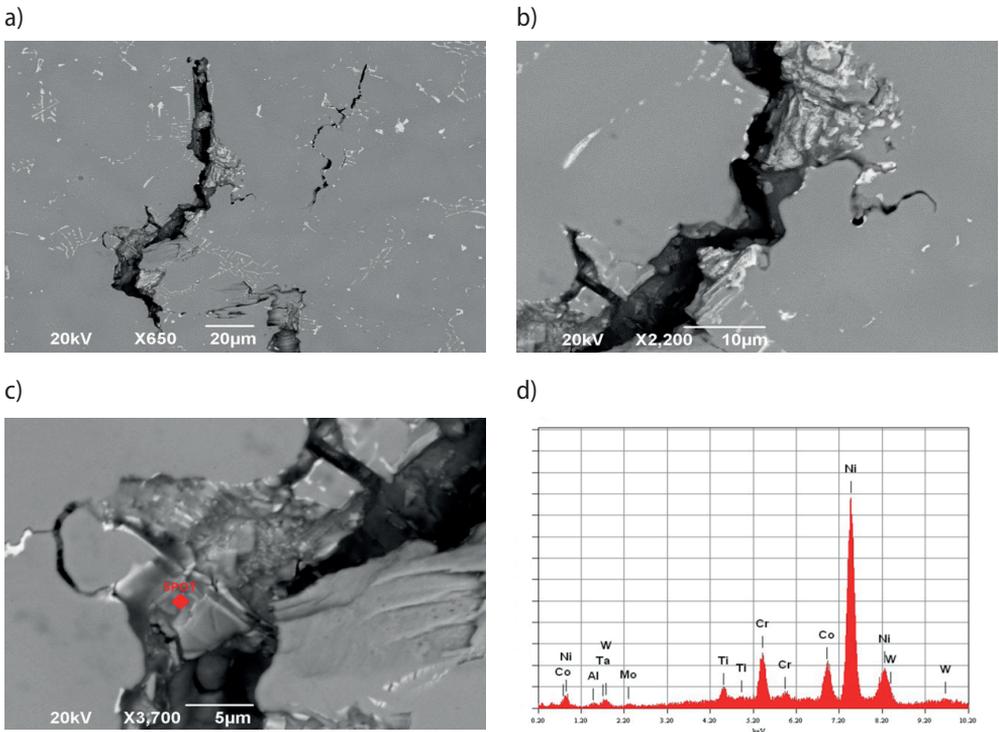
Fig. 7. Microstructure of crack: a) general view; b) liquated carbides; c) location of EDS spot; d) EDS spectrum

An SEM investigation allows us to state that the crack propagated in close proximity to the carbides and eutectic (Fig. 7a). The solidus temperature of the base material is higher than the incipient melting temperature of the eutectic and carbides; so, liquid was present during the welding process along the grain boundaries (Fig. 7b). The thermal stresses and melted constituents caused failure and did not allow us to repair the component. The energy dispersive x-ray spectroscopy analysis shows that the selected area cracked near eutectic γ/γ' (Figs. 7c, 7d).

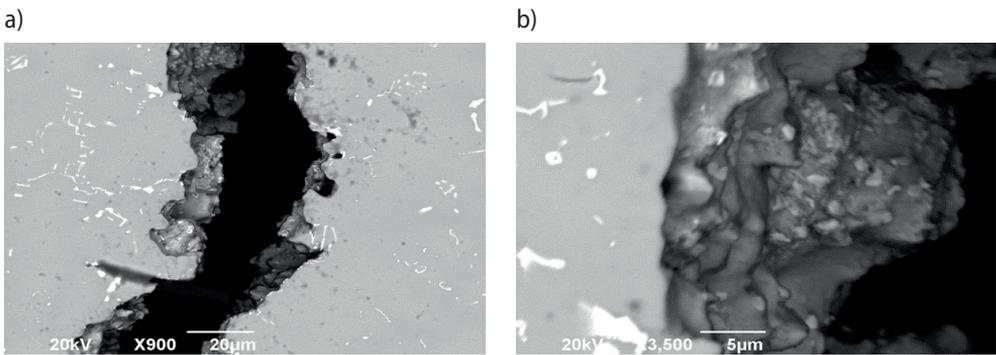
Fig. 8. Change of crack microstructure: a) increased width; b) fracture with carbide precipitates

The greater temperature gradient and increased stresses contributed to the change in the crack's microstructure. The crack in the selected region was wider, while on the edges, the base metal was fully melted (Fig. 8). Figure 8b illustrates the fracture of hot crack and primary carbide precipitates with diameters of about 1 μm .
