Winding machine additional overload state indication as supporting solution for mine shaft hoist operators

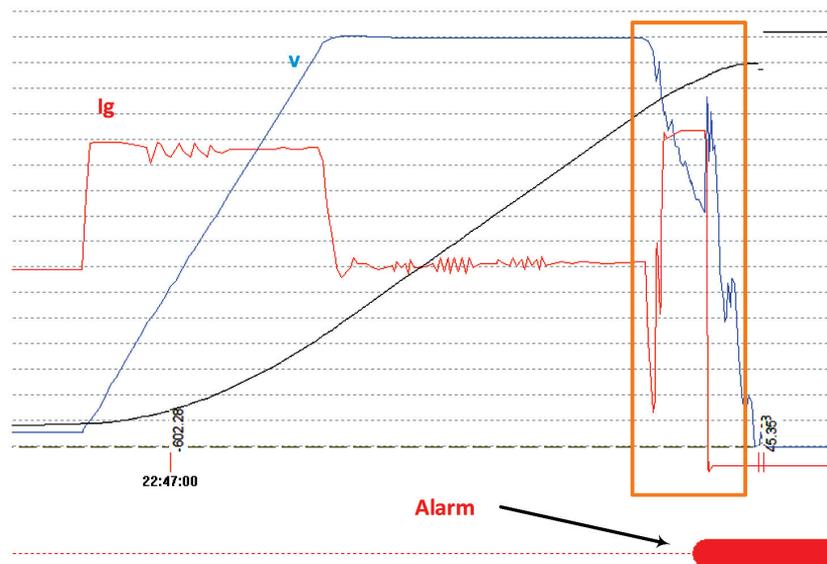
In the case of stopping Vessel No. 2 by the construction of the spill bunker, the load torque suddenly decreased.

Fig. 4. Logger data during incident

The regulation system behaved properly. The current value dropped down to rise to its maximum value limited by regulator settings. At this point, the machine became a single-end machine. After this, the second vessel release skip went into a freefall. This caused its speed to rise above the permissible value and the machine to be switched off due to exceeding the maximum limit.

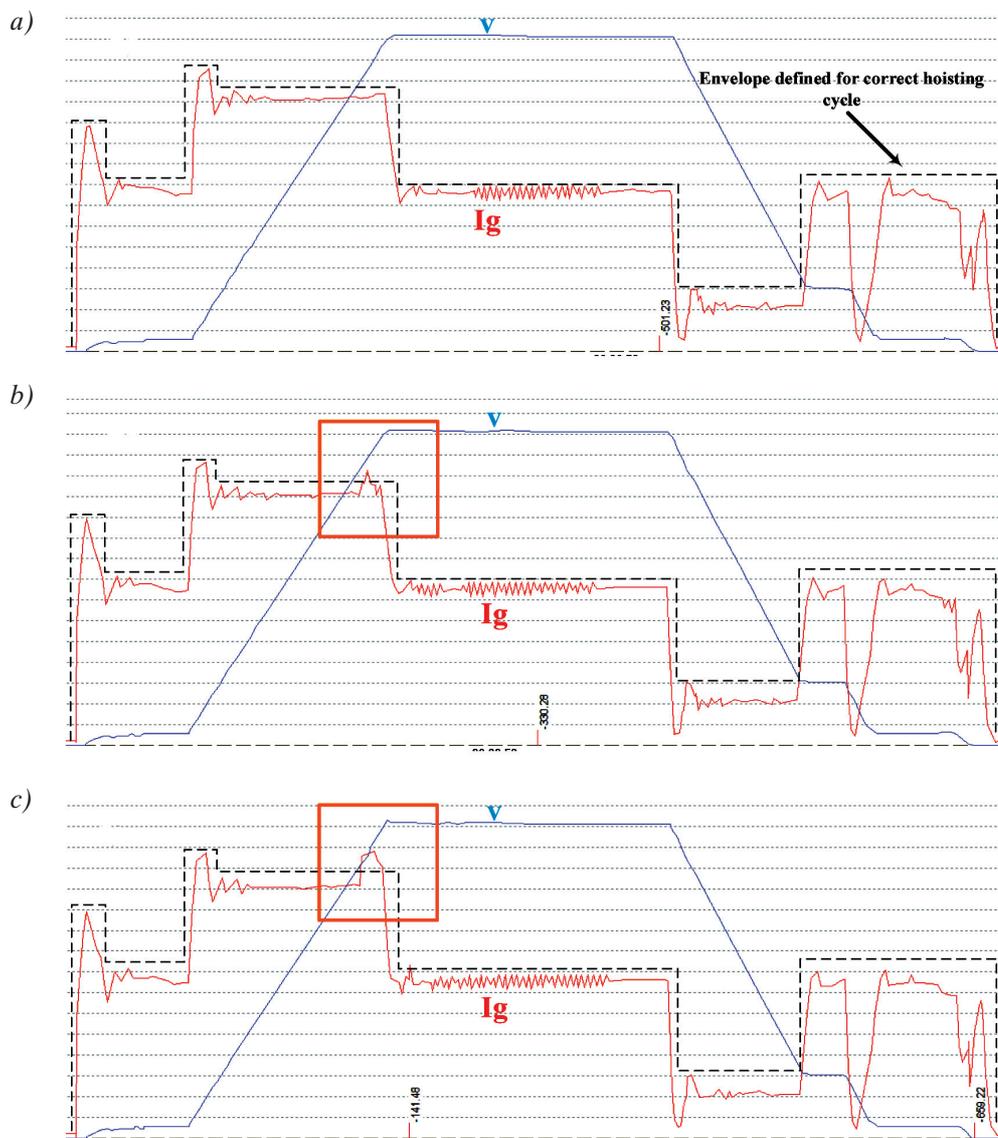
Fig. 5. Main circuit current I_g and vessel speed v waveforms – data acquired from AR-3c logger: a) no disturbances visible (correct waveforms); b) three cycles before incident; c) cycle directly before incident

The ten cycles preceding the incident were analyzed. Further than three cycles before the event, no disturbing changes in either the current or speed can be observed (Fig. 5a). For each form of the current waveforms in Figure 5, the envelope was applied on the basis of the normal course, which is information regarding whether there was an anomaly in the system. Three cycles before the occurrence of the event, an increase of approx. 500A in the main circuit current is visible above the value set for this fragment of the hoisting cycle. The full Vessel 2 was ascending during this time. It can be concluded that the vessel was already in contact with a deviated design of the adjacent compartment tank. The operation of the shaft station devices suggested that disturbing noises were heard in the mining shaft. In the cycle preceding the event, the increase in current when passing the vessel in the vicinity of the tank was already at 900 A and lasted much longer (Fig. 5c).

On the basis of the analysis of the winding machine logger data, it can be stated that it was possible to detect the symptoms of an impending threat earlier. For several cycles before the incident, it was possible to observe anomalies in the course of the main circuit current. The current changes were caused by a variable load torque resulting from the appearance of an additional obstacle to Vessel 2.

It is not possible to detect this type of anomaly only by observing the current waveforms on the driver's desk or in the logger. To properly respond to such irregularities, it would be necessary to place an addi-

tional indicator of such a state on the driver's desk as well as appropriate changes in the regulations [5].

In the form of a visual signal (a glowing lamp) placed on the driver's desk, this indicator would be activated when the permissible value of the current is exceeded by the assumed value for a given fragment of the driving diagram. If established in double-compartment shafts with different levels of extraction, it would require the service staff to take control actions in case of its activation.
