*Wojciech Anigacz **, *Krzysztof Drożdżol **, *Elżbieta Kokocińska-Pakiet **

EXAMINATION OF AN EARTH SLOPE SETTLEMENT

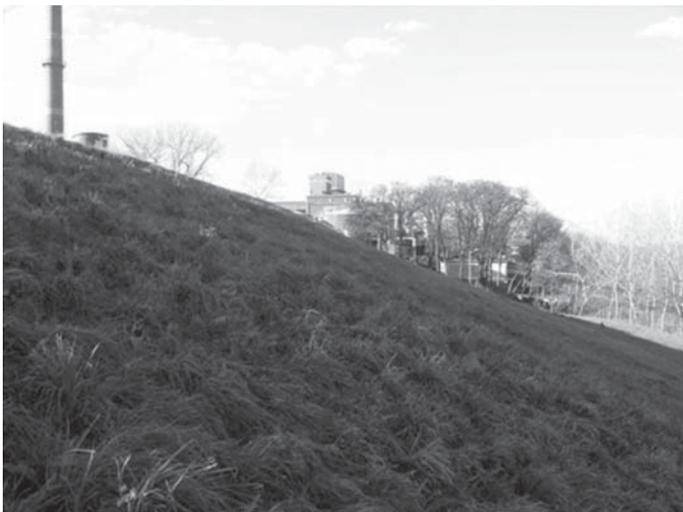
Fig. 1. Present view of the embankment dam [5]

On the basis of tests carried out on the soil embankment dam held in the period of 1997–2011, it has been stated that the present condition of the soil embankment dam of the bleaching soil settlement tanks is good and that it does not threaten any possible instability.

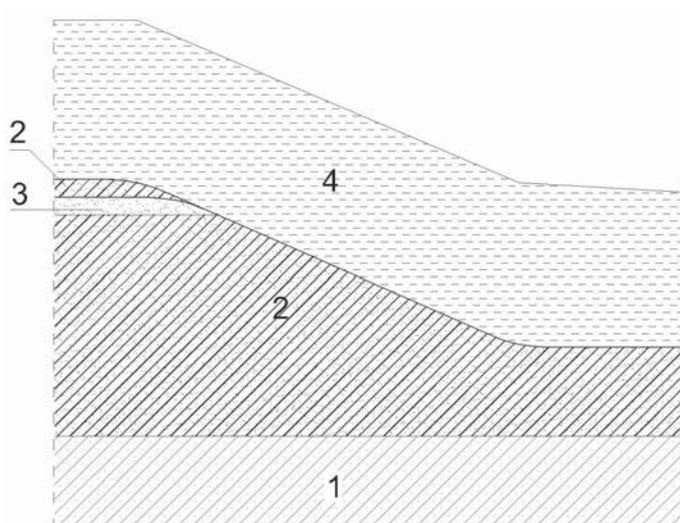
Fig. 2. Geological cross section of the embankment dam: 1 — clay, 2 — sandy loam, 3 — medium sand, 4 — embankment of loamy sand [5]

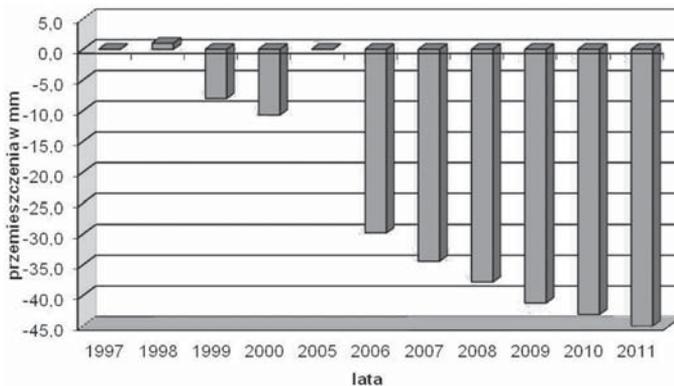
Figure 5 presents the settlement of the no 9 bench mark located on the slope, in section II, about 1.5 m below the soil surcharge of the embankment. This bench mark is settling in a steady way, and its total settlement amounts at 45 mm within 15 years. It is located in a place where a local landslip was observed. The behaviour of the bench mark indicates that this landslip has stabilised. In relation to the settlement of the neighbouring marks, this one does not show any increased vertical dislocation.

Fig. 5. The settlements of benchmark no. 9 in the period of 1997–2011
