Aleksandra Borecka *

DESCRIPTION AND EVALUATION OF THE LANDSLIDE HAZARD. A CASE STUDY IN A LANDSLIDE IN RADZISZOW

* AGH University of Science and Technology, Faculty of Geology, Geophysics and Environmental Protection, Department of Hydrogeology and Engineering Geology, Krakow

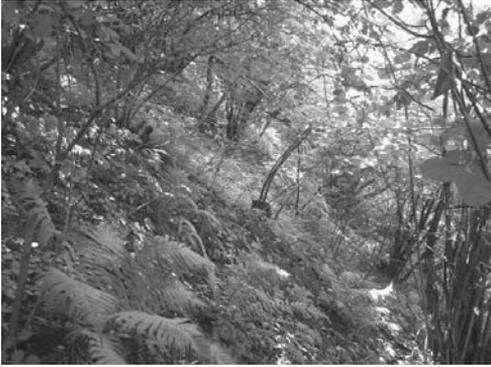
Fig. 2. The main scarp of the landslide.
(Photo by A. Borecka)

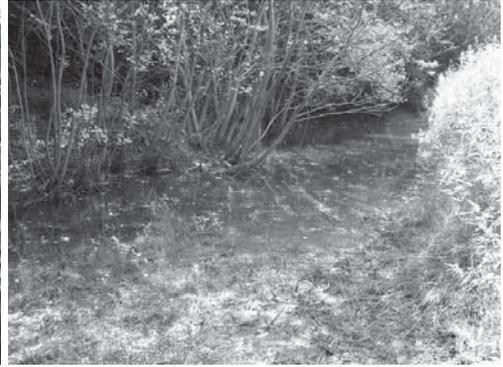
Fig. 3. The landslide ditch filled with water below the main scarp of the landslide.
(Photo by A. Borecka)

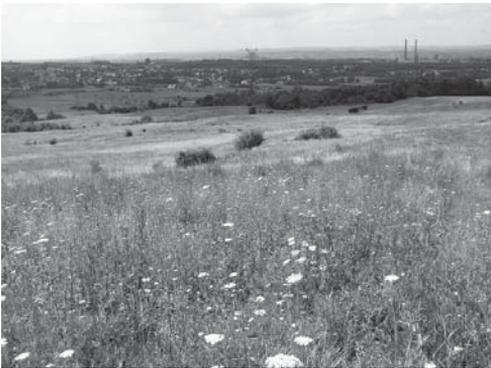
Fig. 4. A view over the central part of the landslide with characteristic undulating surface, such as, step-like forms, hollows.
(Photo by A. Borecka)

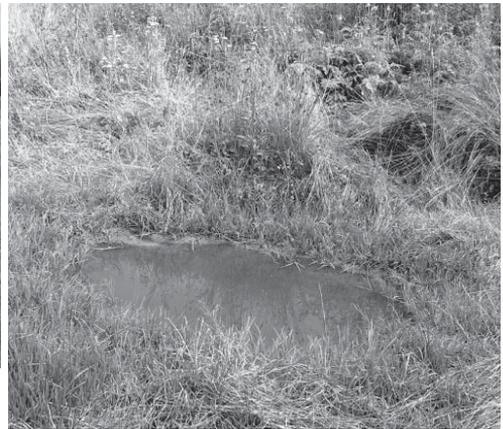
Fig. 5. Bog springs in the area of the landslide.
(Photo by A. Borecka)

Building a storm drain is recommended (using elastic, deformable elements) or channelling storm waters through a system of surface drainage taking it away from the landslide.

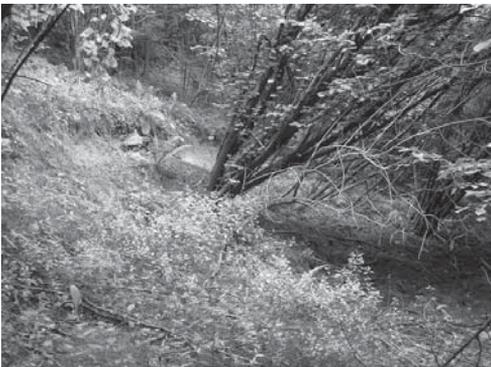
Fig. 6. Fresh detachment faults and tree movements in the crown zone in its northern part.
(Photo by A. Borecka)

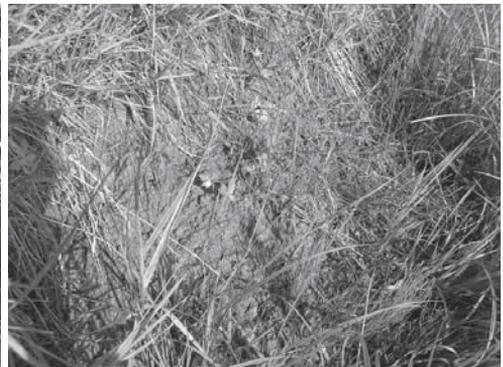
Fig. 7. Water seeps from the crown of the landslide in its western part near Skawinska street.
(Photo by A. Borecka)

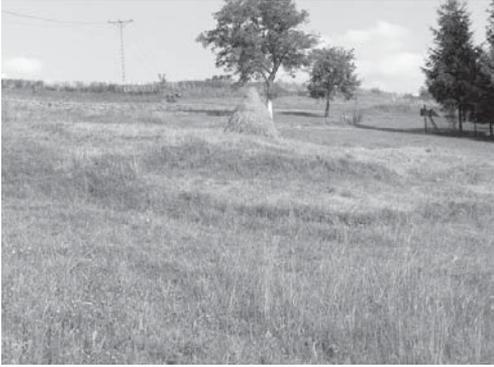
Fig. 8. The crown of the landslide and its deformation and soil ripples, with characteristic steps, hollows and interstices, which are the result of the colluvial masses movement in the western part of the landslide near Skawinska street.
(Photo by A. Borecka)

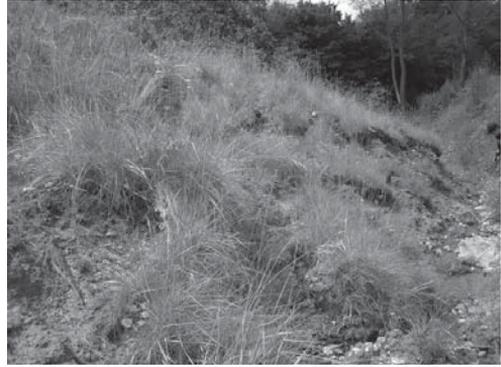
Fig. 9. The crown of the landslide with fresh detachment faults in its northern part, near Lutowka water-course, which shows that there is a very dynamic slip of colluvial masses in the area. There are visible water seepages from the crown of the landslide. (Photo by A. Borecka)

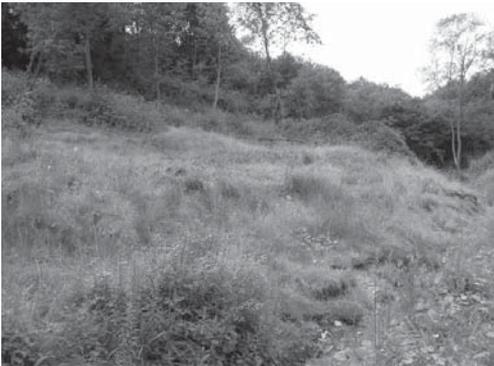
Fig. 10. The crown of the landslide with fresh detachment faults in its northern part, near Lutowka water-course. Fallen trees prove that there is a very dynamic slip of colluvial masses in the area. (Photo by A. Borecka)

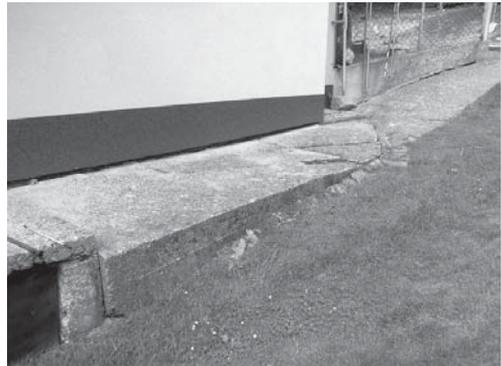
Fig. 11. Cracked concrete pavement near a utility building, Skawinska street, which is a consequence of the landslide's crown pressing forward.
(Photo by A. Borecka)

buildings are located (Kamienna street and the slope below and Pod Gora street in its upper part). There is current observation of the cracks on the buildings and its foundations, cracked concrete pavements surrounding the buildings, damaged property fencing and tilted pylons with taut wires (Fig. 11–15). It shows the effect of the long-term activity of the landslide, chiefly, a creep.

It should also be pointed out that there is a considerable hazard of damage to buildings in the active zone of the landslide during successive landslide movements. In the case of their occurrence, which will result in cracks and damage to the buildings, it will be necessary to relocate the inhabitants and move all the transmission poles away from the active zone of the landslide.

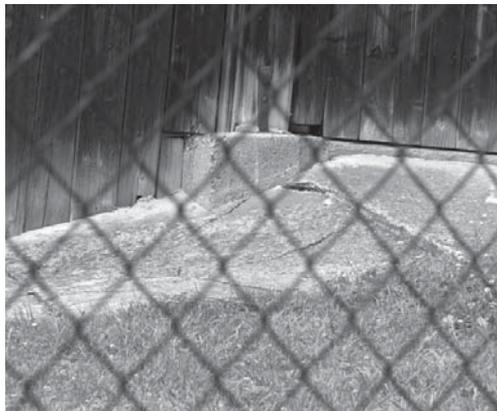
Fig. 12. Cracked concrete pavement near a utility building, Kamienna street, which is a consequence of the colluvial masses movement. (Photo by A. Borecka)

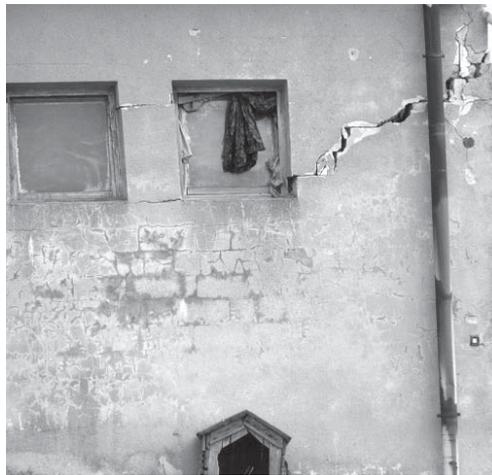
Fig. 13. Cracked walls a utility building, Kamienna street, which is a consequence of the colluvial masses movement. (Photo by A. Borecka)

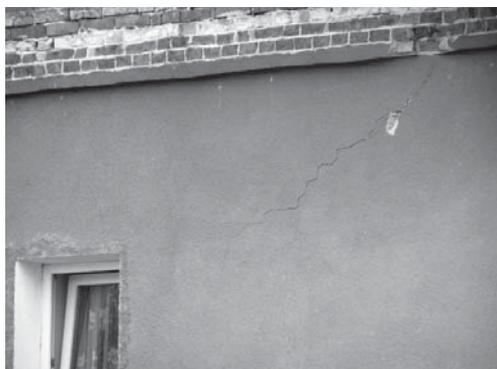
Fig. 14. Cracked walls a single-family building, Kamienna street, which is a consequence of the colluvial masses movement. (Photo by A. Borecka)

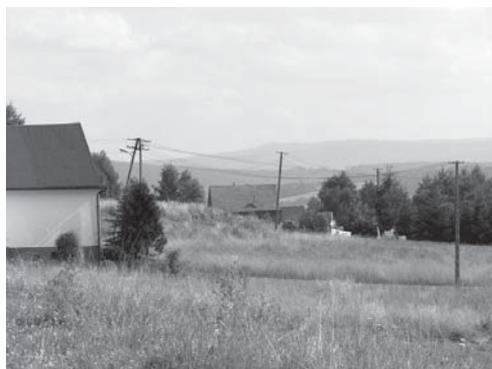
Fig. 15. Tilted pylons near Kamienna street, which is a consequence of the colluvial masses movement. (Photo by A. Borecka)
