Wojciech Kocot*

An Analysis of the Causes of Damage to Reinforced Concrete Road Viaduct Located in the Mining Area**

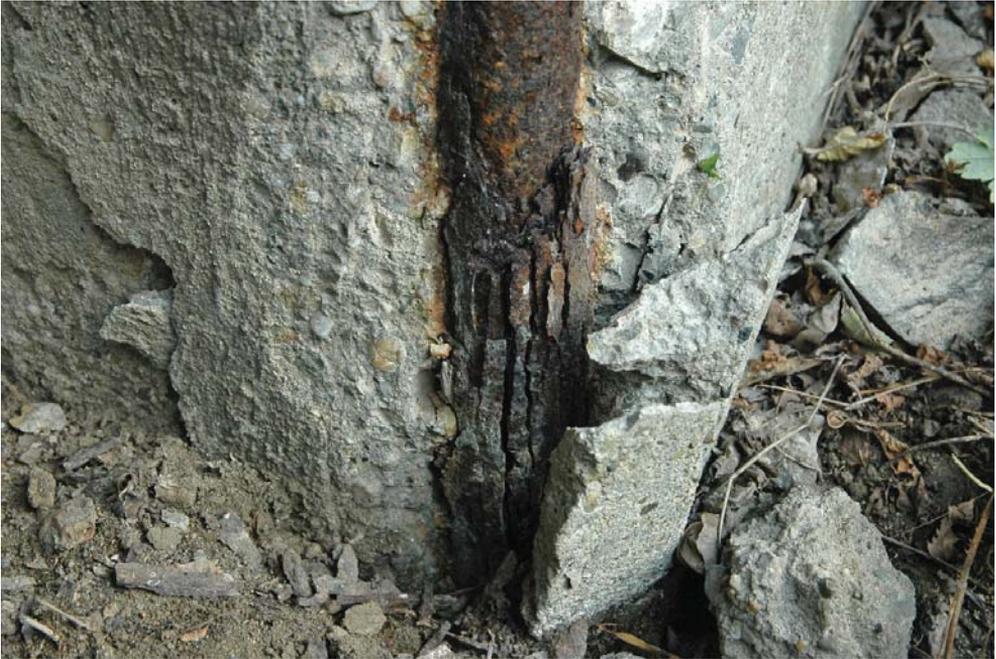
The most significant damage to the piers includes the flaking of concrete coating and the corrosion of reinforcement. They generally occur in the corners of the pillars, mostly in the lower parts (e.g. Fig. 4). The corrosion of concrete is also visible directly at the ground level. The corrosion of the exposed reinforcement is sometimes very advanced. In the upper parts of the pillars there are only a few losses of the coating. However, it is often cracked or scratched, which proves the corrosion of the coated reinforcement. The described damage relates to the outermost beams in the greatest extent.

Fig. 4. South pillar of the eastern pier – visible losses of concrete coating and advanced reinforcement corrosion

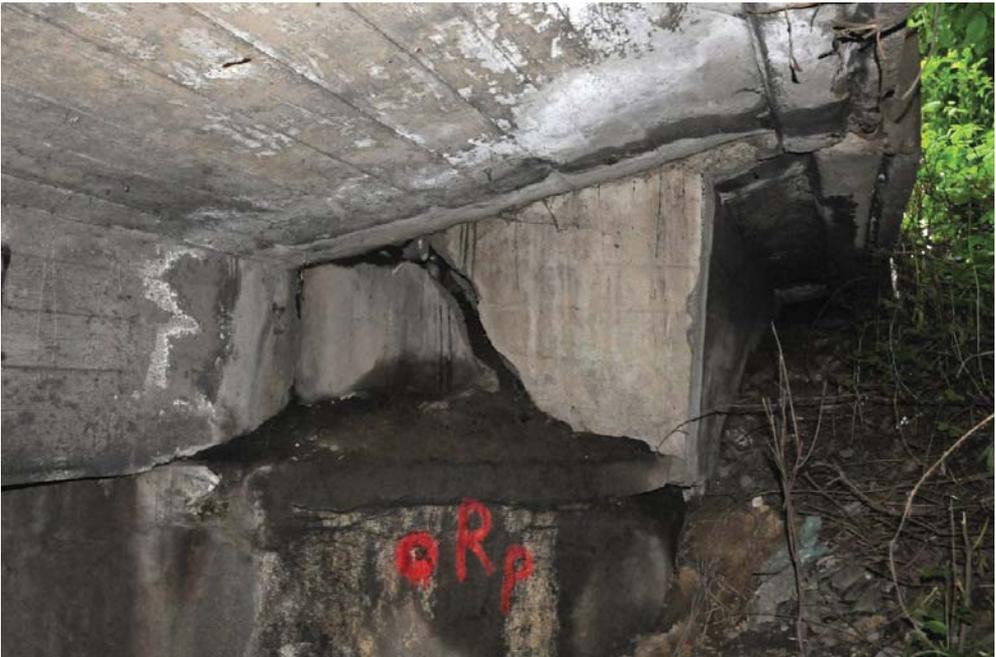
Damages to abutments include cracks in the back walls. The largest, with the aperture of about 100 mm were noticed in the north-west corner (Fig. 5). It is accompanied by a clear dislocation of the wing wall towards the outside. A crack of a smaller aperture, but with chipping and corrosion of concrete occurs at the same abutment on the south side (Fig. 6). A crack on the north side of the eastern abutment has a very similar course and aperture. The smallest one, with the aperture of about 1 mm occurs in the south-east corner. It should be noted that the cracked parts of the abutments were not reinforced.

Fig. 5. Western abutment, north side – visible crack of the back wall and dislocation of broken off parts towards the outside

These cracks occur in varying degrees in all four corners of the viaduct (c.f. Section 2). Yielding to the first impression, it seems that the cause of the cracking is the pressure of the abutments (wing walls and back wall) on the span resulting from creeping. However, the conducted analysis of mining data and the relative position of the object and the exploited walls show clearly that in the location of the viaduct there were only weak horizontal tensile strains. The course of the largest crack (in the north-west corner – Fig. 5) and the direction of dislocation of the broken off wing wall indicate that the force which did it, was not directed parallelly to the axis of the viaduct, but it was perpendicular to it. This could be, for example, pressure on both wing walls of the soil located between them, loaded with traffic. The support of such a thesis is the fact that the largest dislocation of the broken off wing wall occurred in the north-west corner, which is where the ground level on the other (outer) side of the wing wall is the lowest, and due to this fact it does not balance the pressure of the soil formed between the wing walls. Much smaller dislocations

occurred in the south-west corner (Fig. 6) and north-east corner, where the ground level on the other side of the wing wall is much higher. The smallest crack without dislocation occurred in the south-east corner. This wing wall is almost completely buried, thanks to which the pressure of the soil inside and outside of the wing wall balance. It should be emphasized that the damaged elements were made as concrete and they do not have any reinforcement (Fig. 5).

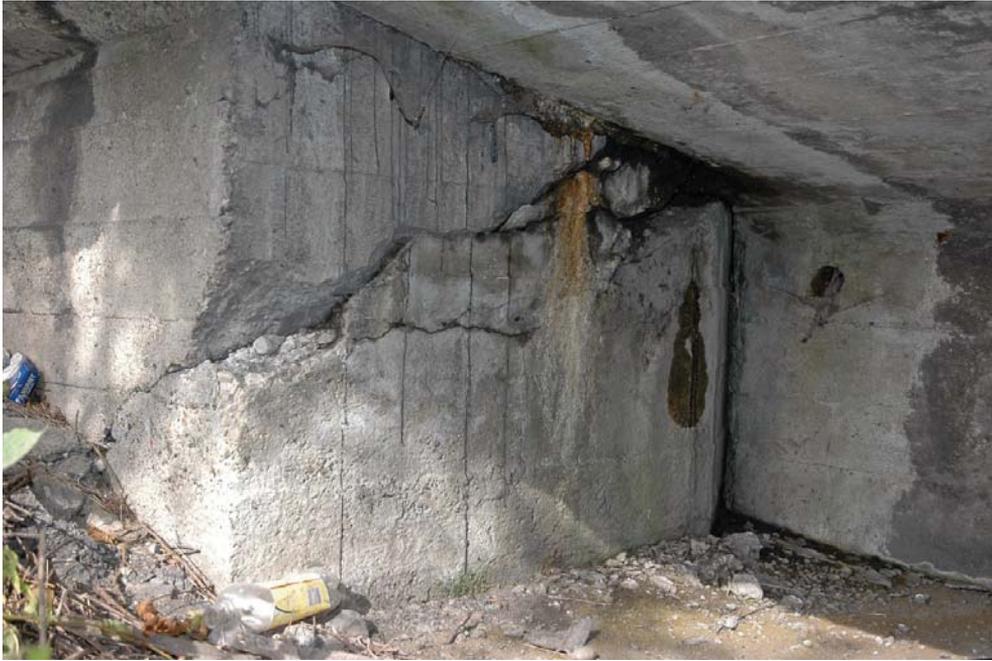
Fig. 6. Western abutment, south side – visible crack of the back wall and chipping of concrete

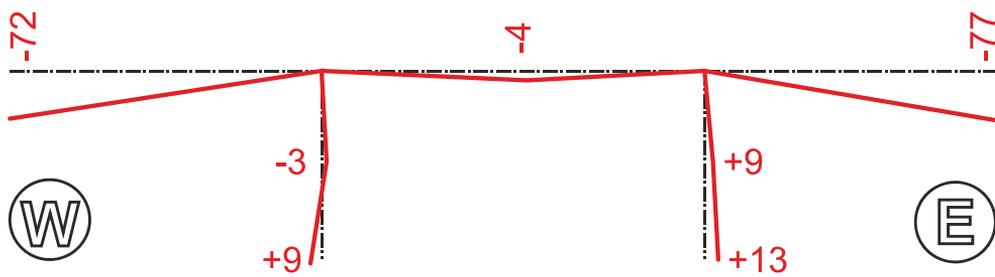
Rys. 7. Deviations from the theoretical axis of the viaduct elements on the north side [mm]

The measurement indicates a several-centimeter subsidence of the span end-points (on the abutments) compared with the points on the piers (values from -54 mm to -77 mm). This result can be interpreted as a shape attributed to the span at the implementation stage, which often occurs when a vertical alignment of the road on the object is in a convex vertical curve. The deviations observed in the middle of the main span on the south side equals to 2 mm and on the north side -4 mm. Taking into account surface irregularities associated with the corrosion damage of the observed outermost beams, it can be claimed that the main span in the vertical section is a straight line.

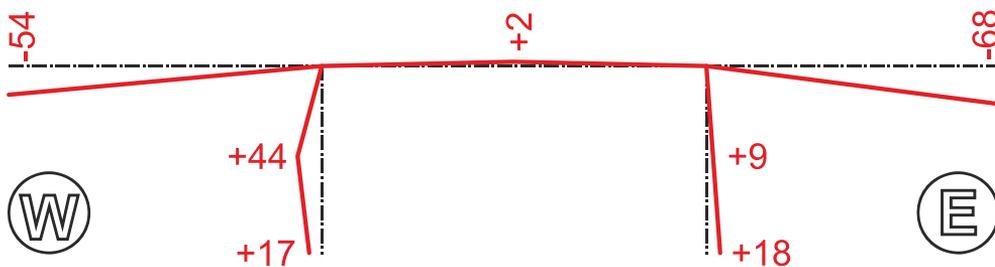
Rys. 8. Deviations from the theoretical axis of the viaduct elements on the south side [mm]
