The influence of microstructure of 30MnB4 steel on hydrogen-assisted cracking

Abstract

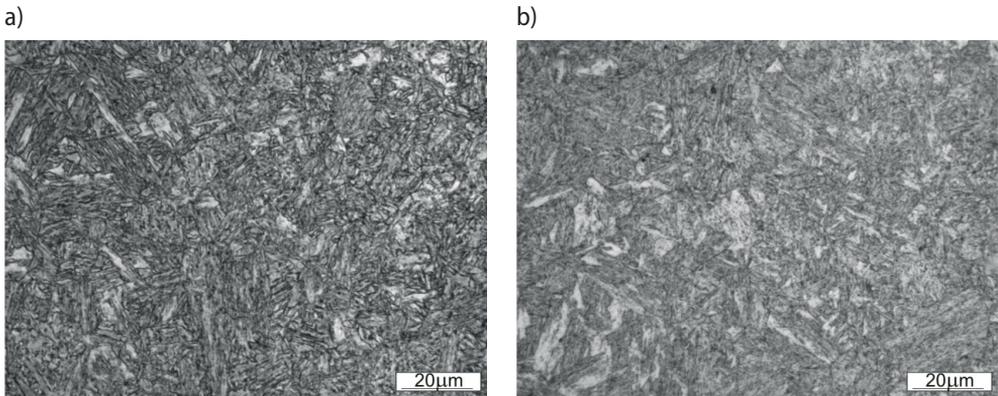
Fig. 1. Cross-sectional microstructure of screws after Process no. 1, light microscope: a) screw no. 1; b) screw no. 2; etched with 2% nital

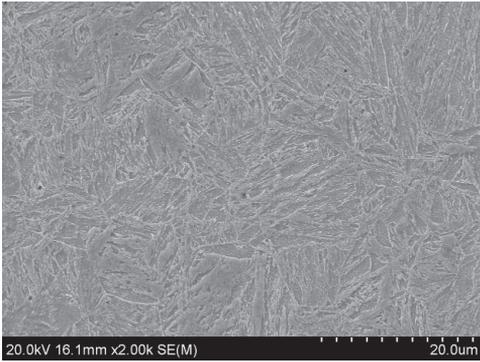
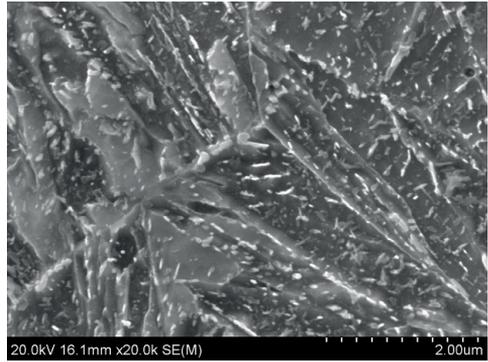
The microstructure of the screw after this process (no. 2) is shown in Figures 3–5. The morphology of the carbides in the screw after Process no. 1, its distribution, and quantity responds to the microstructure expected after quenching and tempering at 410°C (Fig. 2). The higher number of smaller carbides observed in the microstructure of the screw after Process no. 2 as compared to the screw after Process no. 1 responds to the microstructure expected after quenching and low tempering (Fig. 3).

Fig. 2. Cross-sectional microstructure of screw after Process no. 1 (screw no. 1), SEM; etched with 2% nital magn. x2000 (a) and x20000 (b)

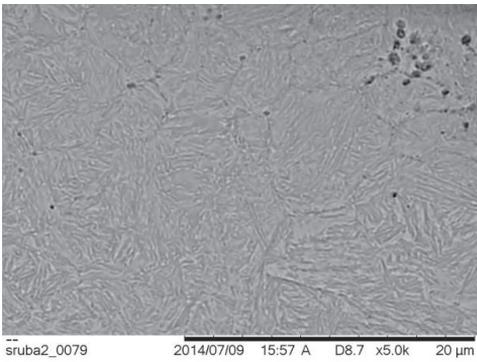
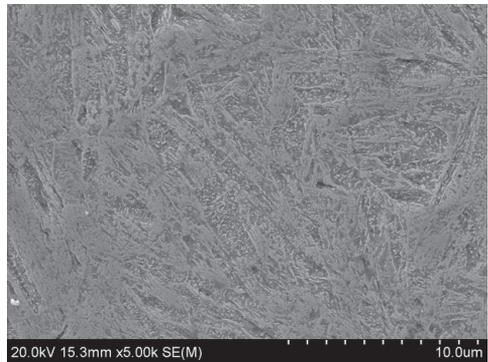
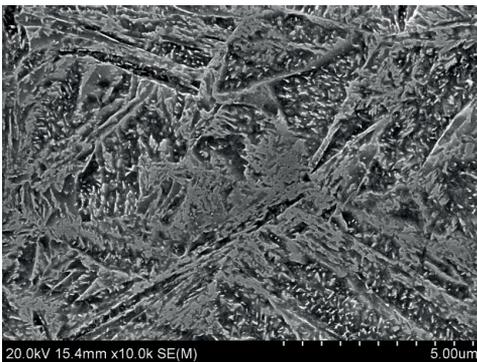
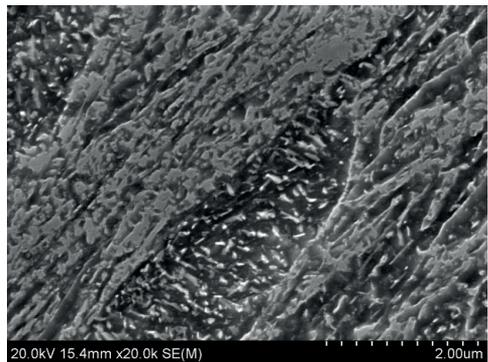
Fig. 3. Cross-sectional microstructure of screw after Process no. 2: a) subsurface below zinc layer; (b–d) area in core of screw; SEM; etched with 2% nital

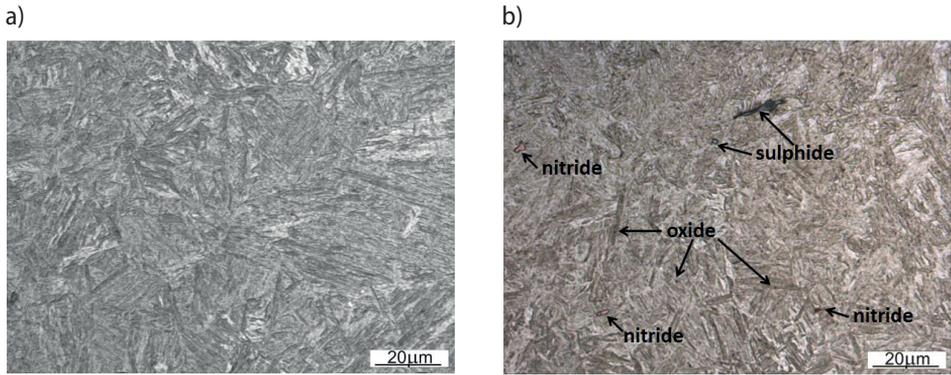
Fig. 4. Cross-sectional microstructure of screw after Process no. 2, light microscope: a) microstructure; b) non-metallic inclusions morphology; etched with 2% nital

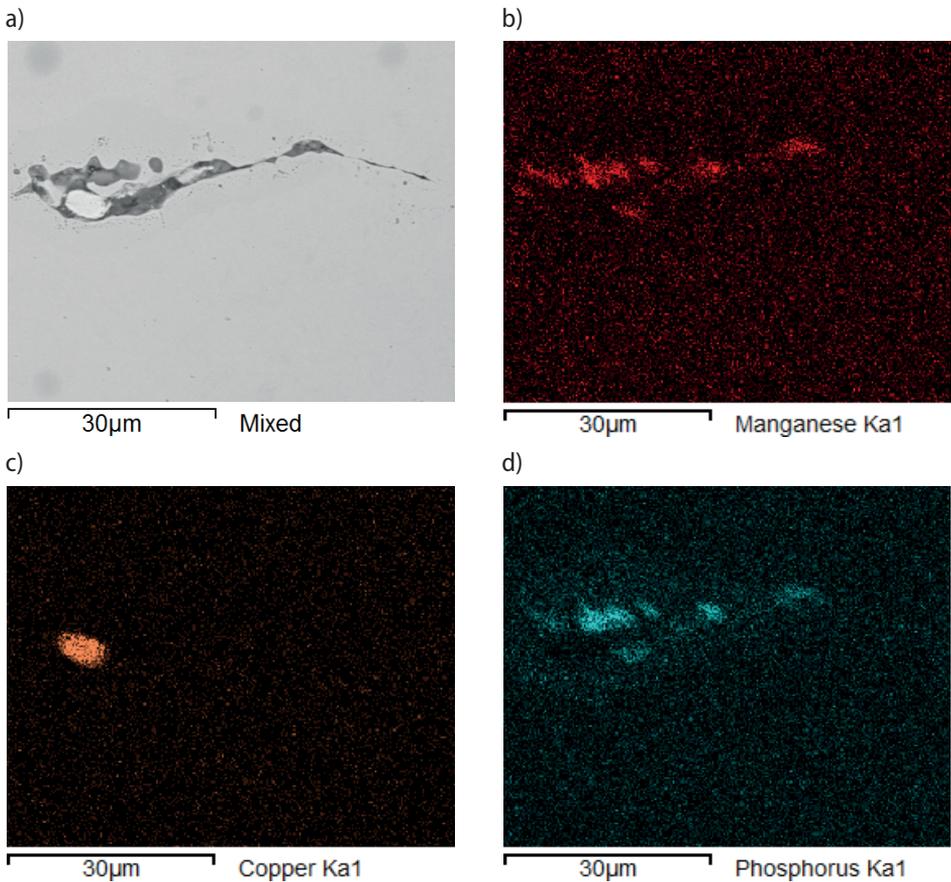
Fig. 5. EDS element map from conglomerate of non-metallic inclusions and copper in cross-section of screw after Process no. 2: area in core of screw: a) SEM; (b–d) EDS element map

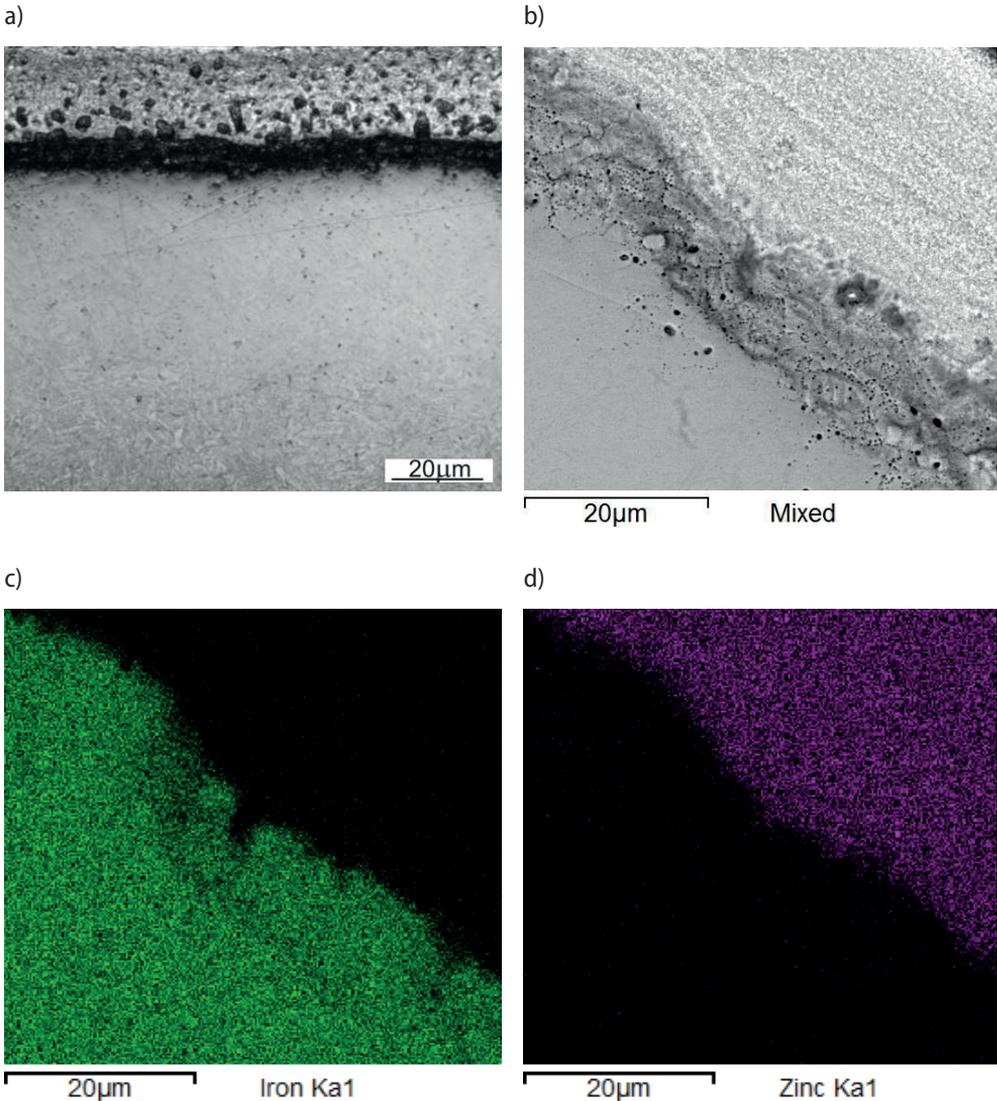
For the screw after Process no. 1, the zinc coating is uniform and proper (Fig. 6). In the case of the screw processed according to Treatment no. 2, the zinc layer is not uniform; however, numerous examples of zinc diffusion in the areas of the subsurface cracks are shown (Fig. 7).

Fig. 6. Zinc coating of screw after Process no. 1: a) light microscopy; b) SEM; (c, d) EDS element map

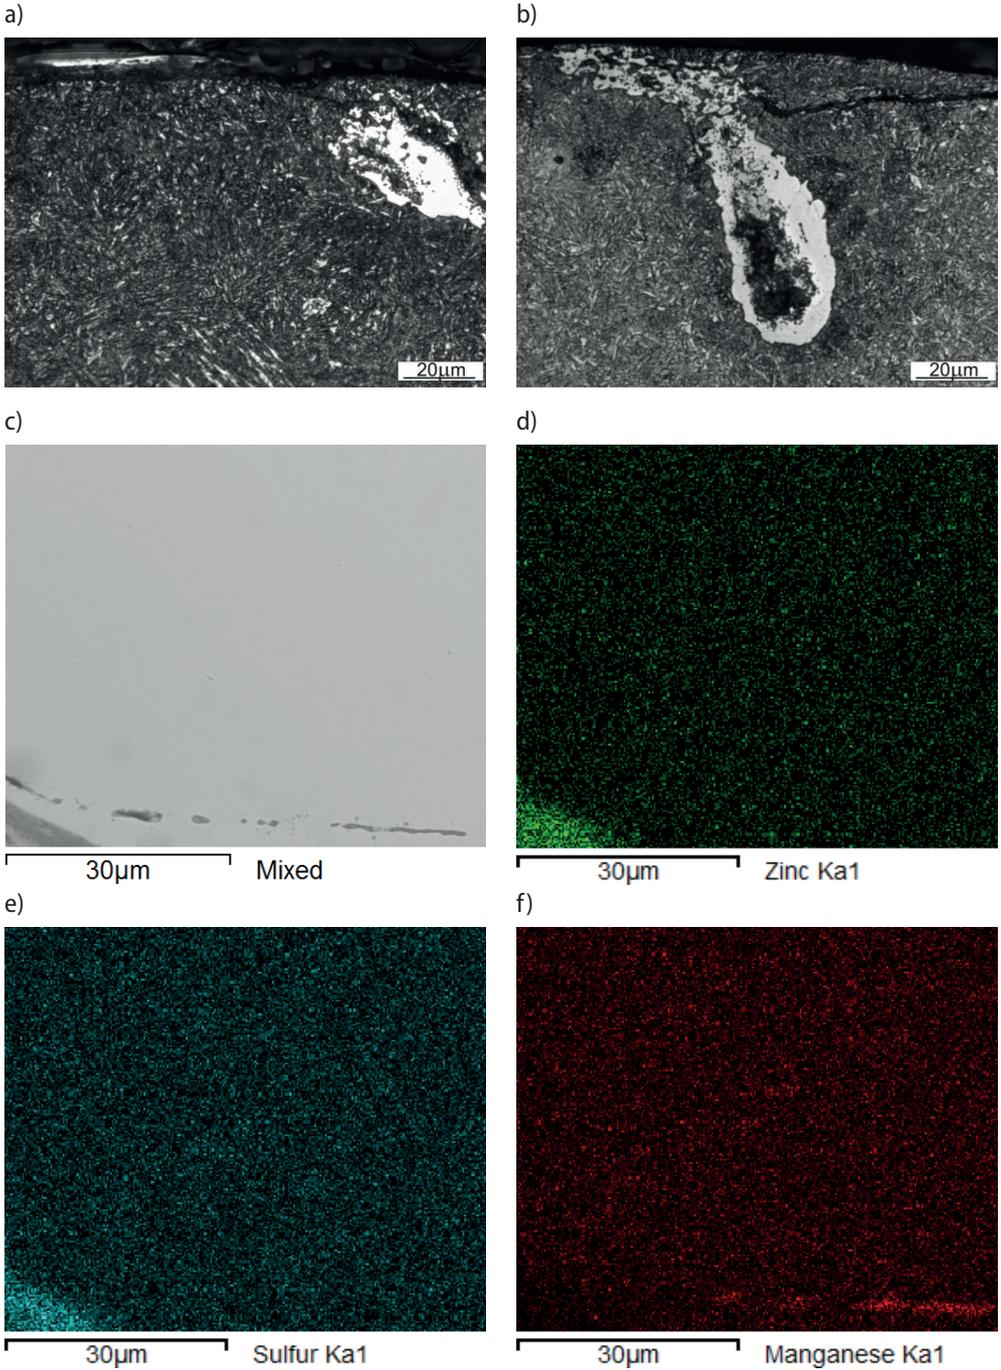
Fig. 7. Zinc coating of screw after Process no. 2: (a, b) light microscopy; c) SEM; (d–f) EDS element map

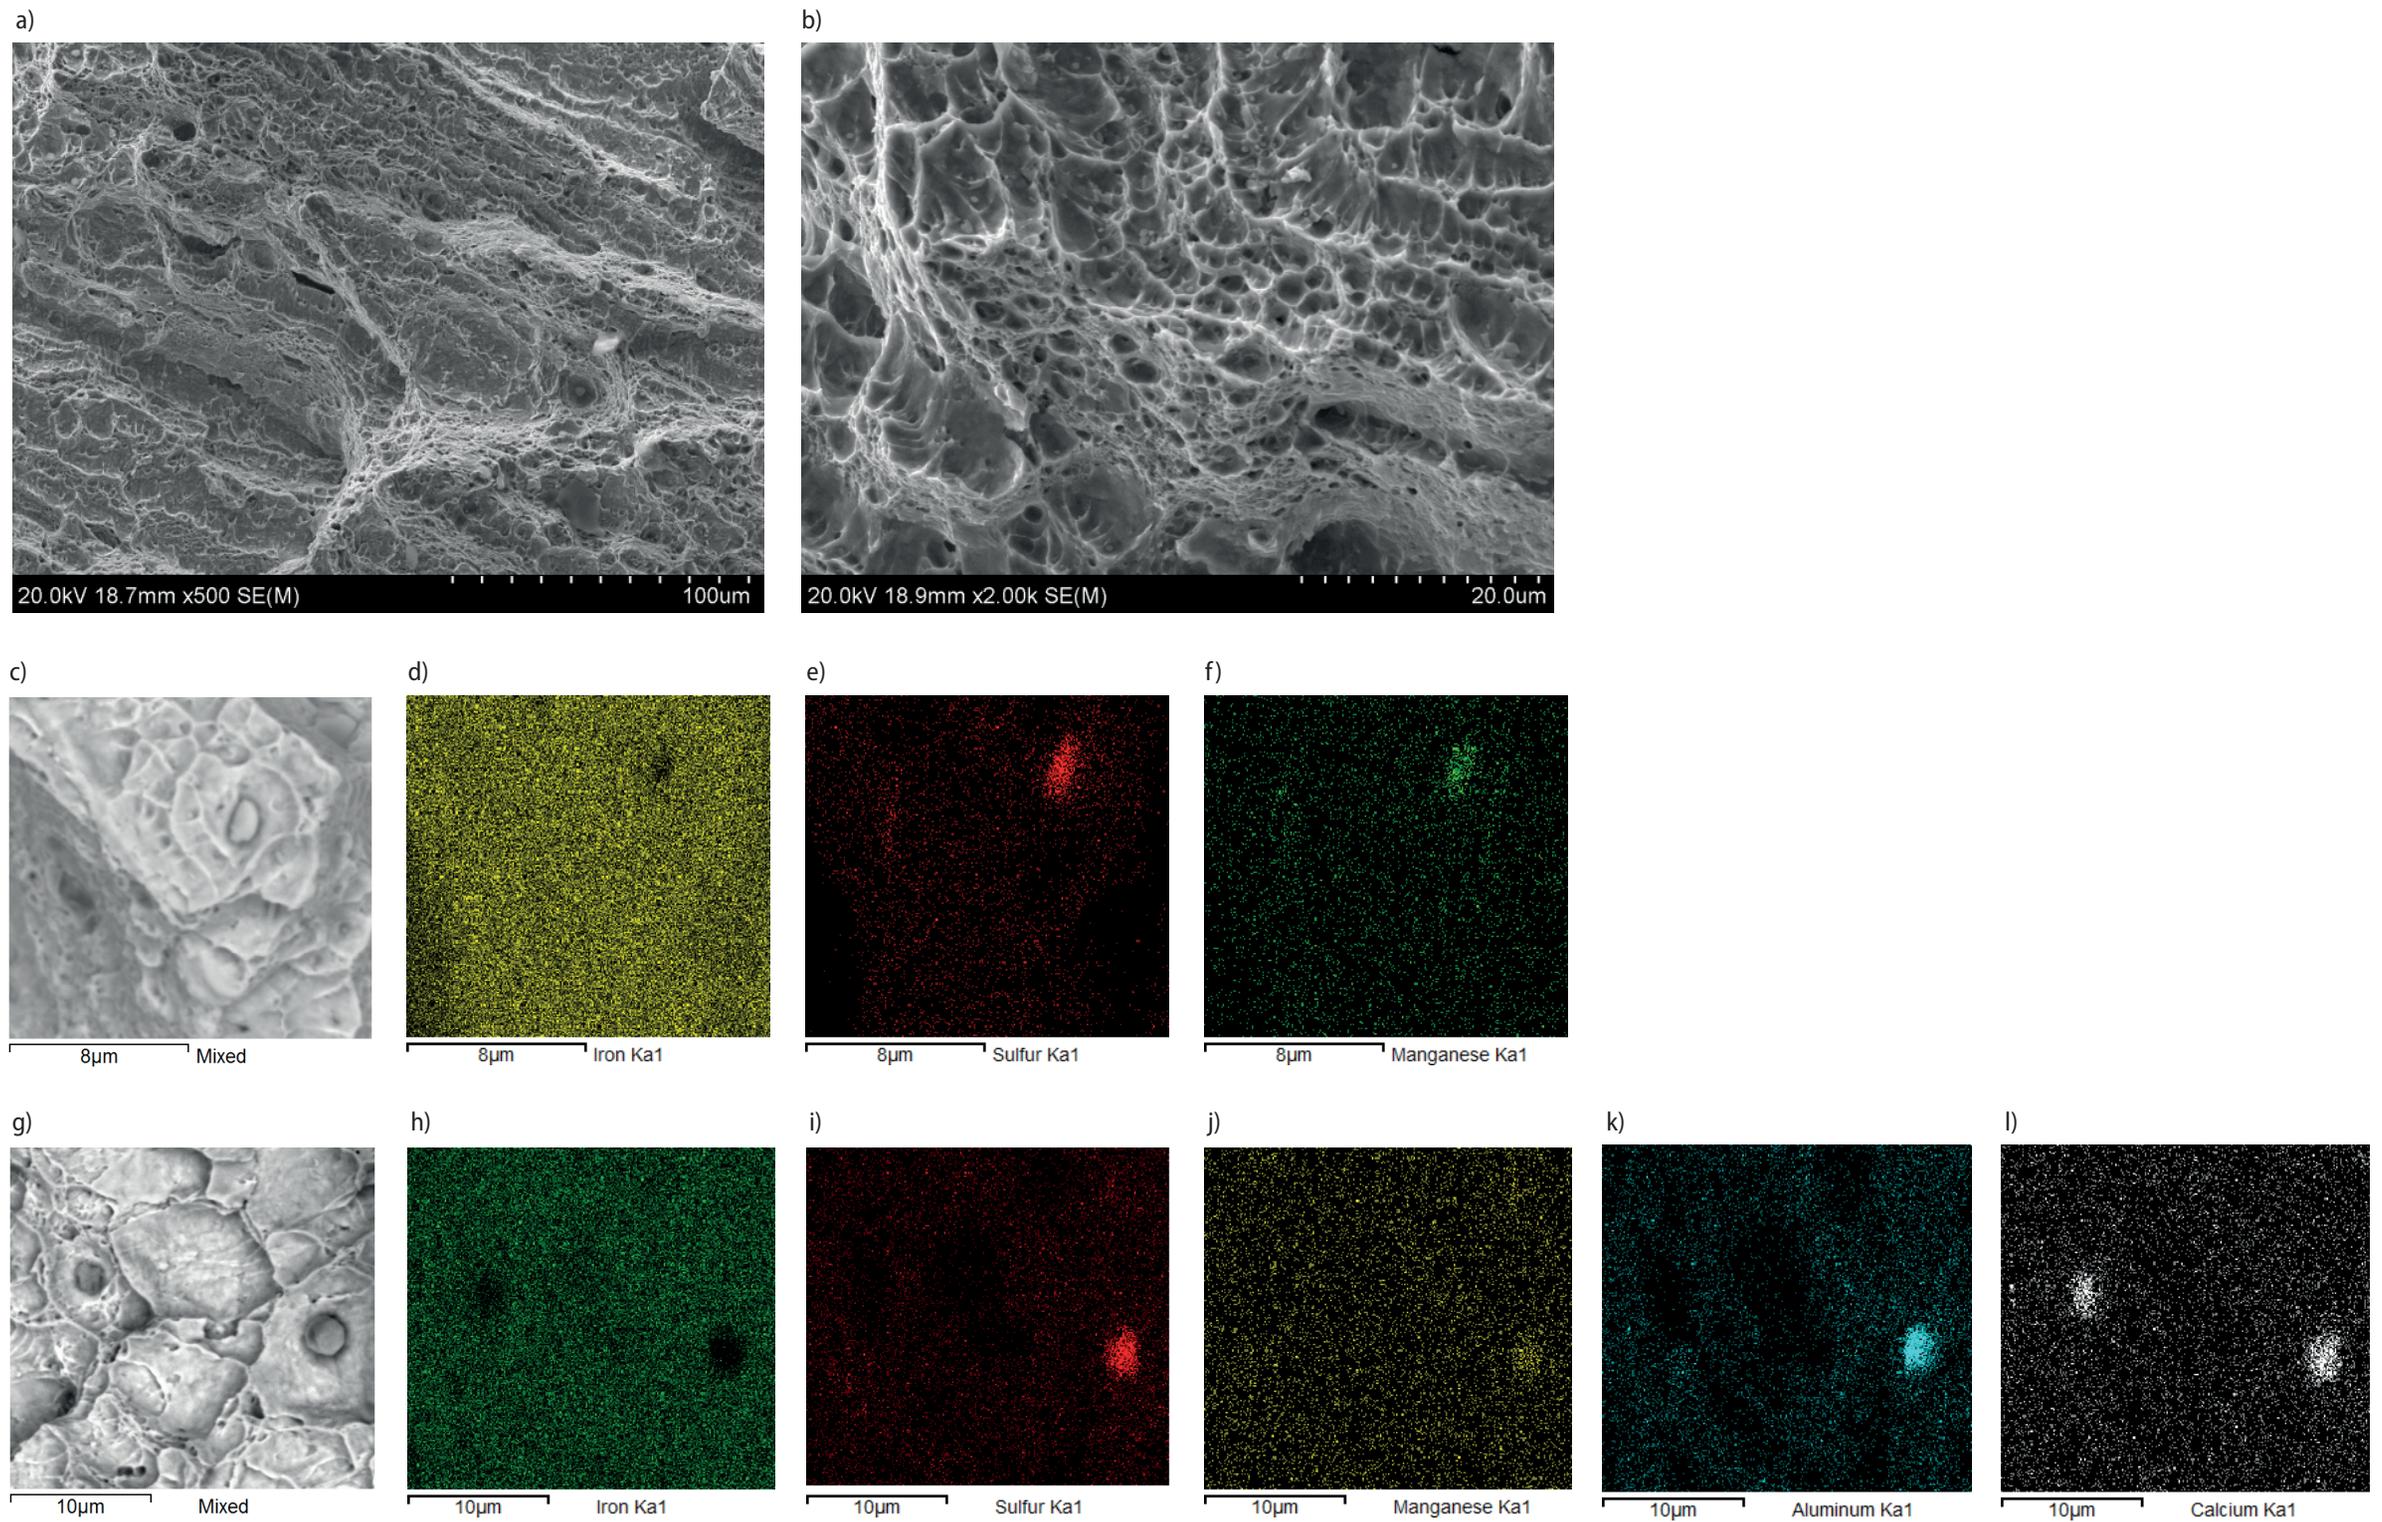
Fig. 8. Fracture of screw after Process no. 1, ruptured under laboratory conditions: a–b) SEM; c) surface for EDS analysis; d–f) EDS element map of area from Figure 8c; g) surface for EDS analysis; h–l) EDS element maps of area from Figure 8g

The rupture surface of the screw after Process no. 1 has only a transcrystalline, ductile, dimpled character (Fig. 8; on the interleaf).

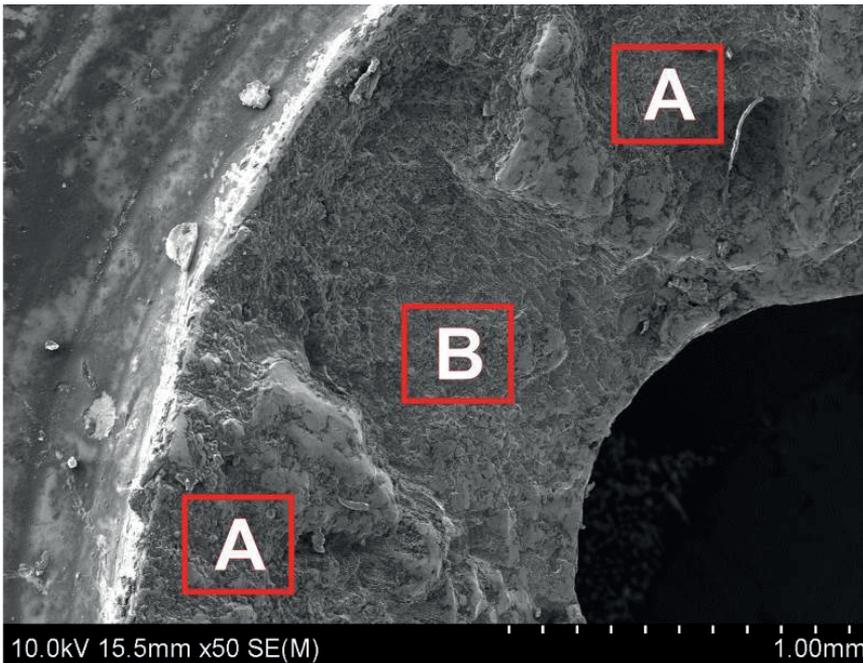
The rupture surface of the screw after Process no. 2 has two distinctly different areas (Fig. 9). In the area further from the surface, it shows a transcrystalline ductile fracture, a so-called dimpled rupture (Fig. 10). In the area closer to the surface, it shows a brittle intergranular fracture, indicating the occurrence of decohesion at the grain boundaries (Fig. 11).

Fig. 9. Fractography of screw after Process no. 2 with two distinctly different areas (A and B)

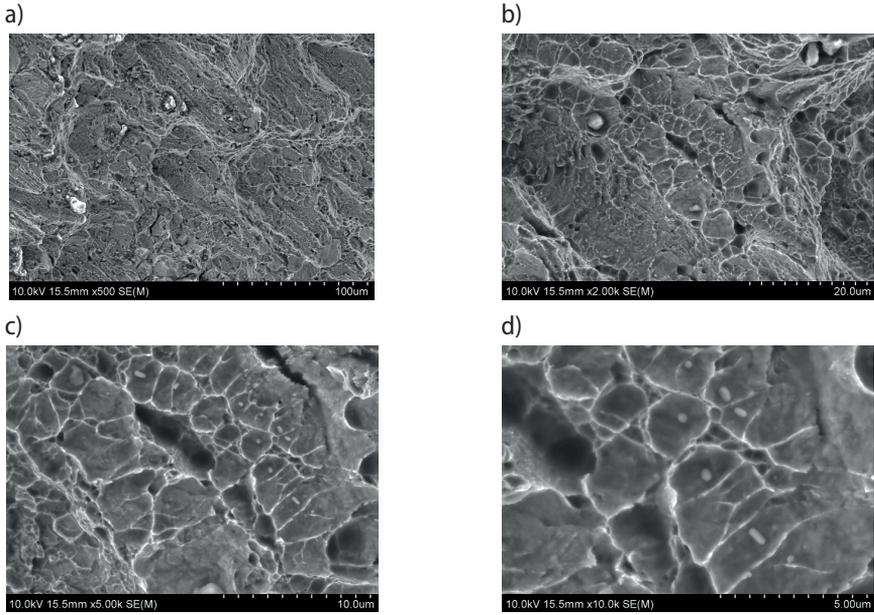
Fig. 10. Fracture surface of Area A further from screw surface, screw after Process no. 2, SEM, magn. $\times 500$ (a); $\times 2000$ (b); $\times 5000$ (c) and $\times 10000$ (d)

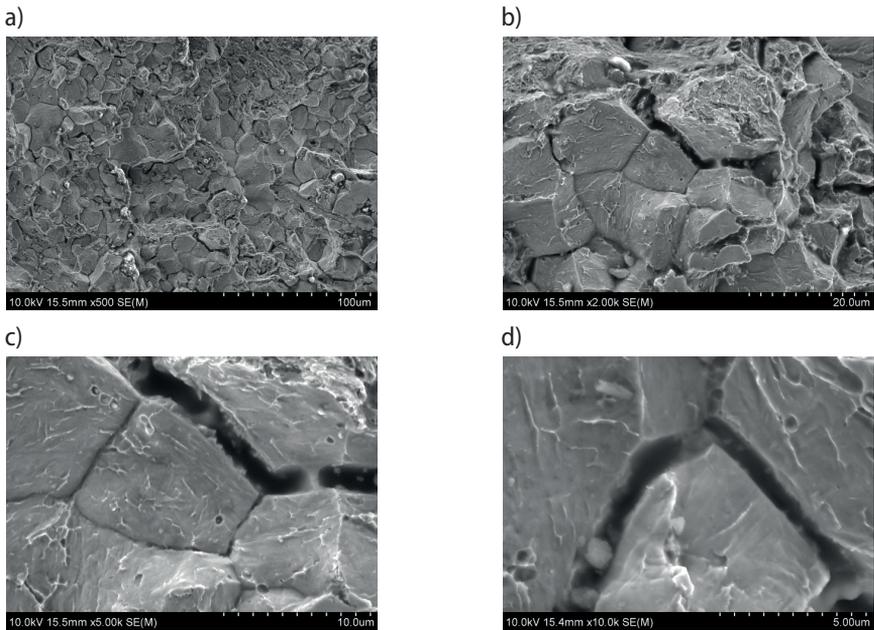
This brittle intergranular fracture corresponds to the hydrogen-assisted cracking [8, 9]. The process that exposes the steel to hydrogenation is galvanization [10, 11]. The effect of hydrogen on the mechanical behavior of steels is twofold: it affects its local yield strength, and it accelerates material damage. On the other hand, the diffusion behavior is influenced by hydrostatic stress, plastic deformation, and the strain rate. This requires hydrogen sorption and diffusion [12–16]. For this reason, trapping and diffusion of the hydrogen depends on the microstructure [17].

Fig. 11. Fracture surface of Area B further away from screw surface, screw after Process no. 2, SEM, magn. $\times 500$ (a); $\times 2000$ (b); $\times 5000$ (c) and $\times 10000$ (d)

3. Most likely, the brittle intergranular fracture is caused by the presence of hydrogen in the microstructure of the screw after Process no. 2 (coming from the electrolytically zinc coating).
