MAREK PŁACHNO
SŁAWOMIR BARANOWSKI
IRENEUSZ OŚLIŹNIOK

Difficulties related to the renovation of the reinforcement of the V shaft at PGG Oddział KWK Ruda Ruch Bielszowice

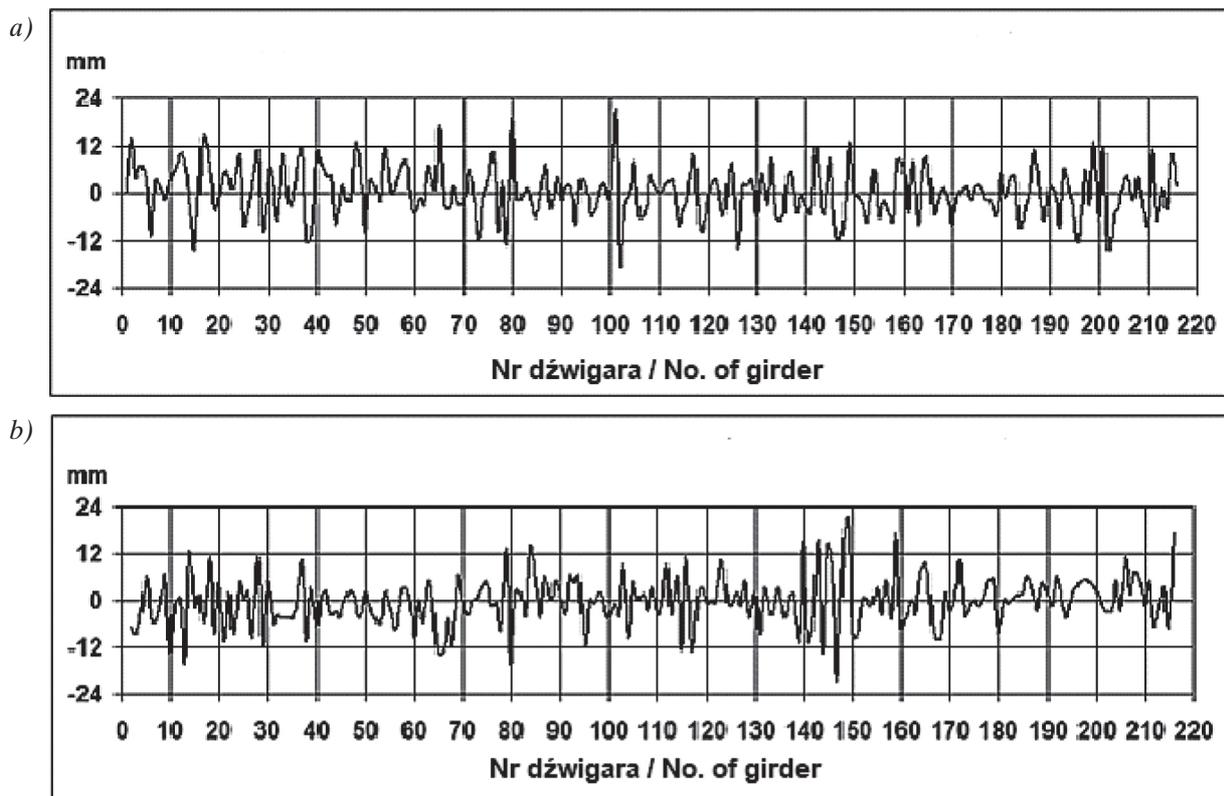
On the basis of the measurement survey [7], for all guide tracks in the V shaft, diagrams were developed reflecting the distributions of differential frontal and lateral deviations from the straightness of the tracks leading the extraction vessels along successive main girders in the shaft. Figure 2 shows, as an example, graphs representing one of these distributions. Each of the discussed distributions was then subjected to the mentioned statistical analysis. It showed that for each of the guide tracks in shaft V, the proportion of the corrosive component in the extreme values of these deviations is not less than 50%. On this basis, it was decided to carry out an inventory of fissure disappearances in the assembly of individual sequences in shaft V, and then to take steps to remove the identified clusters of these disappearances.

Fig. 2. One of the distributions – along the successive main girders – of differential frontal (a) and lateral (b) deviations from the straightness of the tracks leading to the hoisting vessels of the eastern southern ski-frame track in shaft V, developed on the basis of the measurement survey [7]

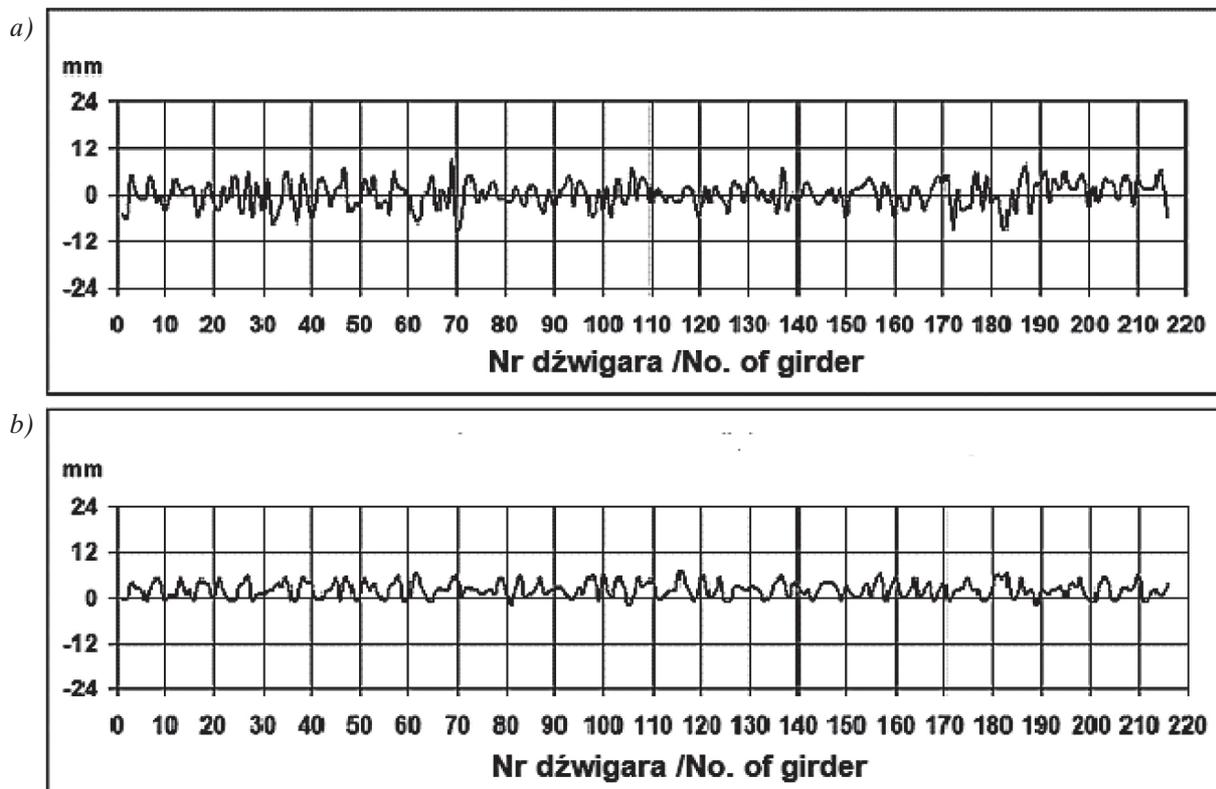
Approximately 3 months after the removal of the largest clusters of gap disappearances on the assembly of the chain of individual track guides, straightness measurements were made again and, based on the measurement frame [8], graphs were again developed reflecting the distribution of differential frontal and lateral deviations from straightness along successive main girders in the V shaft, illustrating effect of actions taken. These charts (Fig. 3) were drawn on the same scale as the previous ones (Fig. 2), which was meant to facilitate the perception of the obtained effect. This effect, in the case of the eastern southern snap-shot guide, is to reduce the greatest frontal deflections from 21 mm to 9 mm and the greatest lateral deflections from 20 mm to 7 mm. As a similar effect was obtained for the remaining lead tracks in the northern section of shaft V, it was not only found that the assumptions made were correct, but also the action taken and implemented was justified.

Fig. 3. One of the distributions developed on the basis of the measurement [6] – along the successive main girders – of differential frontal (a) and lateral (b) deviations from the straightness of the traction vessel tracks of the eastern southern ski-cage track in shaft V – after removing the largest clusters of gap disappearances on folding the chain of guides

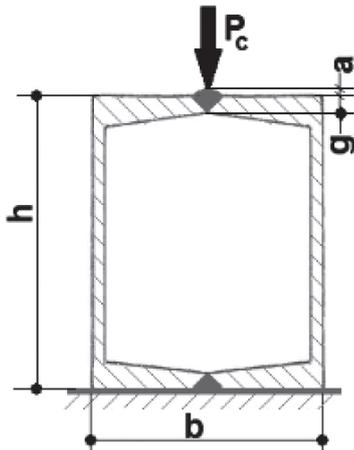
Fig. 4. Calculation diagram for stresses in the weld connecting the chain sections

Using formulas (1) and (2), it was calculated that when the actual force of the extraction vessel on the shaft reinforcement reaches the value of the force P_c , the stress σ_s may have a value of approx. 530 MPa, which means that it will be greater than the immediate strength R_m of the material guides of 380 MPa. Therefore, it was found that the direct cause of cracking of the weld connecting the chain sections is the convexity of this weld, although such convexity is accepted by the standard BN-78/1727 [1].

- Each fracture of the weld has a tendency to propagate along the weld in both directions, and therefore in the conditions of shaft V it will endanger the safety of the chain when it reaches the length of 0.5 m. Then, the chain with such damage may experience a rapid loss of lateral stiffness, which –

- with a probability significantly greater than zero – may lead to the suction vessel falling out of its guide tracks. Any chain in the V shaft showing a weld fracture of a length equal to or greater than 0.5 m should therefore be replaced immediately.

- The guides in the V shaft which show a weld fracture less than 0.5 m in length may be operated if:
 - show wall wear lower than acceptable;
 - this consumption is controlled in accordance with the requirement of point 3.13.7.4.1 of Annex 4 to the Regulation [6];

- the ends of the weld crack are protected against its propagation, e.g. by drilling an appropriate hole;
 - records of chains showing both existing and newly formed cracks in joints are verified at least every 6 months;

- the records, in addition to the number of the girder closest to each fracture, contain information on the length of the recorded fracture and the absence or occurrence of its propagation beyond the securing holes.

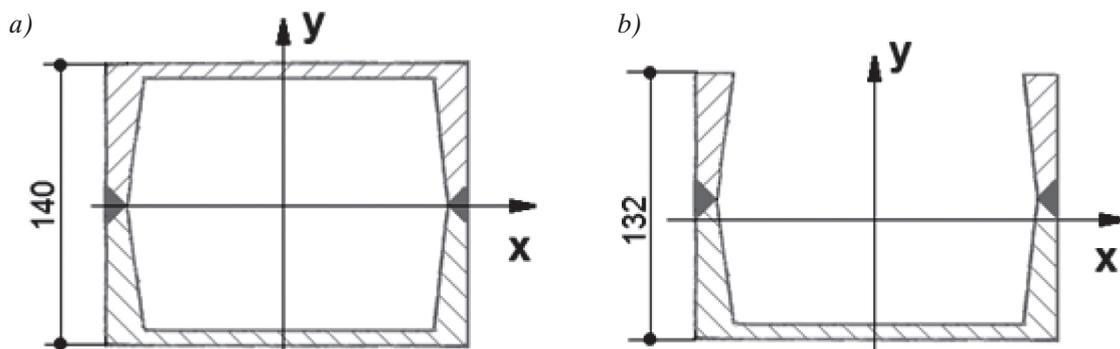
The third and final step in the scope of the research undertaken was to determine the impact of the perforation of the upper walls of the main and strut girders on the safety of the guide tracks. For the main girders, this influence was determined by comparing the bending strength indices calculated – according to the diagram in Figure 5a – for the cross-section of the main girder without perforation of its walls with such indices calculated on the basis of the diagram shown in Figure 5b. The comparison was made using the graphs in Figure 6, which show the results of the calculations performed. On this basis, it was determined that the perforation of the upper wall of the main girders in the V shaft reduces their strength by approx. 16%, therefore the main girders in this shaft showing such damage can be safely used, as long as their wear outside the perforation area is not greater than 84% of the permissible wear of girders without perforation.

Fig. 5. Calculation diagrams of the cross-section of the main girder in the V shaft for the girder case: a) without perforation of its walls; b) with perforation of its upper wall

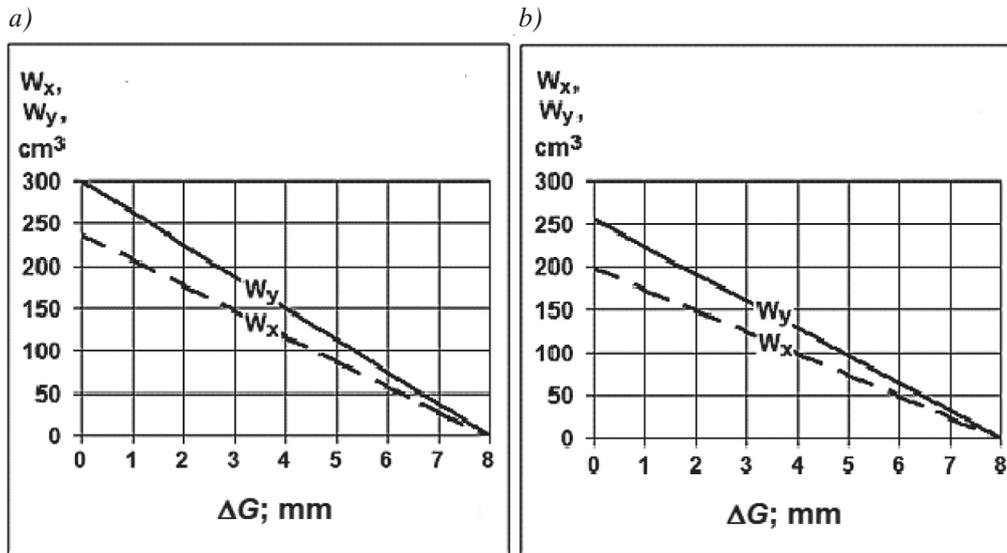
Fig. 6. Influence of the decrease in thickness (ΔG) of the walls of the main spar in shaft V on its bending strength indexes (W_x , W_y) in the absence of (a) or presence (b) of perforation of its upper wall

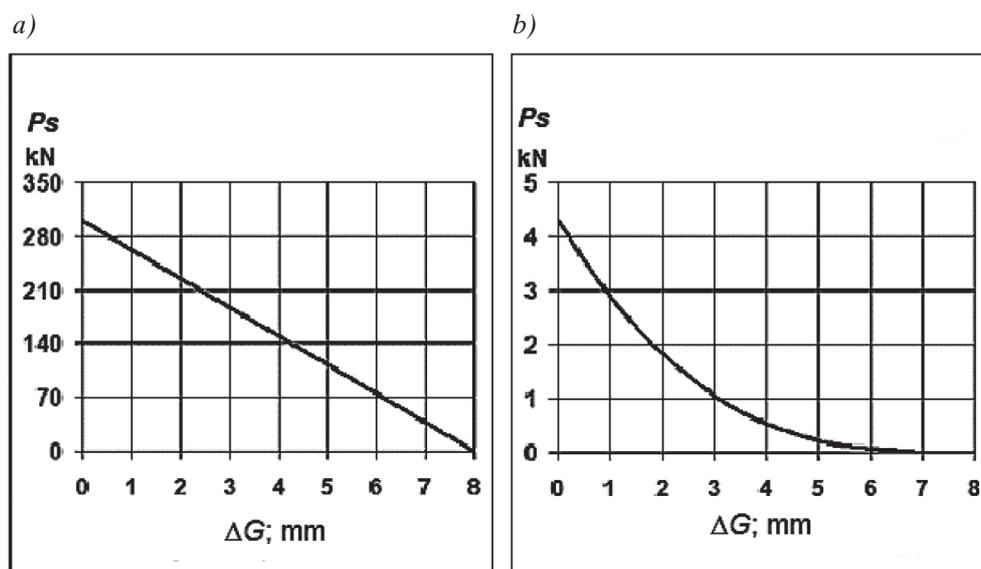
On the other hand, for the spreader beams, it was assumed that, before formulating the analysis scheme that would enable the determination of the impact of the perforation of their upper walls on the safety, calculations of the permissible compressive force of these beams were made. Their results (Fig. 7) showed that the perforation of the upper wall of the expansion beams in the V shaft significantly reduces their allowable compressive force that in strength calculations of the V shaft reinforcement, the perforated span beams cannot be considered as rigid supports of the main

Fig. 7. Influence of the thickness loss (ΔG) of the walls of the expansion girder in the V shaft on the allowable compressive force (P_s) of this spar in the absence of (a) or the presence (b) of the perforation of its upper wall

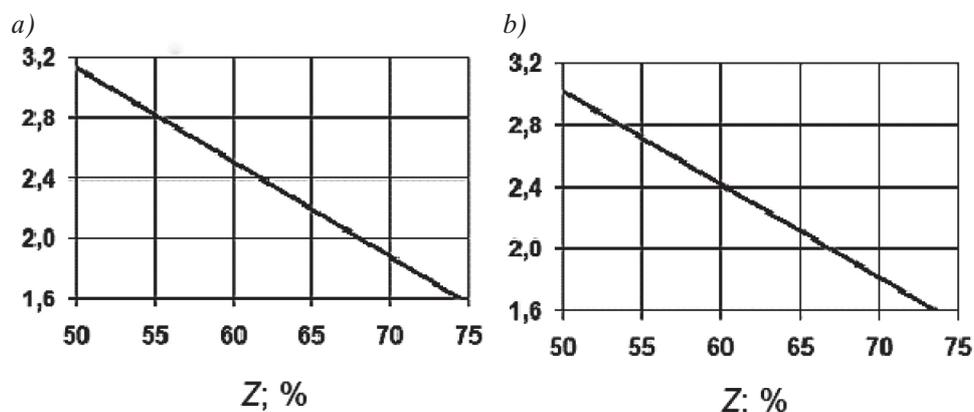
Based on the results of the discussed comparison, it was found that the perforation of the upper walls of the strut girders in the V shaft did not have a significant impact on the safety of the tracks of the exhaust vessels in the shaft. This is due to the fact that the loss of the expansion girder – due to the perforation in question – of its ability to perform the function of a sufficiently rigid support of the main girder causes a reduction in the structural rigidity of the main girder as a support for the guides attached to it. As a result – in the elastic range of the material – also the maximum frontal forces absorbed by the main girder from the suction vessels are proportionally reduced. Then the guidance track safety coefficient does not experience any significant reduction, nor does the deflection of this track increase significantly.

An equally important finding resulted from the evaluation of the values of both variables appearing in the graphs in Figure 8. With the wear of the walls of the guides and girders equal to 50% of the initial thickness of their webs, the smallest excess of the calculated value of the safety factor of the tracks leading the exhaust vessels in the V shaft, in relation to the required value of this coefficient as it amounts to approximately 67%. This statement indicated that with the current technical condition of the reinforcement of the V shaft, it is possible to maintain the required safety of the tracks of the extraction vessels during the renovation of this reinforcement with an increase of over 50% of the permissible wear of the guides and girders. On this basis, the user of the shaft in question decided to take action in this regard, in accordance with § 536 par. 1 lit. h of the Regulation [1] and with the recommendations given in the publication [2, 11].

Fig. 8. One of the sets of results for the calculation of the safety coefficients of the southern ski-cage guides in the V shaft, corresponding to the stretchers without (a) and (b) with wall perforation, depending on the wear (Z) of the walls of the guides and main girders
