Rafał Gawałkiewicz*, Mikołaj Skulich**

Surveying Monitoring of the Annunciation of the Blessed Virgin Mary Church in Inowrocław, Located in a Mining Area, **Applying Reflectorless Technologies** and Precise Levelling***

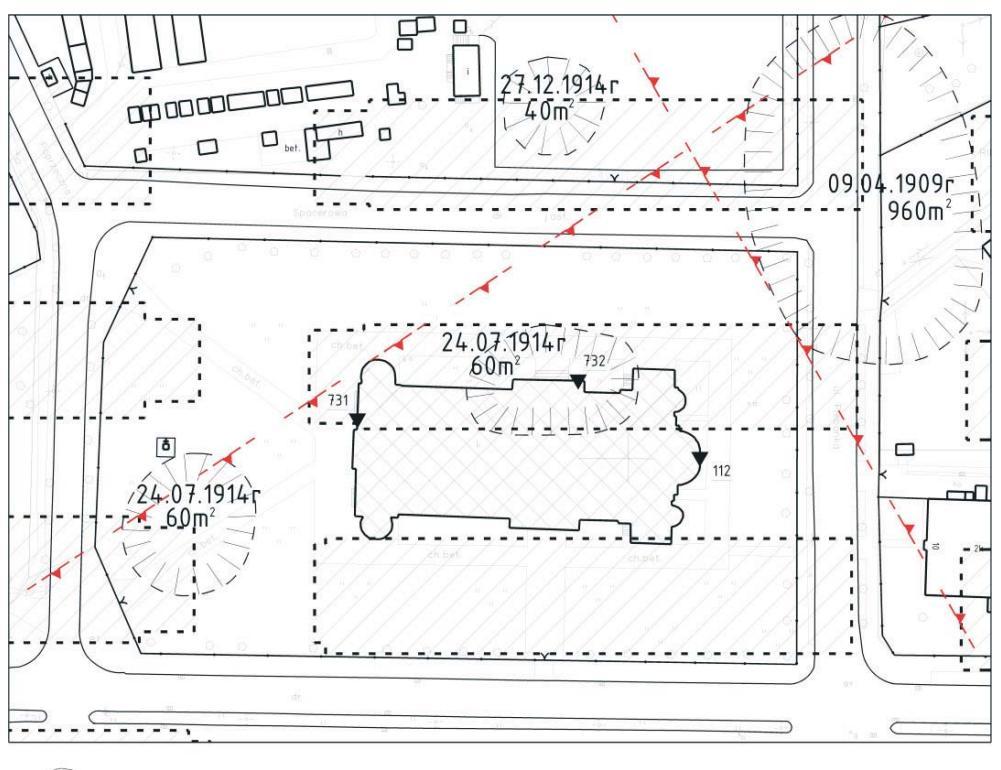
caused, already in the first years of the mining industry, mining damage in the form of large-surface subsidence areas of the surface, damaging or totally destroying many construction objects located on the surface [1]. One of such objects, which was seriously damaged by the subsidence in the first years of mining was the Annunciation of the Blessed Virgin Mary Church [2] (Fig. 1 – depression no. 4).

Fig. 1. Location of historical depressions in the closest vicinity of the Annunciation of the Blessed Virgin Mary Church in Inowrocław: 24.07.1914 (area 60 m²), 27.12.1914 (area 40 m²), 24.07.1914 (area 60 m²), 09.04.1909 (area 960 m²)

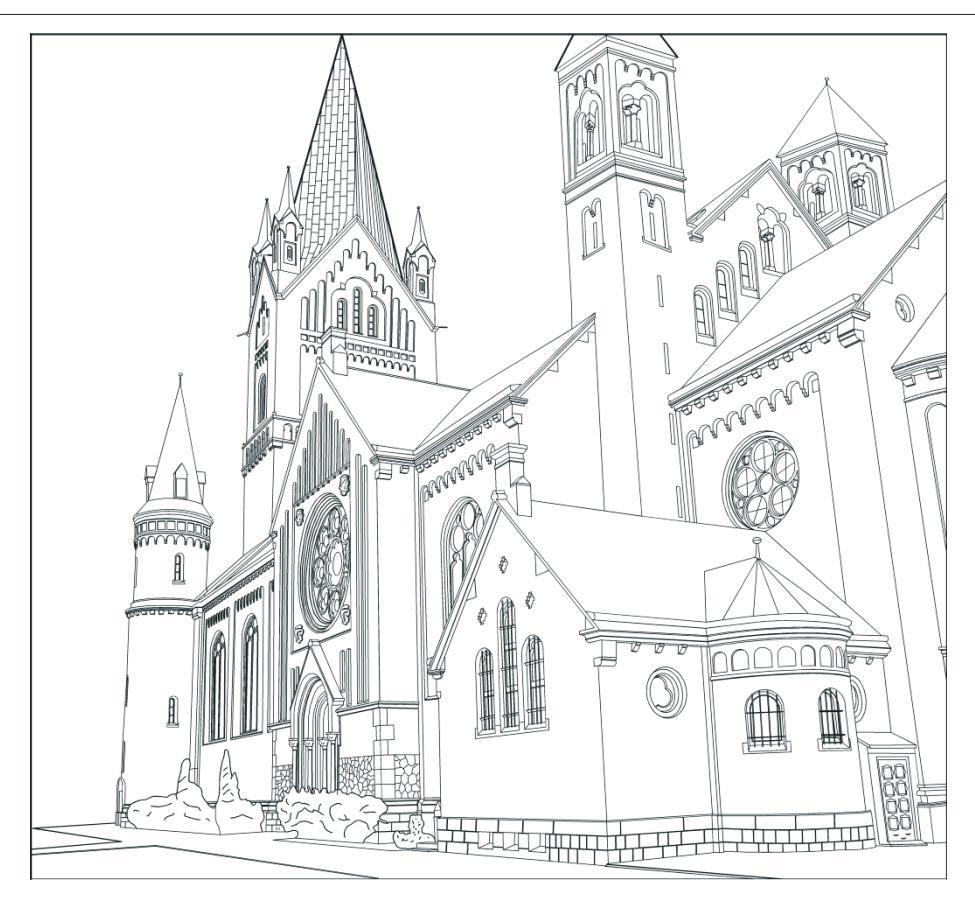
Fig. 2. The Annunciation of the Blessed Virgin Mary Church in Inowrocław – view from the south-east

Delicate construction of a monumental character is extremely sensitive to even slight movements of rock mass (bed). A characteristic element of this object, which dominates over the city, is a huge 76 m high spire (Fig. 2), with a very large rosette window and highly ornamented portal. Three-ale character of the church [4], of the dimensions: length 63 m, transept width 27 m, makes the object very sensitive to all the changes in the morphology of the bed. Apart from the uneven subsidence of the elements of the building construction (pillars, pilasters) also the floor and ceilings of the ales were deformed. A particularly dangerous effect of these deformations include scratches and cracks (often with dislocations) on the walls and ceilings being a result of the uneven strain of the bed. These phenomena became the source of the deformation of the building, and this way contributed to undertake all the activities aimed at the definition of the carried out surveying monitoring.

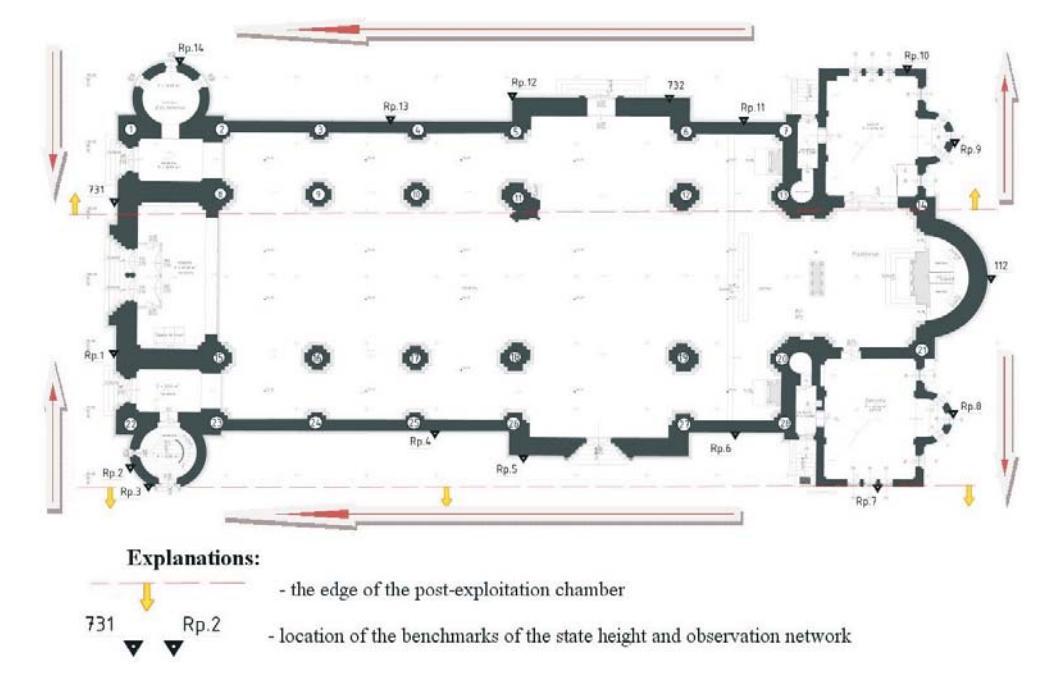
Levelling studies included the measurements of the differences in the height between the neighbouring benchmarks in chains following the scheme presented in figure 3.

During the first two years visible and significant changes in the morphology of the floor were recorded in the central zone of the church (crossing between the main ale and transept) in the region of pillars no. 10, 11 and 12 (numbers given in figure 3). Changes in height differences in the triangulation network do not exceed the value ±1 mm. The situation changed significantly within a longer period (5 years), when many measures were taken to secure the solid of the church at the height of about 8 m over the floor.

- southern (right-side ale) within benchmark Rp. 4, where near pillar no. 24 changes in height differences reached 3 mm;
- visible changes in the vicinity of pillar no. 11 (with the pulpit), where the flattening of the floor occurred reaching about 1 mm;
- in the north-west part, in the vicinity of pillars no. 8 and 9 the deflection increased by more than 1.5 mm.

directions of these changes) terms. Particularly visible changes were registered in case pillar no. 12 (Fig. 3), which, in the period of the 5 recent years was subdued to significant deflection and can make a particular threat to the ceiling in this part of the church and the pilaster of the northern walls no. 4 (Fig. 3), which was subdued to the rectification process on the other hand.

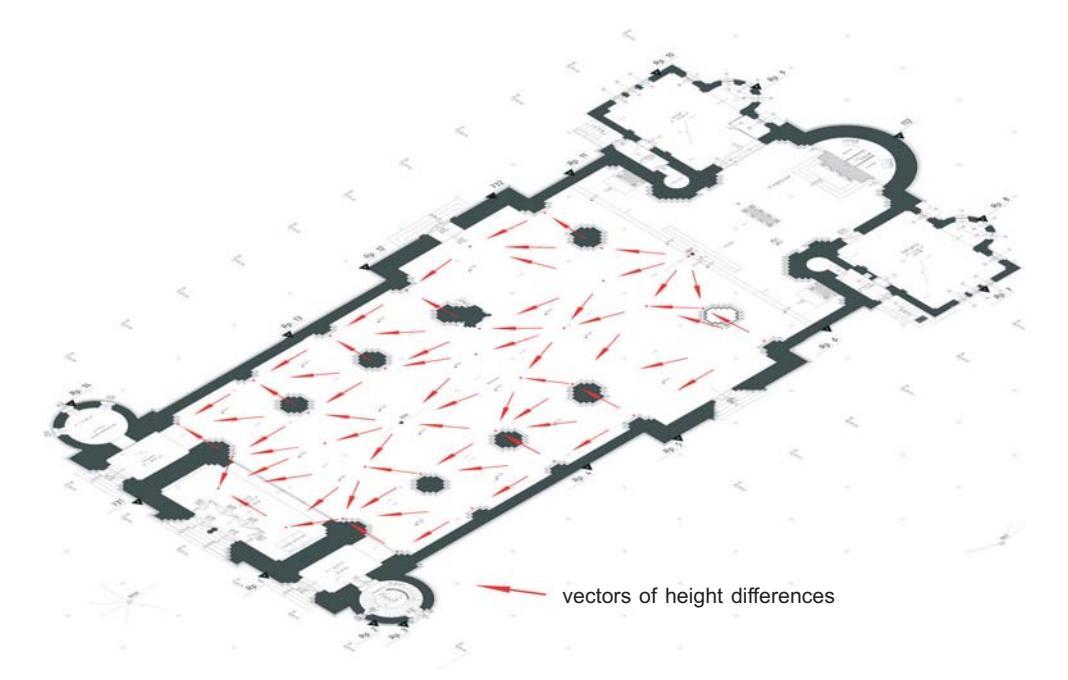
To find the accuracy of the analysis and regard the variability of not only the values of height differences ΔH , but also their signs (effect similar to "floating" of subsequent parts of the fundament) directions of the analyses on individual bays were accepted following the scheme as in figure 4.

Fig. 4. The scheme of the triangulation network – vectors of the marked height increases in the primary measurement (2005)
