*Marek Ciało **, *Jerzy Flisiak **, *Justyna Adamczyk **,
*Malwina Kolano **, *Michał Kowalski **, *Agnieszka Stopkiewicz **

THE ANALYSIS OF THE SLOPE STABILITY IN A BASALT STRIP MINE BY MEANS OF THE BACK ANALYSIS METHOD TO DETERMINE STRENGTH PARAMETERS

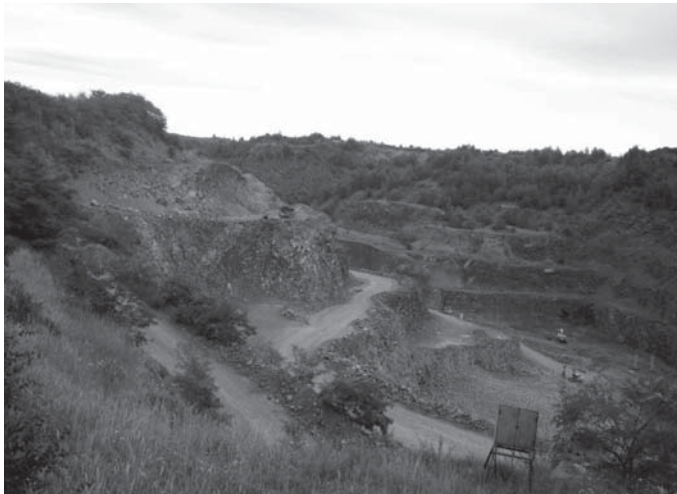
The basalt mine in Gracze is situated in Opolskie Province, in Niemodlin commune territorial division. The mine is one of the oldest mines of that type in Poland, and its history dates back to the 16th century [8]. The mined basalt deposit is the upheval of WSW-ENE strike, and dimension of 100 m by 130–170 m of width, leading up to a height of 197 m above sea level. The deposit is surrounded by silty formations, marls, chalk formations and silty basalt residual soil. The mine carries out mining by means of cut-and-cover method in the slope deep-seated quarry of 8 levels of mining. At present the depth of the mine reaches approximately 90 m. Mining is conducted by means of wall system with the average wall length of 15 m. The inclination of the slopes amounts to 80–85° (Fig. 1).

Fig. 1. Bazalt Gracze mine

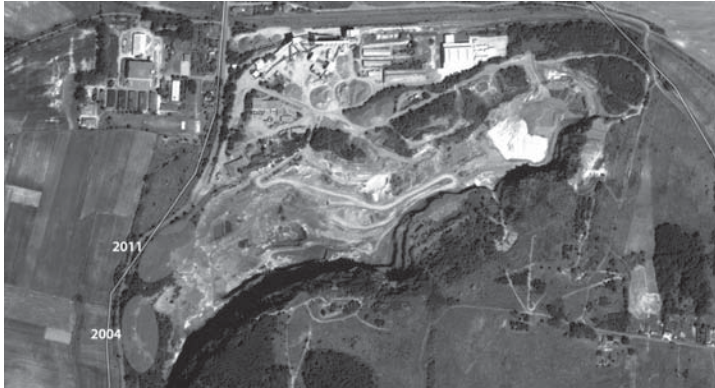
central part of south-western slope [3]. The other one is north-western part of the open cast. In this part there are two landslides, which occurred within a short distance. The first one is the landslide that occurred on 28th June 2004, which is 150 m long and 270 m wide, the one which occurred on all mining levels. The rock volume that underwent landslide processes is estimated at approximately 700 thousand m³ [1]. That landslide (Fig. 2, Fig. 3) occurred in the neighborhood of the road Gracze-Niemodlin.

Fig. 2. Landslide areas that occurred on 19th July 2011 and in 2004 [4]

On 19th July 2011, in the North-Western part of the open cast, there was a landslide that covered an area, which measured 170 m by 120 m. That landslide affected the upper part of the slope of about 75 m height, up to the floor level VII [6]. It resulted in damage to a 50 m stretch of the district road at Gracze-Rogi. The area affected by landslide processes is shown on the reconnaissance map (Fig. 2) and in the photo (Fig. 3).

The presented stability analysis of north-west part of open cast in ‘Bazalt-Gracze’ mine was conducted on the grounds of data determined by means of back analysis. Back analysis in the presented case was made which data which came from the landslide area, which occurred in 2004 (Fig. 2, 3), adjacent to the area where the new landslide occurred in 2011. The parameters were based on that and were verified by doing calculations for the state before the landslide (for the landslide area from 2011). In that way, the safety factor $FS = 1.064$ (Fig. 8) was obtained for the intersection located in the central part of the landslide. It indicates great probability of landslide movements’ initiation in this region, and also appropriate choice of parameters. For such determined data, stability analysis was done for the slope geometry, which was re-profiled by the landslide. It made it possible to determine the zones of direct landslide hazard.

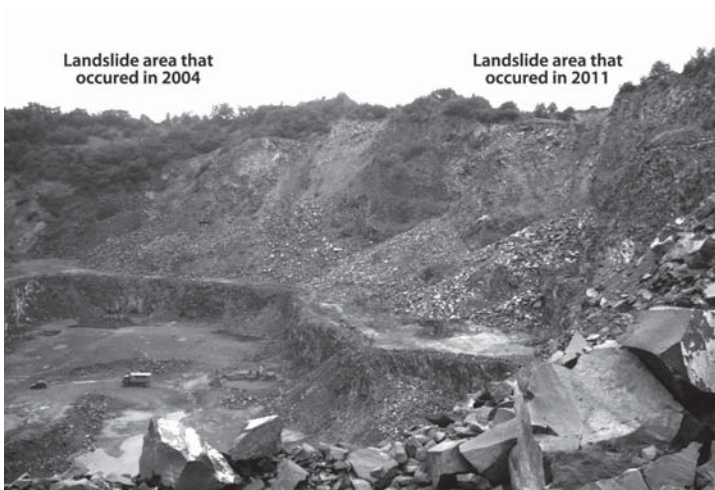
Fig. 3. Open cast view with the marked landslide area in 2004 and 2011

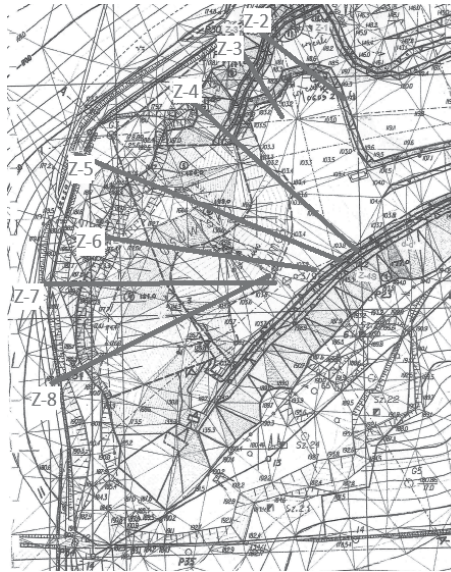
The analysis was conducted on three intersections: Z-2, Z-3 and Z-4 with the mining, which came from or was present in the close neighborhood of the landslide area from 2011 (Fig. 4).

Fig. 4. Location of the analyzed intersections

The stability analysis for the landslide area that occurred in 2004 was conducted by means of the limit equilibrium method, Janbu. To reproduce the situation before the landslide, intersections Z-5, Z-7 and Z-8 were used, which were located in the landslide zone (Fig.4); they were corrected in accordance with height-situational map showing the state of the open cast on 31st. Dec. 2003 [5]. The values of the parameters shown in Table 1, which come from the study carried out in 2004 [1], were accepted as starting point for calculations of the state before the landslide occurrence.
