**Maciej Pawlikowski\***

## **The mineralogical characteristics of plasters of various ages used for restoration of walls of the Chapel of Amun, Temple of Hatshepsut –Upper Egypt.**

\*/ Institute of Mineralogy, Petrography and Geochemistry, University of Science and Technology – AGH, Cracow

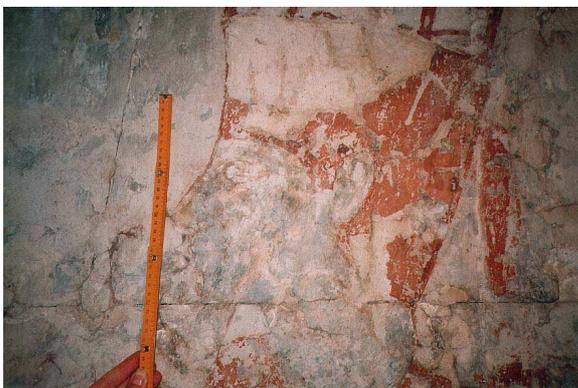
**sample AN1** -  $x = 8,83$  m,  $y = 3.77$  m (Photo 1, A) - pinkish plaster at the crown of Amun

Photo 1A. Location of sample AN1

Phot. 1, A - sample AN1 - pinkish plaster at the crown of Amun (  $x = 8.83$  m,  $y = 3.77$  m)

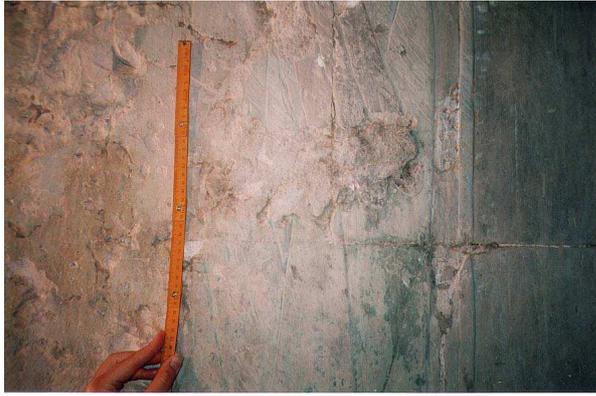
**sample AN3** -  $x = 6.18$  m,  $y = 3.56$  m (Photo 1, C) - flowers behind Hatshepsut coarse grained plaster composed of two layers from the second restoration

Photo 1C. Location of sample AN3

Phot. 1, C - sample AN3 - flowers behind Hatshepsut -coarse grained plaster composed of two layers; second restoration (  $x = 6.18$  m,  $y = 3.56$ m)

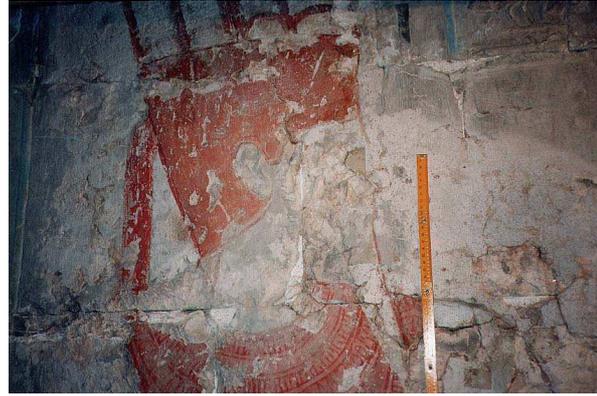
**sample AN4** -  $x' = 8.83$  m,  $y' = 3.85$  m (Photo 1, D) - nose of Amun, painted plaster after the first restoration + plaster made of Nile silt.

Photo 1D. Location of sample AN4

Phot. 1, D - sample AN4 - nose of Amun, painted plaster after first restoration + plaster made of Nile silt (  $x' = 8.83$  m,  $y' = 3.85$  m)

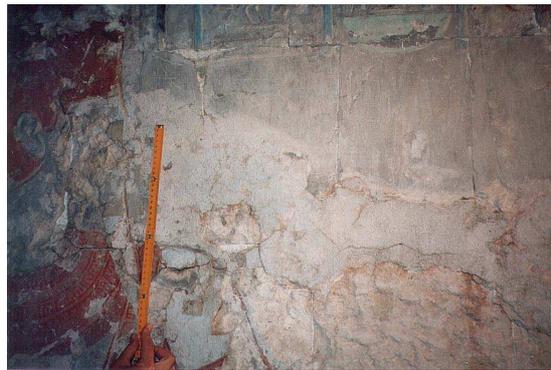
**sample AN5** -  $x' = 9.45$  m,  $y' = 3.85$  m (Photo 1, E) - left arm of Amun, original plaster used for primary reconstruction of a poorly prepared limestone block

Photo 1E. Location of sample AN5

Phot. 1, E - sample AN5 - - left arm of Amun, original plaster used for primary reconstruction of a poorly prepared limestone block (  $x' = 9.45$  m,  $y' = 3.85$  m)

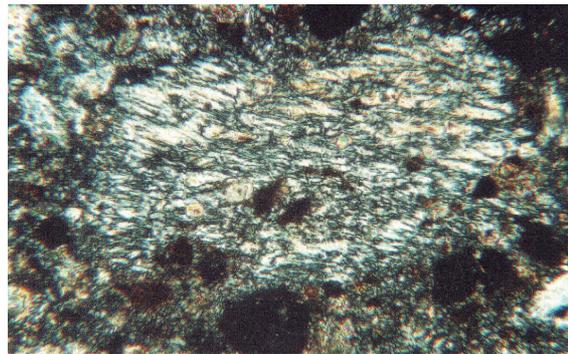
Photo 4E' Not grinded grain of Gypsum at fine gypsum mass. Polarizing microscope, polaroides X, magnify. 60 x.

Observation of morphology of plaster showed that material used for preparation of this plaster is of various granulation (Photo 2E). There are parts where material is finer but at other places one can see slightly coarser grains. This means that material for preparation of plaster was not well mixed. Observation of internal mineral structure conducted using polarizing light microscope showed the presence of coarser grains of fibrous gypsum and limestone mixed together with organic matter and relatively coarse grains of quartz (Photo 4E and 4E'). All mentioned components are fixed with fine gypsum.
