## **Geological and mineralogical investigation. PAVA project. Italy. Part I.**

### **Introduction**

The aim of presented investigation (part I) was to determine geological layers and relation between theses layers and phases of functioning of the site. On the other hand documentation of the rests of byzantine church as well as reconstruction of the elements of temple was performed.

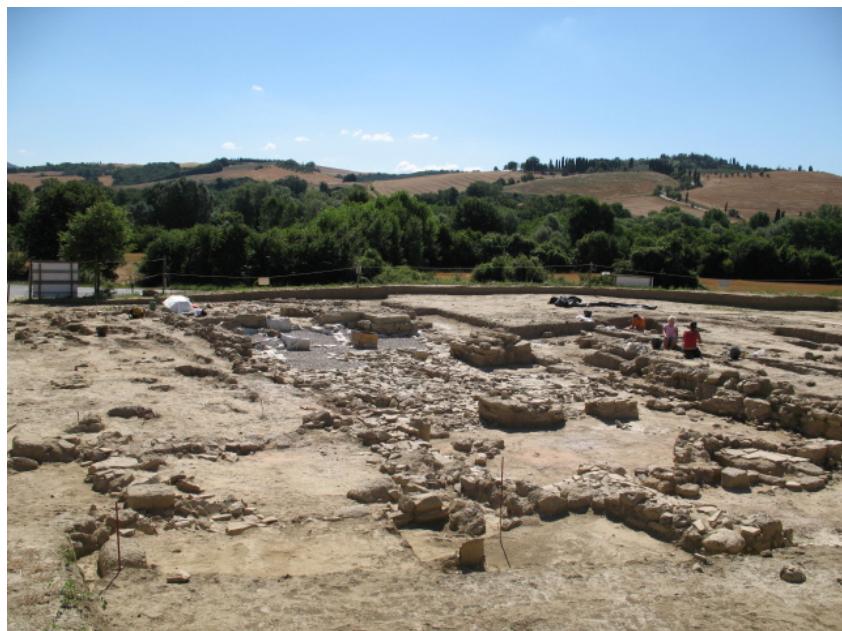
Photo 0. General picture of the site (from West)

Geological, mineralogical and other investigations of site near San Jan de Asso were performed (realization of PAVA project) during 28.06-16.07 2008. The site contains, at the base, the rests of destroyed byzantine church (B.CH. - photo 0) and it's been explored for more than eight years by a group of archaeologist directed by prof. S. Campana (Campana 2005, 2008 a, b, Campana et al 2006, 2007, 200A). Early medieval church- E.M.CH. was built on the walls of this monument. This church was, once again, destroyed and early medieval church was built over the rests, next to the medieval church – M.CH. (Campana et al The Vall d'Asso project. The first eight years of work - draft copy).

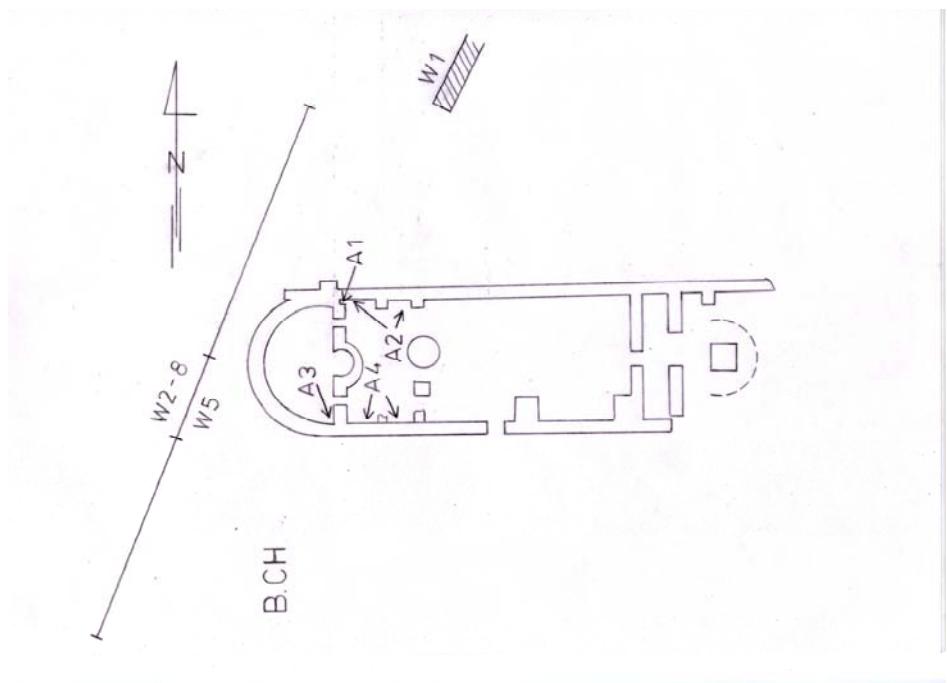
Fig. 1 Rests of byzantine church - (B.CH)

W1 – location of geological profile W1 (Fig. 2), W2-8 – location of West geological profile where W5 is part of profile (with tombs), A1-A4 places of investigation and reconstruction of fragments of byzantine church

was constructed. On the other hand the understanding of sequence of geo-archaeological layers helps determine sequence of tombs present around the churches i.e. and also relations between phases of functioning of churches and phases of cemetery. Because of all supposition the profiles of sediments were examined at places marked on fig 1.

Profiles of walls of church help understand the sequence of construction of parts of byzantine temple. They constitute the base for reconstruction of destroyed elements of church. Because of this, four points (A1-A4) of church were examined in details (Fig. 1).

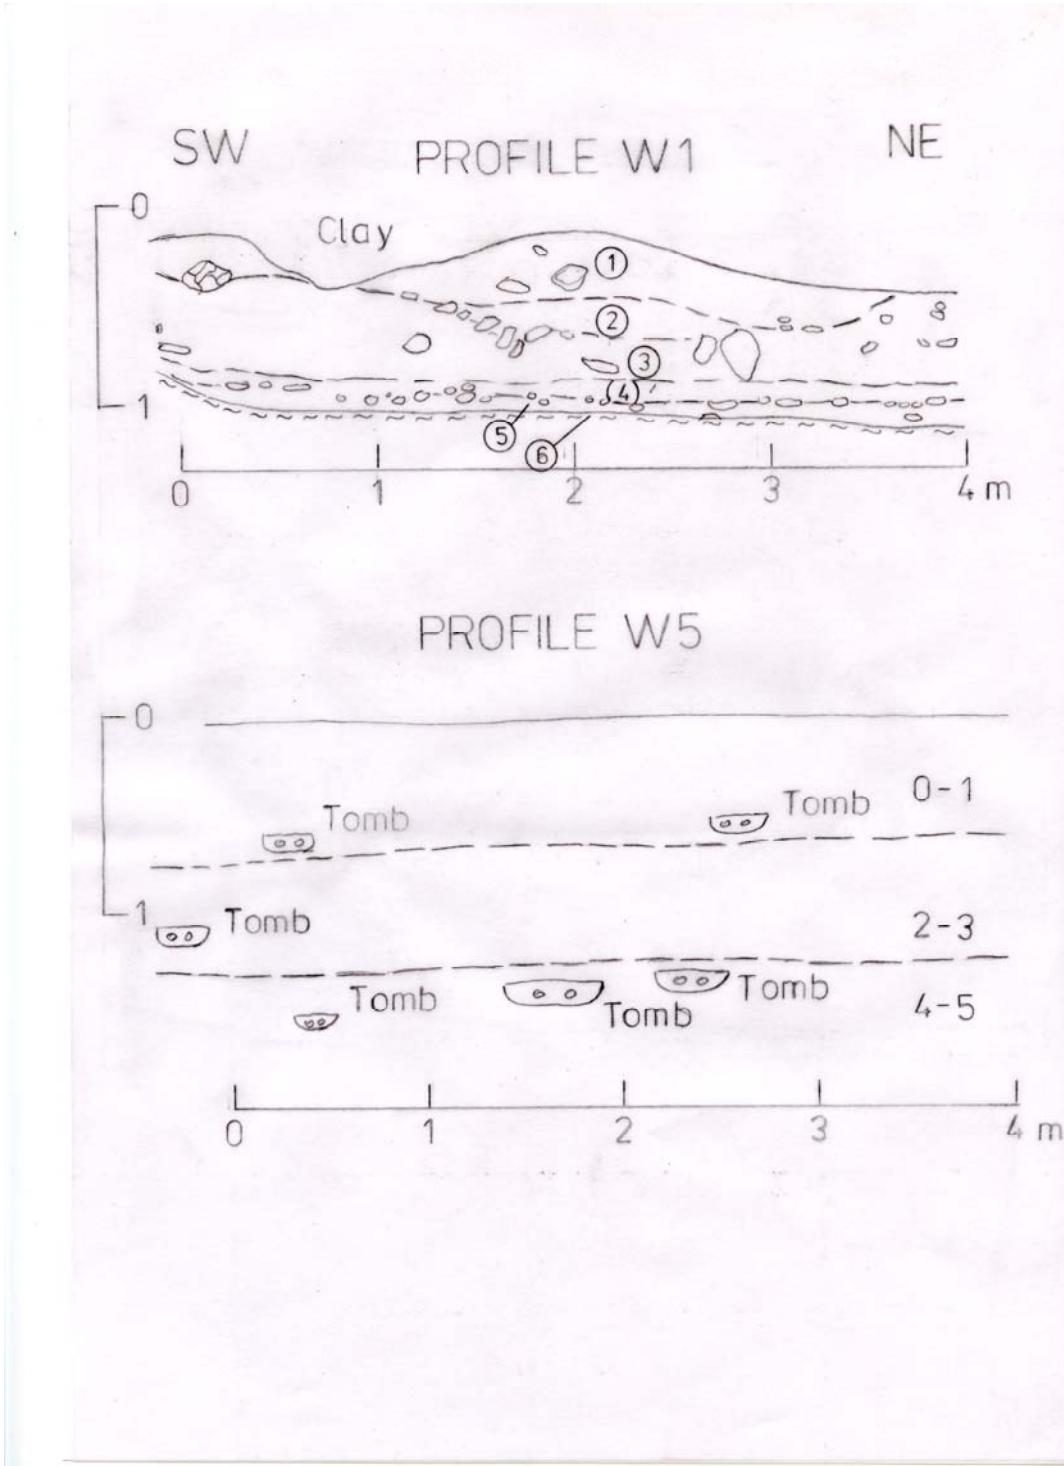
Fig. 2 Profile W1- 1-6 geo-archaeological layers, layer no 6 represents natural sediment. Profile W5 - part of geo-archaeological profile W2-8 where one can see the relation between position of tombs (at the profile of sediments) and sequence of layers (no 0-1 up to 4-5)

Analyses of profile W-1 (Fig. 2) help select six layers (1-6) where the lowest layer (6) represent natural grayish clayey mudstone. Over this sediments one can see the sequence of geo-archaeological layers (5-1) represented by grayish and beige-grayish muds containing various admixture of anthropogenic admixture represented mostly by fragments of bricks. Some of layers contain mentioned admixture in all volume of sediments. This suggest that they are the sediments deposited during construction of church. At other layers fragments of bricks are present mostly at the irregular top of layers. This means that they are (rests of bricks) concentrated on natural surface washed out by rains.

Analyses of profile W5 (part of profile W2-8) showed evident relation between geo-archaeological layers and the presence of tombs at the profile of sediments (Fig. 2). On the base of geological sequence one can see younger and older tombs around the church. Older tombs are located deeper at archaeological profile while younger are present more shallow.

Observed geological situation suggests that tombs present at layers 4-5 comes from byzantine phase of functioning of the site while tombs present at layers no 2-3 are from early medieval phase. Tombs present at layers 0-1 are the youngest i.e. slightly later medieval.

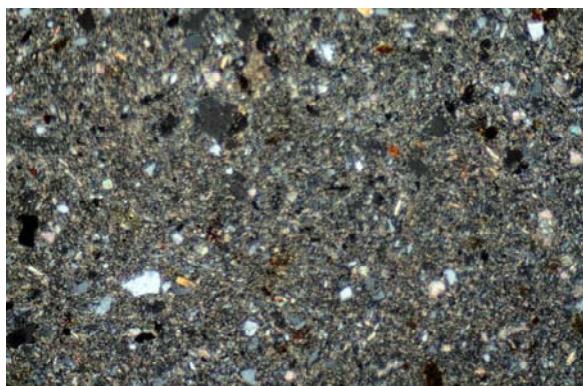
Photo 1A Structure of natural sediment (6) present under B.CH. Polarizing light microscope, polaroides X, magnification 40 x

Microscopic observation confirmed that all layers are composed of clay minerals quartz, micas and traces of plagioclases as well as K-feldspars (Photo 1A-1D, Table 1)

The most important difference between natural layer no 6 and geo-archaeological layers present above layer no 6 concerns the presence of fragments of bricks. They are present only above layer no 6 confirming anthropogenic origin of layers 5-3.

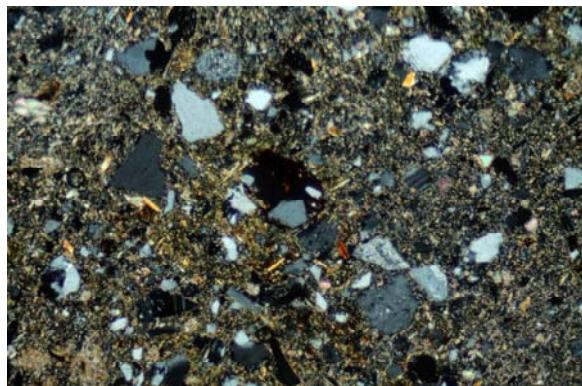
Photo 1B Structure of layer 5 (see Fig. 2) Polarizing light microscope, polaroides X magnification 40 x

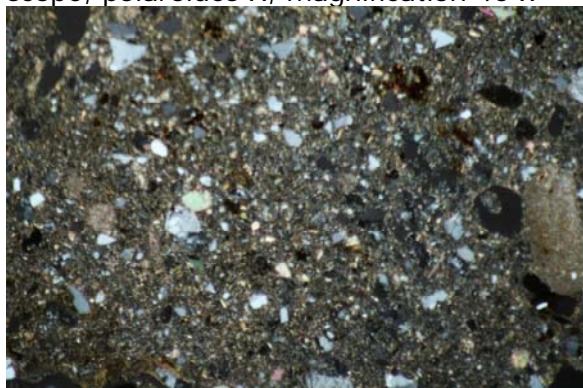
Photo 1C Structure of geological layer 4 Polarizing light microscope, polaroides X, magnification 40 x

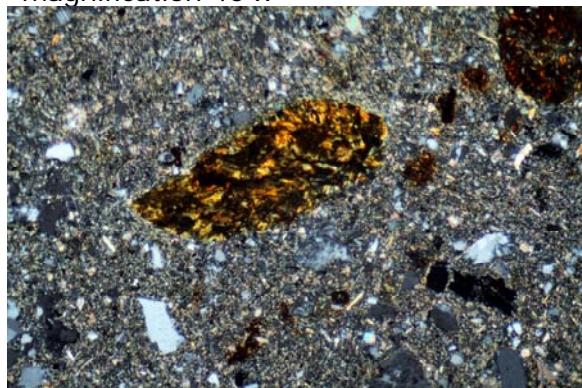
Photo 1D Structure of geological layer 3 Polarizing light microscope, polaroides X magnification 40 x

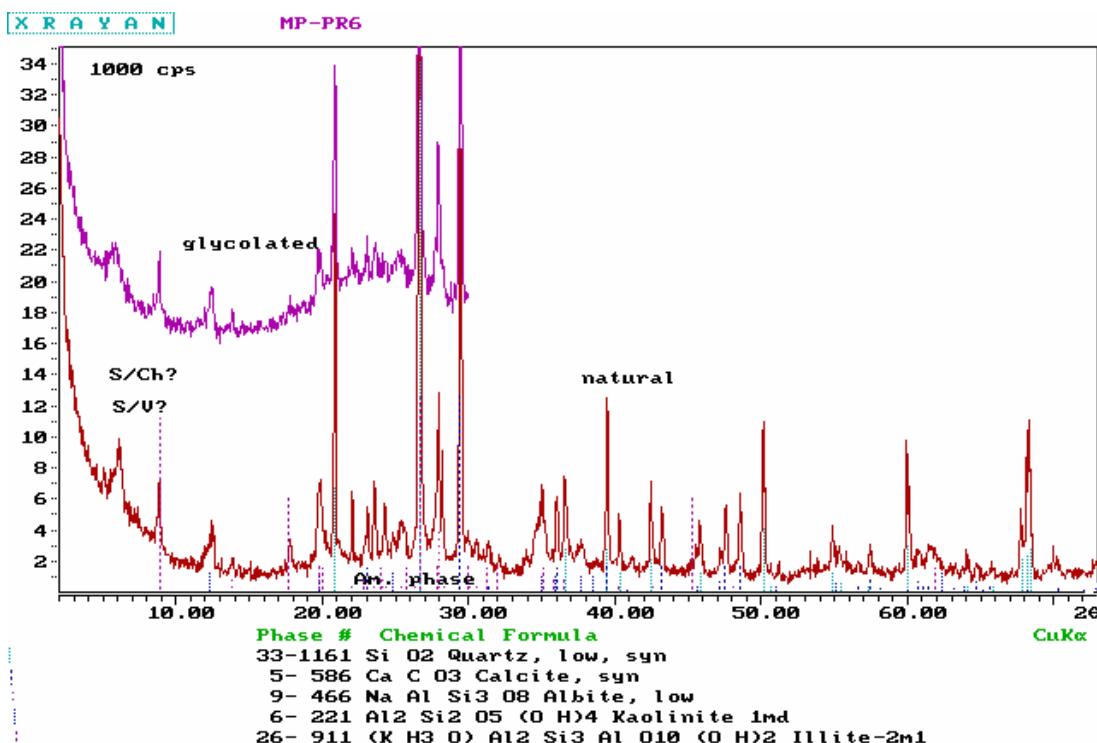
Fig. 3 X-ray pattern of natural gray clayey-mudstone 9 (layer no 6 – see Fig. 2)

Because of very fine character of clay minerals sample representing layer 6 was additionally examined using X-ray method. Obtained X-ray pattern indicate that natural-clayey mud is composed of clay minerals, quartz, feldspars and calcite (Fig. 3 - natural). Clay minerals are represented by smectite-chlorite or smectite - vermiculite mixed layer mineral (Fig. 3 upper pattern glycolated). This means that local clayey-mudstone may swell if it's wet. This feature of natural sediment is very important because churches were build on geological layer which may swell if they are wet. It was probable the reason of destruction of churches. After rains the mud underlying church swells and walls may collapse. On the other hand similar effects may create the use of local clay for the construction of walls of early medieval church (E.M.CH.). Details will be presented at separate publication (Part II).

This identification was very important because of similarity of clay minerals present in this sediments and in mortar used for construction of walls of Early Medieval Church (details will be presented at part II – under preparation)

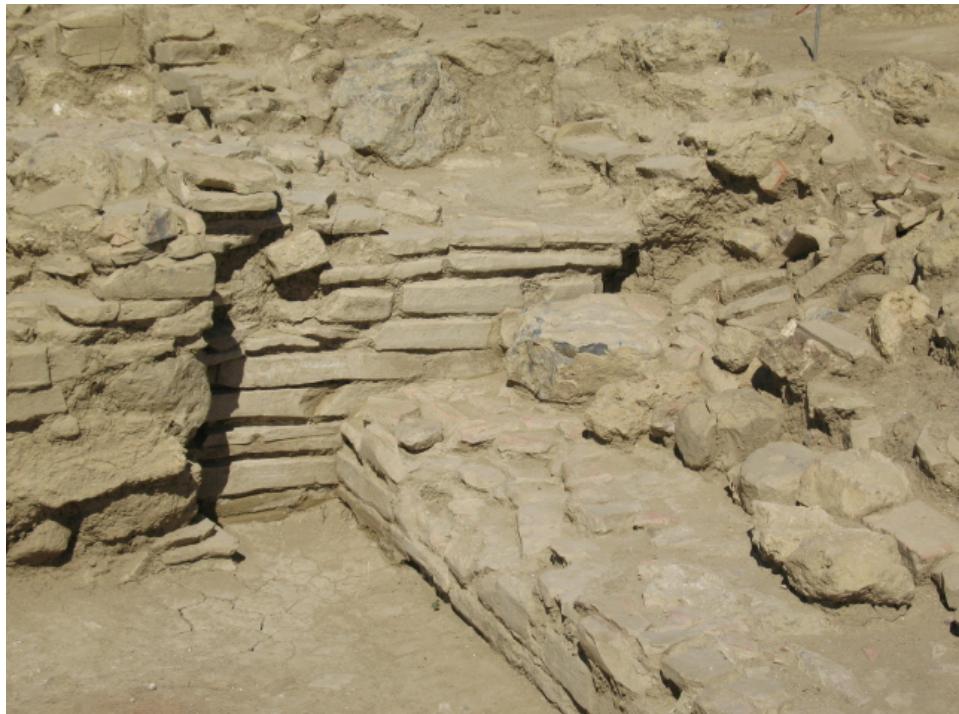
Photo 2 Point A1 (see-Fig. 1). West wall of the entrance into byzantine church seen from inter of church. One can see steep into the church (right site of the photo), the wall built of bricks with edge (enface), and part of wall built of stones and bricks (left part of the photo).

Profile A1 is located at northern wall of B.CH. at the place where the entrance to the temple was located (Photo 2, Fig. 4). Investigation of this place helps to

determine west wall of entrance where is seen wall build of bricks with edge connected with wall build of plate brick and stone. The structure of entrance suggest the presence of one step leading down from area surrounding the temple.

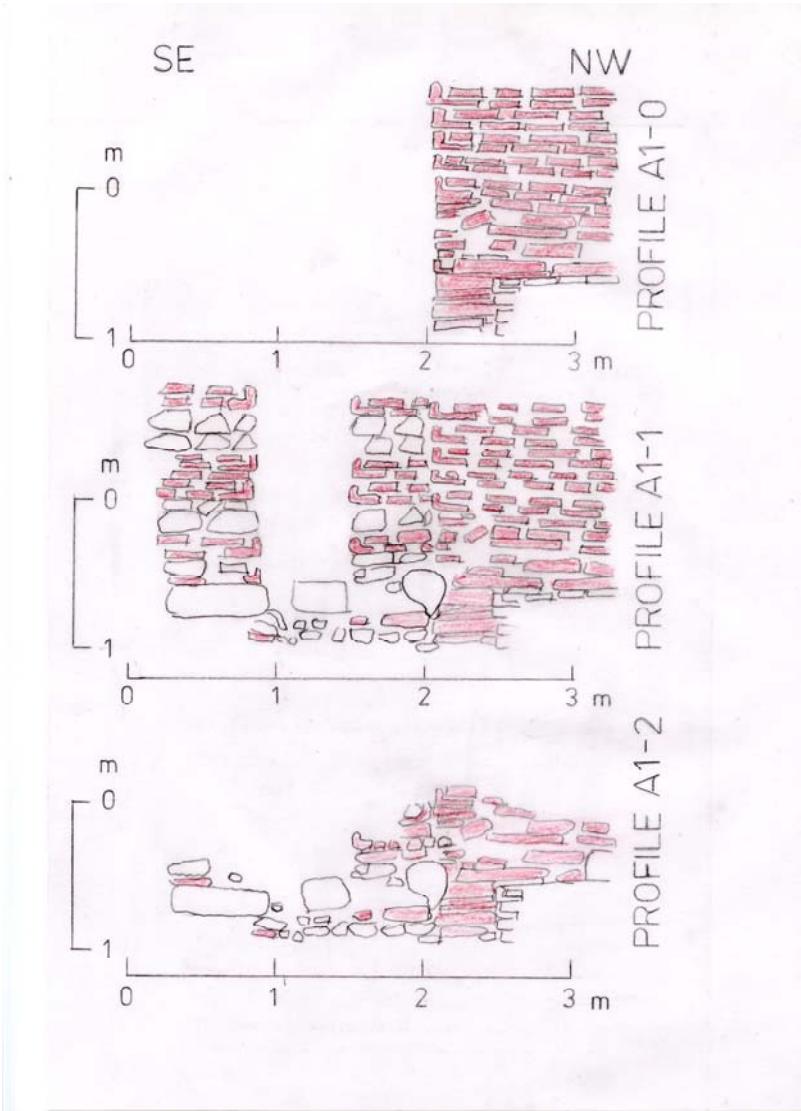
Fig. 4 Present profile A1-2 (see fig. 1) at the entrance leading into the B.CH. (seen from church). One can see steep leading into the church, wall built of bricks with edge (left side) and rest of wall built of stone and plate bricks (separating apse of church from rest of church).

A1-0 – reconstruction. Phase of construction of west part of entrance with step (built of bricks with the edge).

A1-1 – reconstruction. Phase of construction of wall (built of stone and plate bricks) (separating apse from rest of the church).

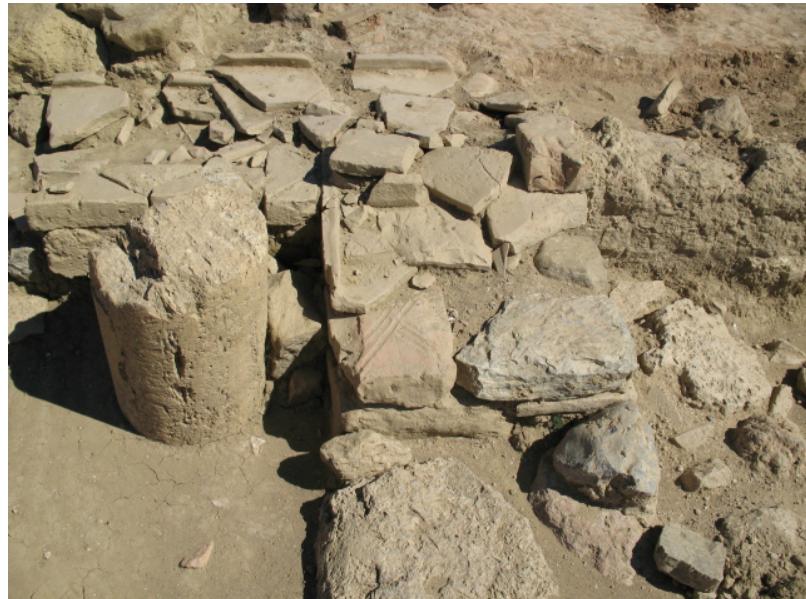
Photo 3 East part of point 2. Rests of strongly damaged walls of B.CH. with fragment of travertine column.

It is fragment of the wall with entrance into B.CH. with fragment of travertine column and vertical contact of wall built of brick with edge with wall build of stones and flat bricks

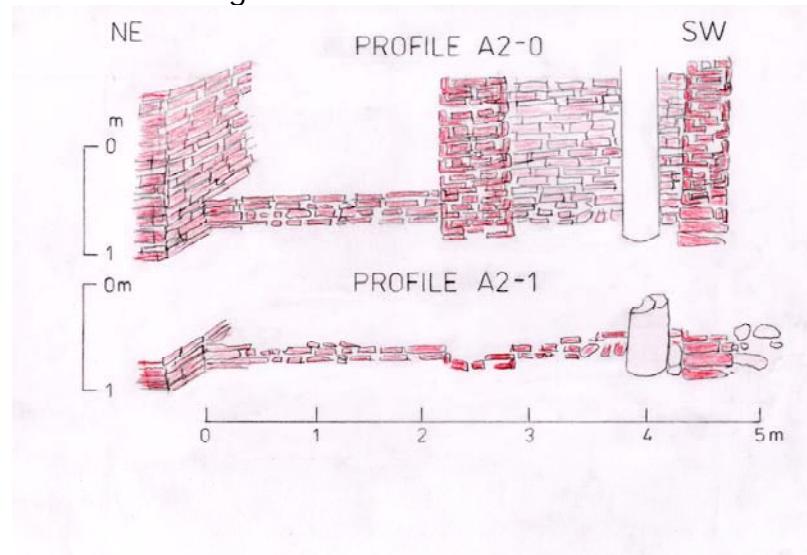
Fig. 5 Present profile A2-1 (see fig. 1) of North wall at the entrance leading into the byzantine church (left part of drawing) seen from the church.

A2-0 - reconstruction. Entrance into the B.CH. seen from church.

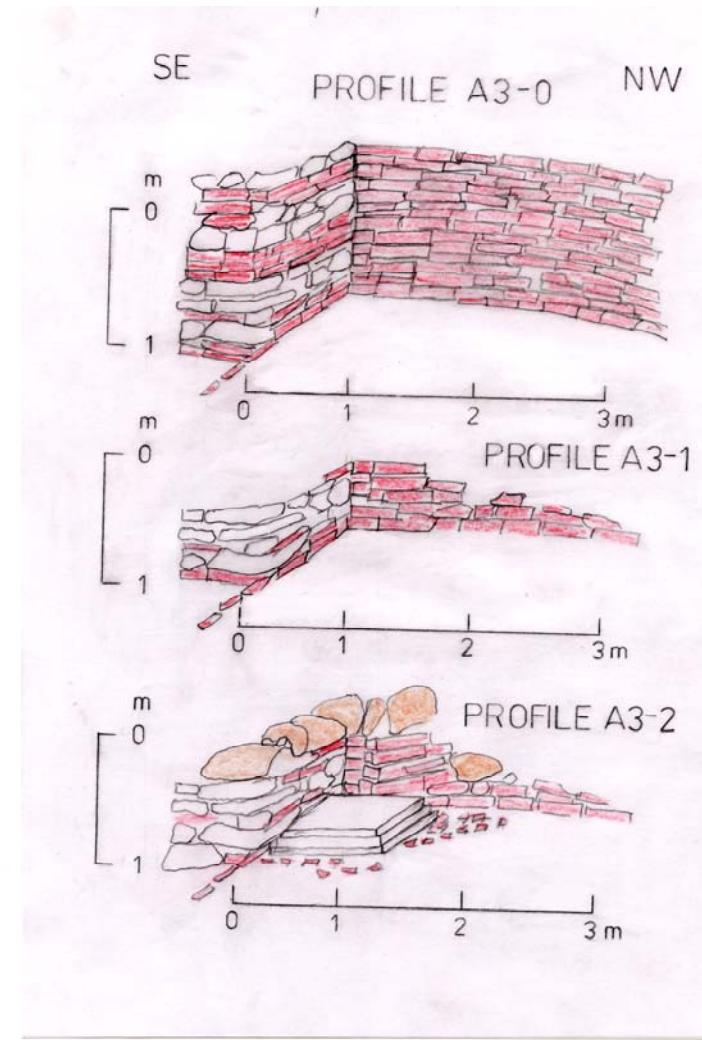
Fig. 6 Present profile A3-2 (see fig. 1) of the contact of apse with wall separating apse from rest of B.CH.

The rest of wall build of bricks with edge (apse) contacting with the wall built of stones and plate bricks. Above rests of B.CH. wall one can see river cobbles (brown) used for construction of Early Medieval Church (E.M.CH.).

A3-0 – reconstruction. Phase of functioning of B.CH. The place of binding of apse built of bricks with edge with wall built of stones and plate bricks.

A3-1 – reconstruction. Phase of destruction of B.CH. at point A3 before construction of wall of E.M.CH.

This point is located at the place of binding of two walls of B.CH built using various materials (Fig. 1) i.e. wall built of bricks with edge and wall built of stones and bricks between apse and rest of church (Fig. 6)

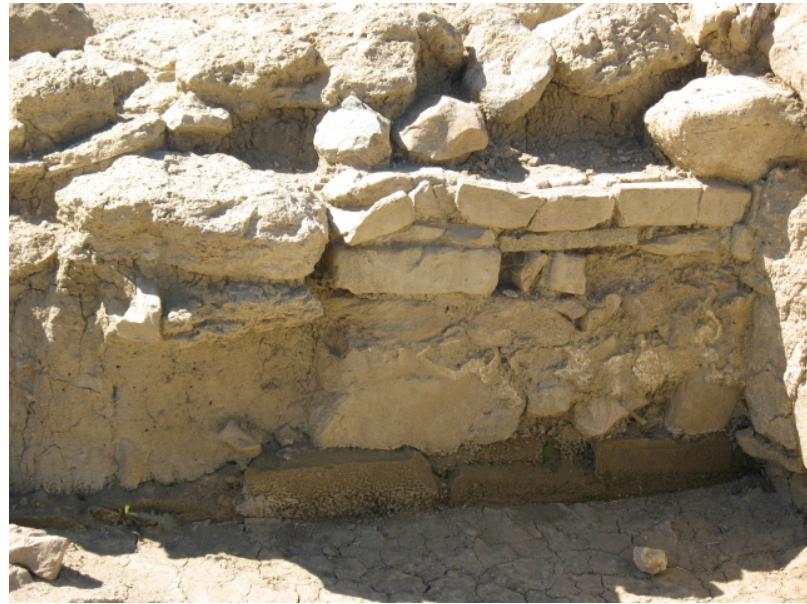
Photo 4 South wall of B.CH. showed at fig. 1. The contact of byzantine wall built of stone and plate bricks (right side of photo) with gray mud and rubbish (central and left side of profile) filling up the entrance to not examined space

This point (Fig.1) is especially interesting because of complicated structure of wall present there (Photo 4) One can see damaged old byzantine wall built of plate bricks and stones contacting with rubbish and present above wall of E.M.CH. Central part of this wall is especially interesting. The structure of wall suggest the transition from the main part of B.CH. to the room located to the South from southern wall of B.CH. (Fig. 7)

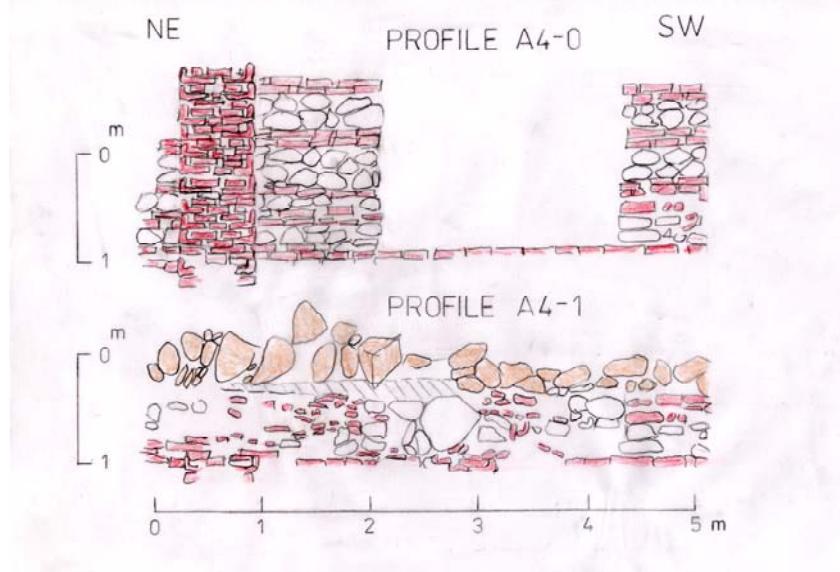
Fig. 7 Present profile A4-1. Damaged rest of wall of B.CH. built of stone and plate bricks with space filled up with gray mud and rubbish. Above one can see brown river pebbles used for construction of E.M.CH. Between wall of E.M.CH and present below remains of B.CH. one can see plaster made of clay and calcite (marked) used for preparation of surface under the wall of E.M.CH.

A4-1 reconstruction. The same place. Transition into next room (?) located South from wall of B.CH.

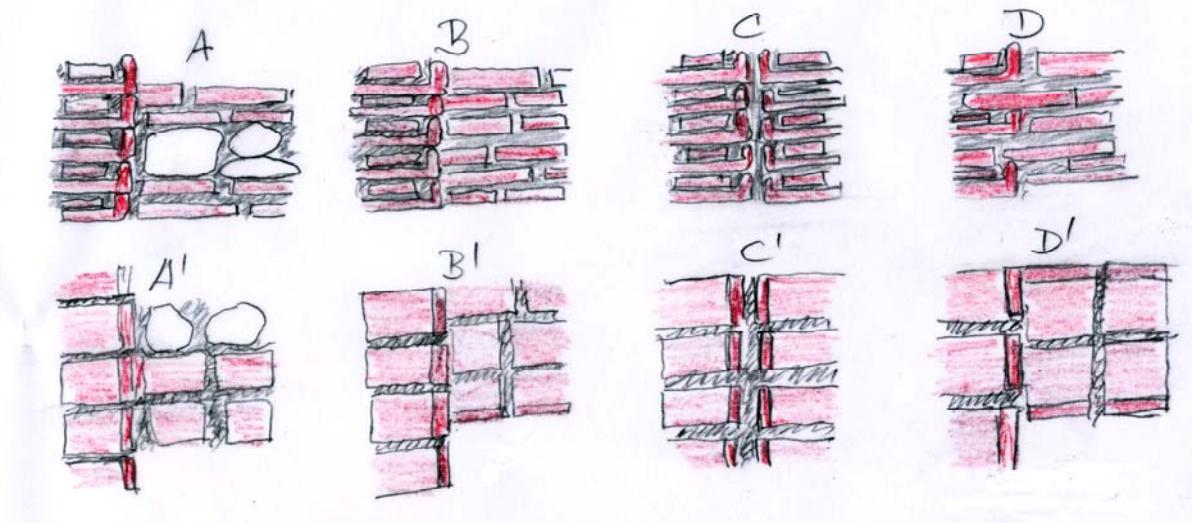
Fig. 8 Various types of walls and wall binding in B.CH.

A,B,C,D – cross section of contact of walls build of bricks with edge  
A',B',C'D' – - map of walls binding built of bricks with edge

In most cases the walls are only contacting one with another and they are fixed only with the use of mortar. This situation was observed when wall of apse built of bricks with edge was contacting with the wall build of stone and plate bricks - wall separating apse from the rest of B.CH. (Fig. 8A,A') . Other type of binding is seen at the entrance to B.CH. where step is built of plate bricks and only west wall of entrance is built of bricks with edge (Fig. 8B,B'). Only the edge of step was built with the use of bricks with edge.

There are other types of binding of walls. For example the walls build of bricks with edge contact one with another as shows Fig. C, C'. Corners of church where bricks with edge are contacting, as shown at fig. D, D', where walls are really fixed one with another are especially interesting.

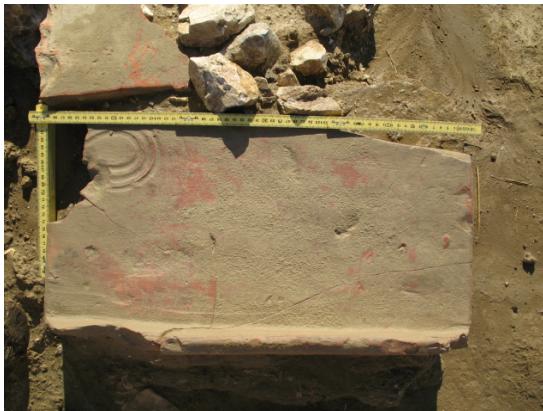
Photo 5A Damaged brick with edge

It is interesting that bricks with edge have traces of fingers on the surface (photo 5A) similarly as thick brick (Photo 5C) but mineral composition of both bricks is different (Tab. 2A and 2C) documenting use of various primary raw materials.

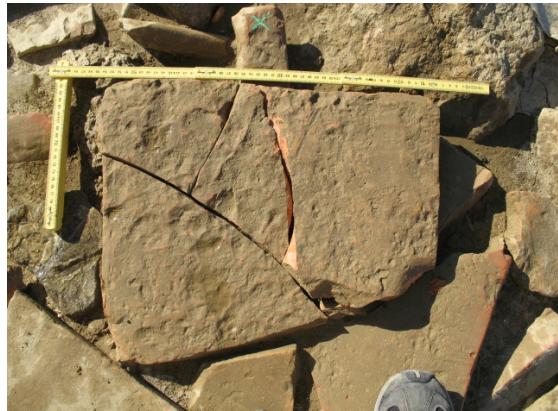
Photo 5B Crushed plate brick

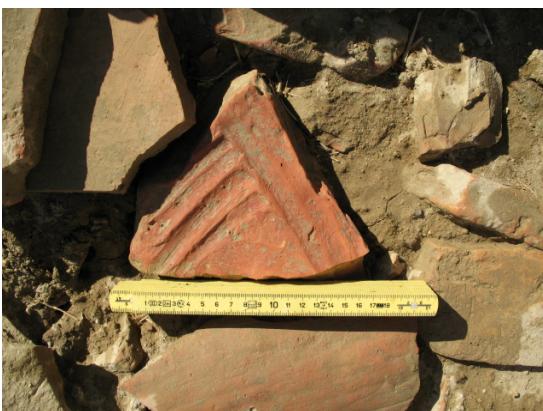
Photo 5C The fragment of thick brick with traces of fingers

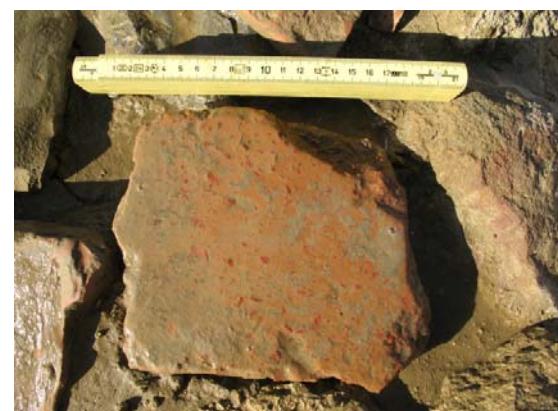
Photo 5D The fragment floor terracotta

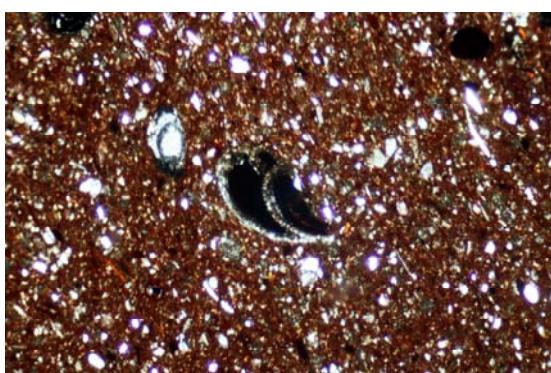
Photo 6A Structure of brick showed at photo 5A Microscope NX, magnific. 60 x

The differences concern mostly relation between thermally changed clay minerals and fine quartz. (Photo 6A-D). Observation of thin sections confirmed that bricks with edge shows mineral composition very similar to clayey mudstone representing geo-archaeological layer no 6 (Fig. 2, Tab. 1). Moreover the same species of small skeleton of foraminifera was identified at brick with edge as well as in natural layer no 6 - clayey mudstone (see photo 6A – skeleton of foraminifera at the centre of photo).

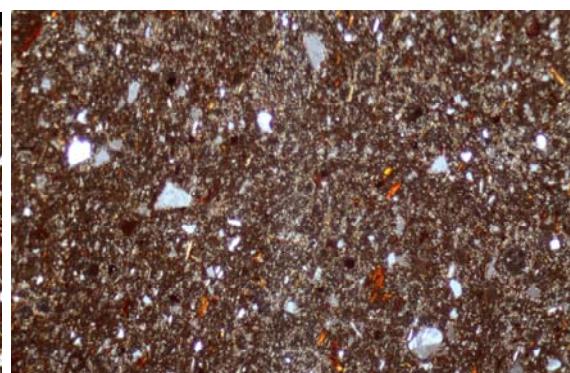
Photo 6B structure of brick showed at photo 5B Microscope NX, magnific. 60 x

The composition of other tested bricks is also differentiated (Photo 6B-D, Tab 2A-D, Fig. 9A-D). Very interesting is terracotta containing fragments of pottery (Photo 6D) and showing other mineral as well as other grain size composition. Mineralogical data suggest that terracotta was not made of local materials but it was imported from unknown area with clays containing fragments of rocks and more micas represented mostly by muscovite-sericite.

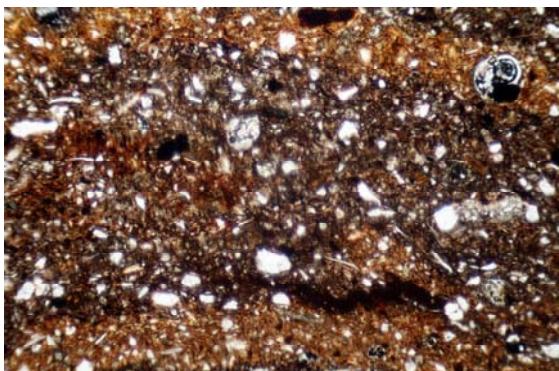
Photo 6C Structure of brick showed at photo 5C Microscope NX, magnfic. 60 x

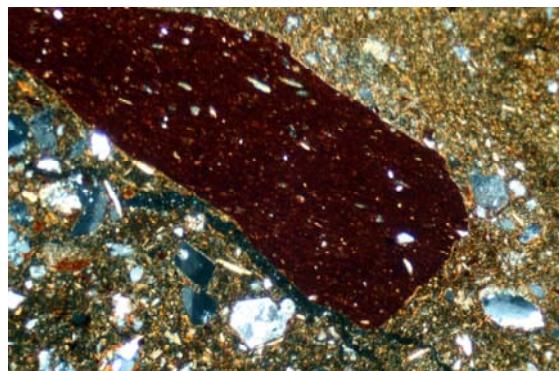
Photo 6D structure of terracotta showed at photo 5D Microscope NX, magnfic. 60 x

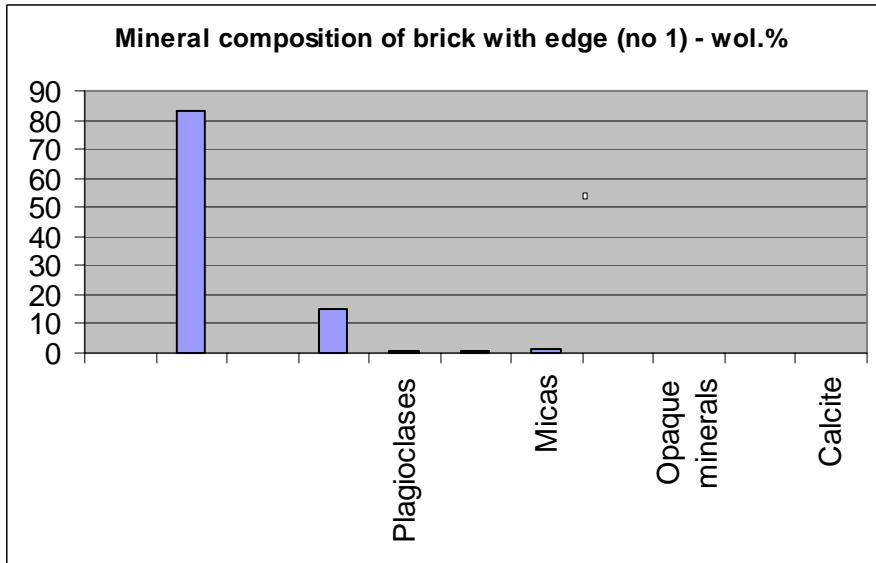
Fig. 9A Diagram showing relation between mineral components of brick with edge

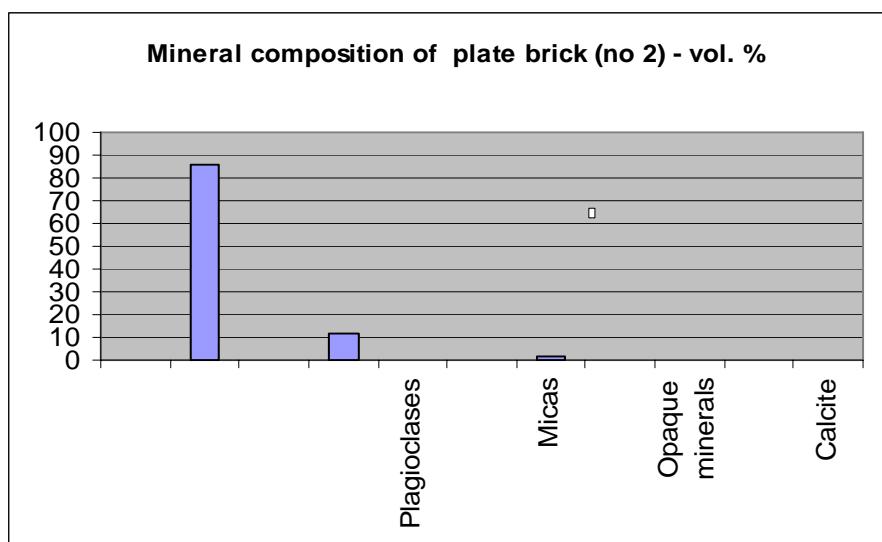
Fig. 9B Diagram showing relation between mineral components of plate brick

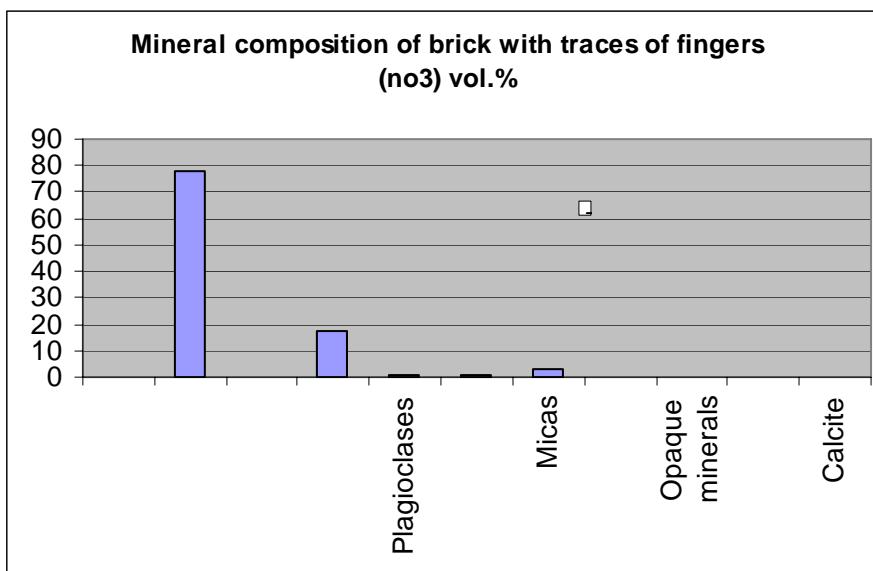
Fig. 9C Diagram showing relation between minerals components of brick with traces of fingers

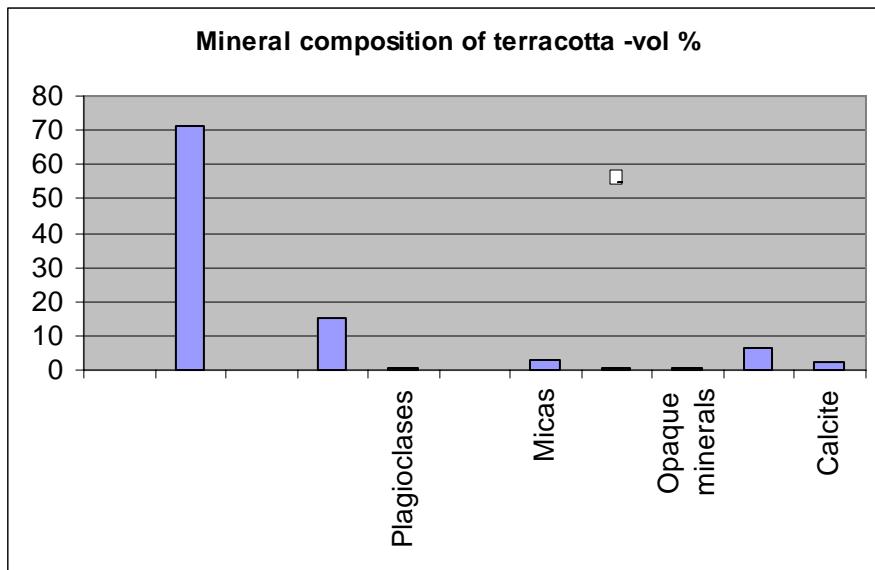
Fig. 9E Diagram showing relation between mineral components of terracotta

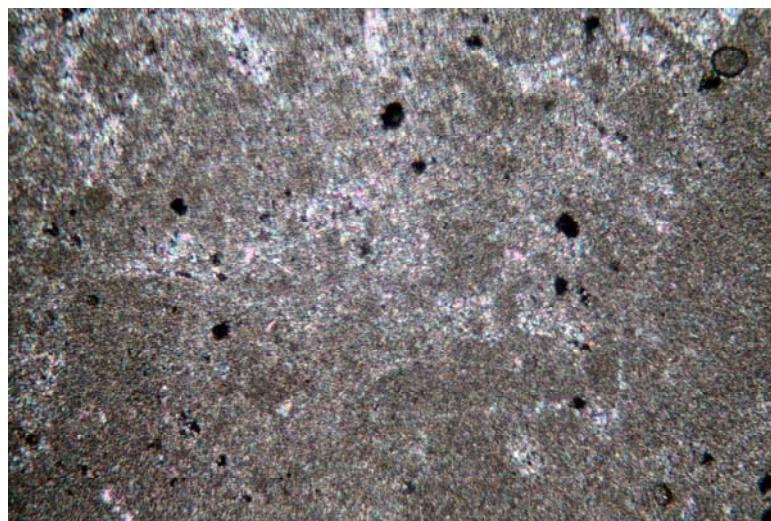
Photo 7 Structure of limestone used together with bricks for construction of wall of B.Ch. Polarizing light microscope, polaroides X, magnification 60 x.

Examination of stones present at the wall build of bricks and stones were performed using polarizing light microscopy. Observation of thin section (Photo 7) showed the presence of fine crystallized calcite cut with rare veins of coarse crystalline calcite. At calcitic background one can see black small spots of opaque minerals represented mostly by iron sulphides.

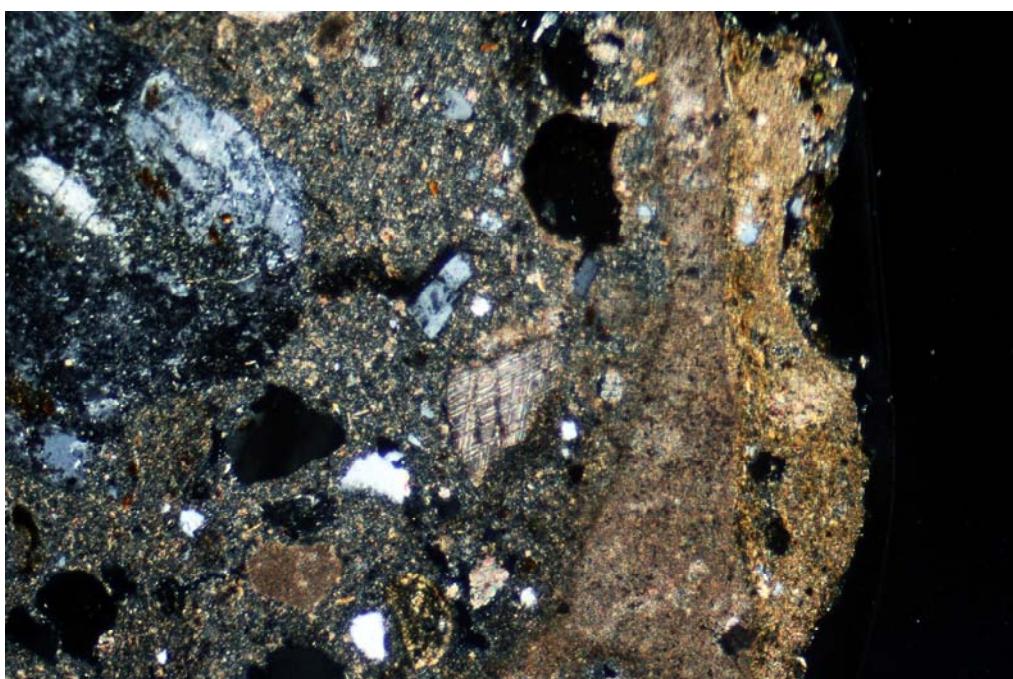
Photo 8 The structure of grey plaster coated with two layers of various mortar – beige and yellowish (right site of photo). Microscope NX, magnific. 60 x

Under the microscope one can see two layers coating the plaster (white painting-right side of photo no 8). Older layer (beige) is composed of pure calcite while second younger is composed of calcite and quartz (yellowish). This younger painting is now strongly damaged.

Investigation of plaster confirm minimum two phases of painting of walls of apse of B.CH. Diversified thickness of first painting (beige) documents phase of destruction of walls of B.Ch before another restoring painting of walls of apse (yellowish layer).

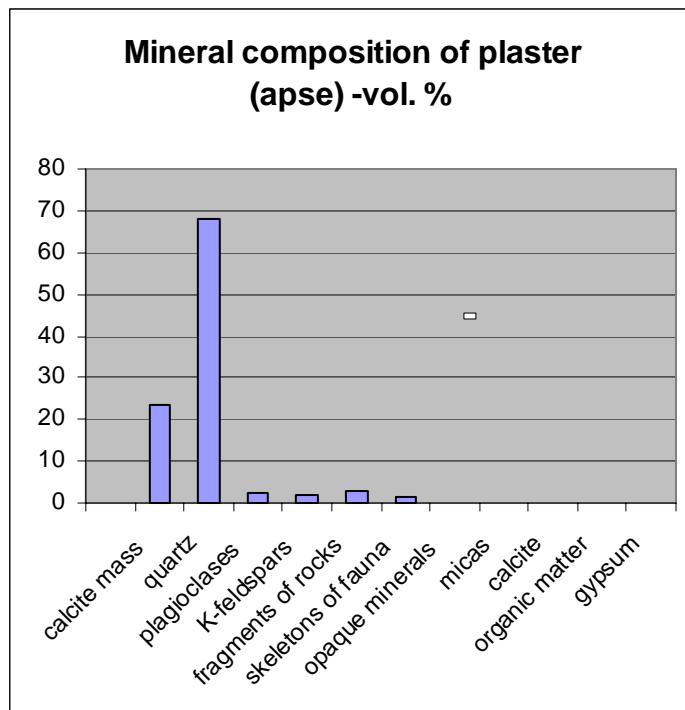
Fig. 10 Diagram showing mineral composition of plaster from B.CH. (apse)

The plaster for the examination was collected from the wall of B.CH. apse. Microscopic investigation of thin section of this plaster (cut perpendicularly to the wall) showed that base is composed of coarse sand containing grains of quartz, fragments of magmatic and metamorphic rocks, other fixed with calcite and other (Photo 8- central and left part- Table 3, Fig. 10. This mineral composition confirm that sand used for preparation of plaster was probably not local.

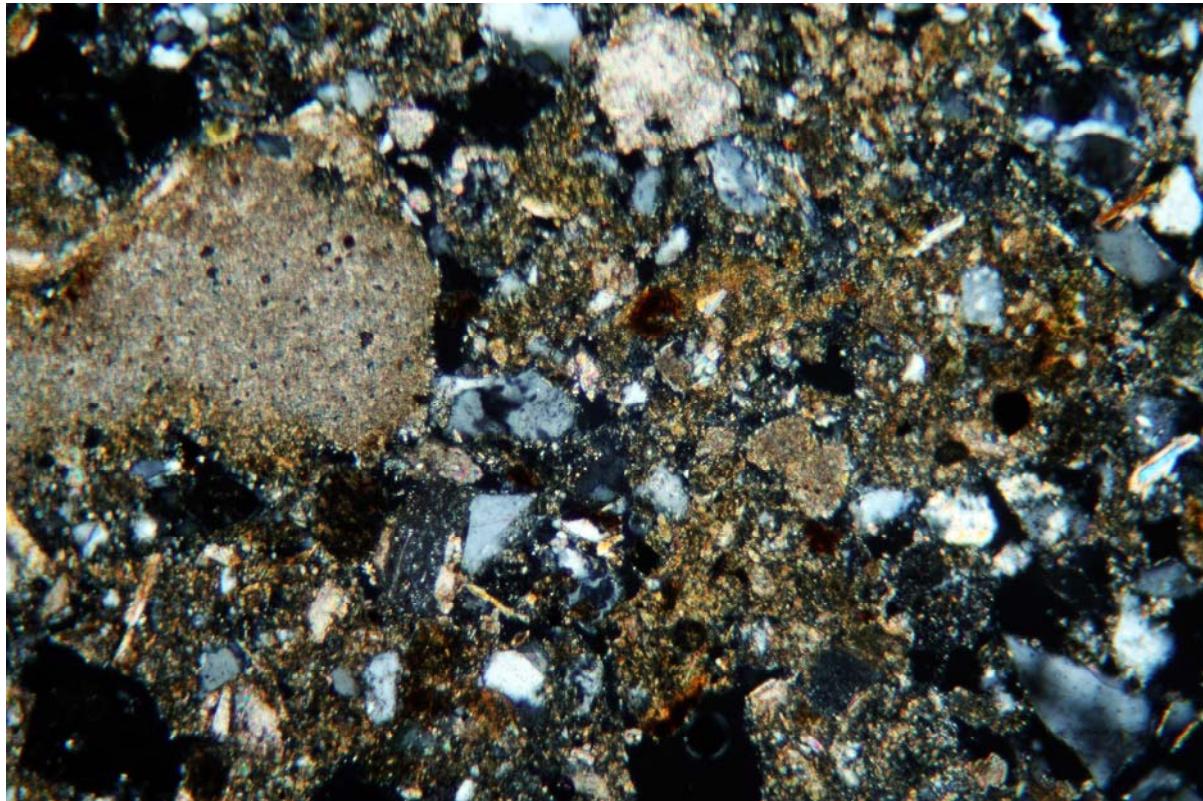
Photo 9 Structure of mortar, clay minerals and fine gray grains of quartz mixed with fragments of calcite added specially for better quality of mortar. Microscope NX, magnification 60 x

Microscopic observation showed that mortar is composed of fine grains of quartz cemented with calcite mass (Tab. 4, Fig.11). This cementing calcite mass is not homogeneous because at the background can be observed very fine calcite together with coarse fragments of not well mixed carbonate mass (beige coarse grains –Photo 9). Together these mentioned mineral compounds small mica flakes, rare feldspars and opaque minerals are present.

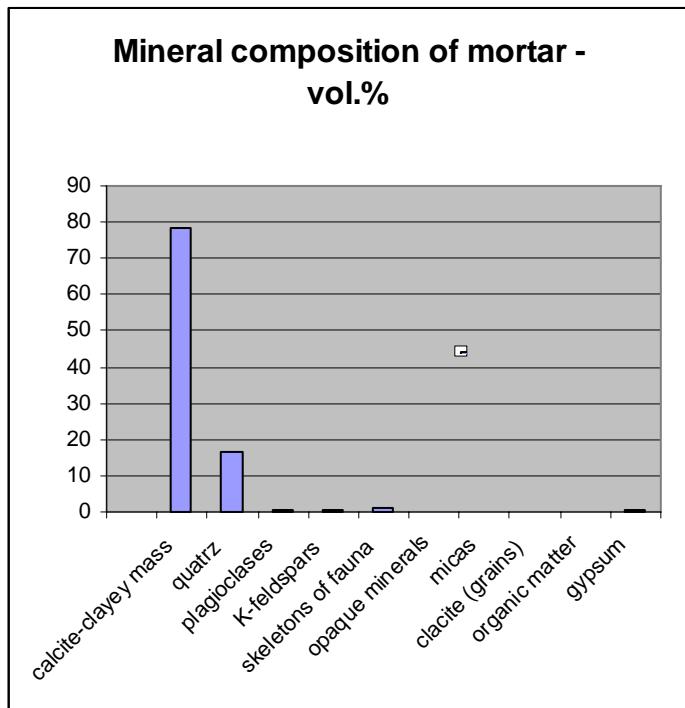
Fig. 11 Diagram presenting mineral composition of mortar . B.CH.-apse

Performed examination document that plaster and mortar have various mineral composition, Structure of mortar and slightly mineral composition are similar to mineral composition of geo-archaeological layer no 4, but contain admixture of artificially added carbonate (calcite)
