Corroded steel support friction joint load capacity studies as found in Piast-Ziemowit coal mine

This article presents the load capacity study results of the corroded friction joints obtained during heading relining conduction. The main goal of the study was to determine the operational characteristics of heavily corroded friction joints as well as their load capacity. An additional goal of the study was to indicate which parameter is crucial from the point of view of corroded support technical condition evaluation – friction joint load capacity or arch strength. Mine conditions in which the LP support operated were also briefly characterized in the article. The study presented in the article is of a pilot character; while the obtained results reveal a very significant influence of corrosion on the support operational safety, the studies of corroded joints will be continued in the future using a larger number of samples and various types of shackles.

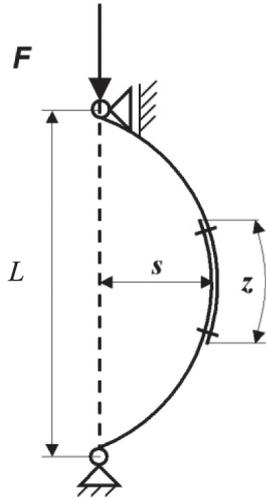
Fig. 1. Load diagram of arcuate joint subjected to force F acting in fixed support pivot axis, where L is the joint chord length, s – joint arrow length, and z – overlap length

Arcuate joint tests without passive pressure (passive force exerting influence on the joint) were conducted according to the load diagram presented in Figure 1 (based on standard PN-G-15026:2017-04) [20].

Negative bending moment value M_g (decreasing the joint arch radius of curvature) in the joint cross-section (in the location of its arrow s) was calculated from the following formula:

$$M_g = -F \cdot s \text{ [kN}\cdot\text{m]} \quad (1)$$

- F – force loading the joint during its yield [kN],
- s – joint arrow length [m], calculated as the distance between the neutral axis of two V29 sections in the joint and the force F axis.

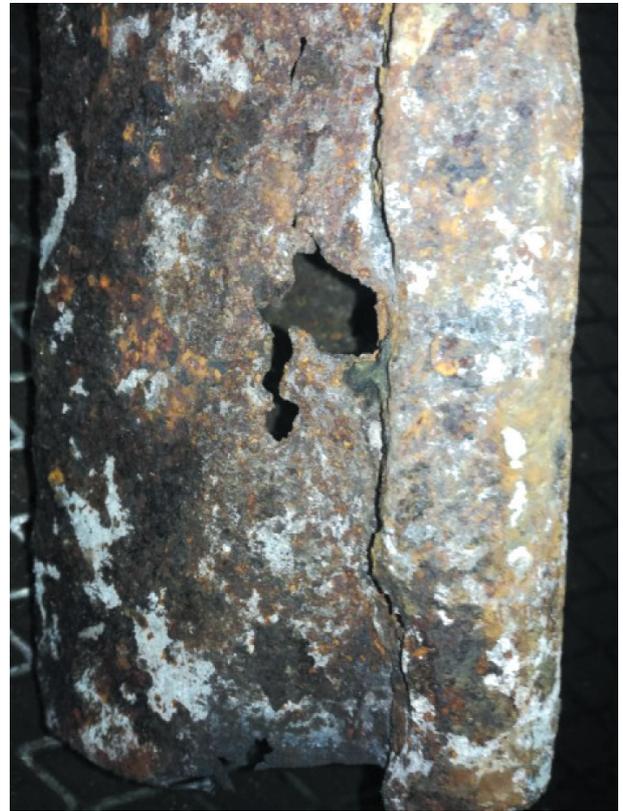
Fig. 2. Section perforation in flange area

The joint ends in contact with the tensile testing machine parallel loading plates were cut in such a way so they would adhere to the machine plates. Due to the fact that section perforations were found in the joint (Fig. 2), its ends were additionally reinforced with a V29 section segment and a single shackle. This was done to prevent the occurrence of V29 section deformations in the joint (which would block its yield) and, thus, disrupt the joint course of operation. A view of the joints prepared for testing is presented in Figures 3 and 4.

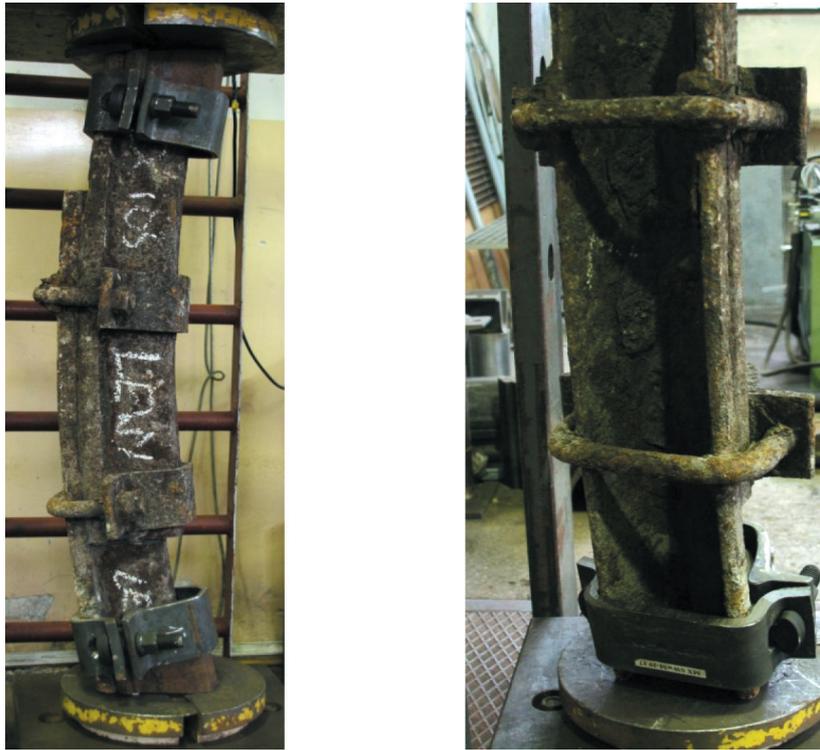
Fig. 3. Friction joint 1 prepared for testing and shackle technical condition

Geometric measurements of the K29 bow shackles in friction joint 1 showed that the M27 bow bolts exhibited slight corrosion resulting in bow diameter reduction within a range of 25–26 mm (both in the lower and upper shackles). The joint overlap of $z = 560$ mm did not change (neither before nor after testing).

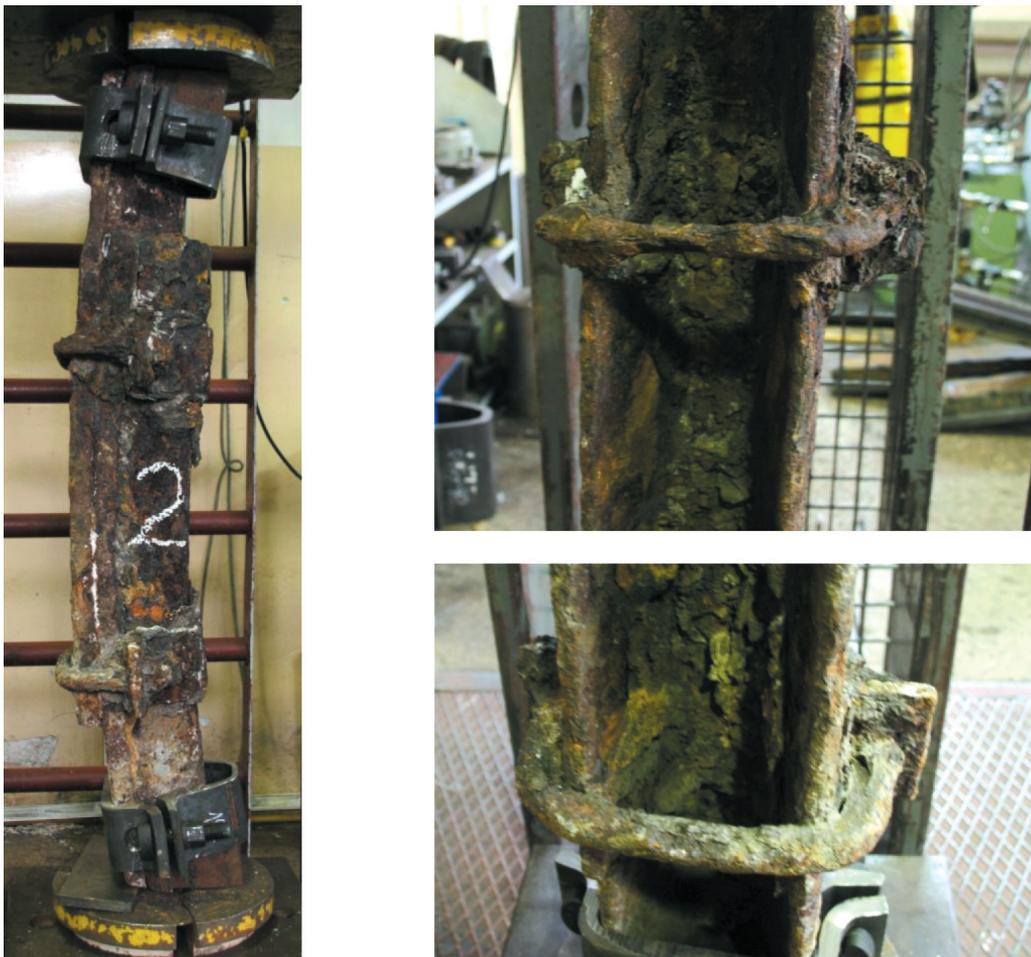
Fig. 4. Friction joint 2 prepared for testing and shackle technical condition

Geometric measurements of the K29 bow shackles in friction joint 2 showed that the M27 bow bolts exhibited significant corrosion resulting in bow diameter reduction within the ranges of 7–20 mm in the upper shackle and 18–23 mm in the lower shackle.

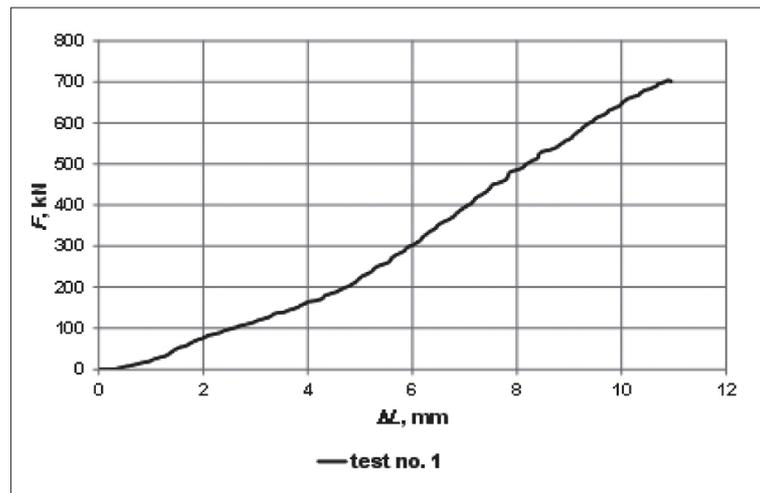
Fig. 5. Friction joint 1 characteristics

Test results in the form of $F = f(\Delta L)$ courses are presented in Figures 5 and 6.

During Test 1, the joint loaded with a force of $F = 700$ kN at a bending moment of $M_g = 75.6$ kNm did not yield, and no plastic deformation was found in it after the test either. Arcuate joints constructed from V29 sections connected with two K29 shackles typically tend to yield at a loading force of approx. 220 kN. The blocking of the joint was most likely the result of crevice corrosion between the arches, which resulted in the locking of the sections and shackles in the joint.

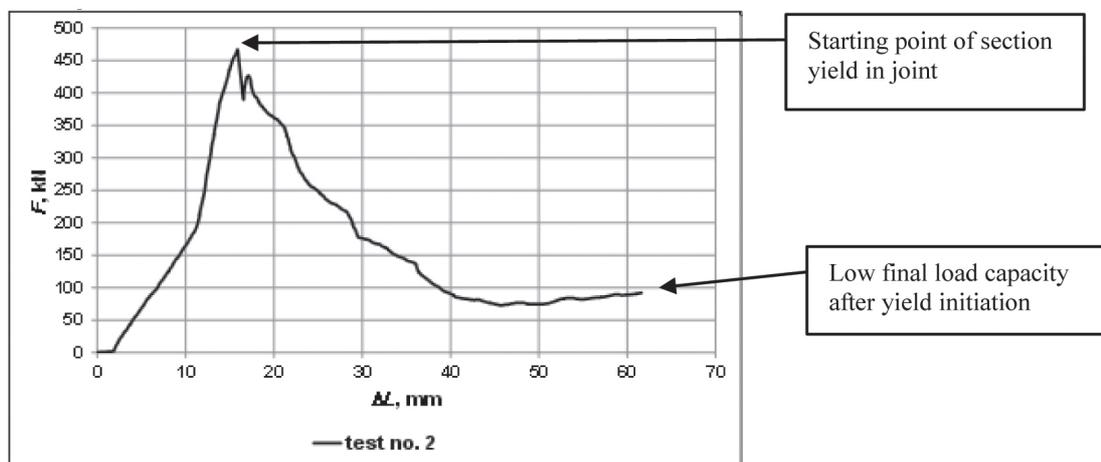
Fig. 6. Friction joint 2 characteristics

A different manner of operation was observed during Test 2. The joint loaded with a force of $F = 467$ kN and a bending moment of $M_g = 50.4$ kNm did yield

(Fig. 8). The yield was a continuous yield, and the joint load capacity end value stabilized at a level of approx. 90 kN. No section plastic deformations in the joint were observed after the test either. The most likely cause of the joint yield and systematic decrease of its load capacity was the bad technical condition of the upper and lower shackle bow bolts as compared to the bow shackles utilized in Test 1 (Fig. 7).

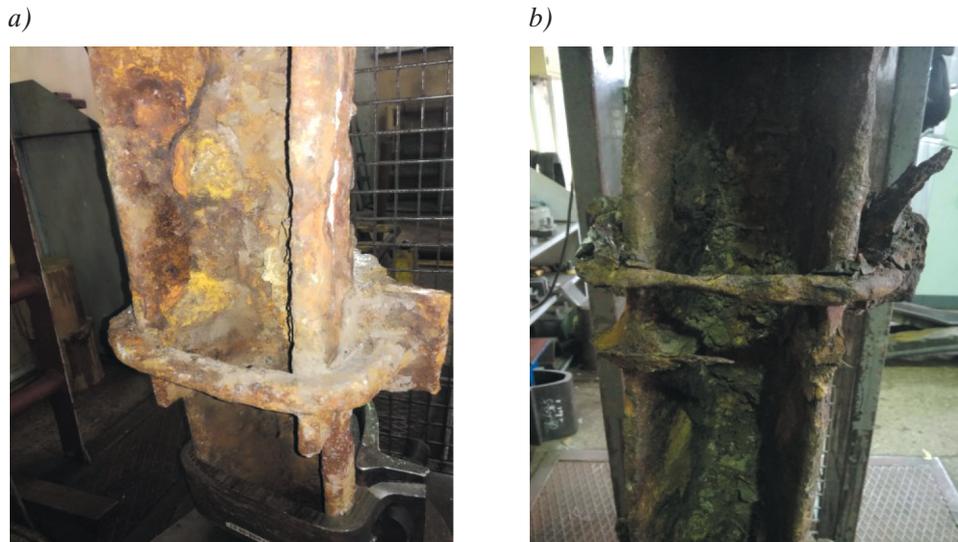
Fig. 7. Bow bolts in joints during testing: a) no. 1; b) no. 2

When yielding, bow bolts undergo slight beveling, which results in their increased tension as related to the nominal (generated by nominal tightening torque). Due to the fact that the bow bolts have a considerably reduced cross-section resulting from corrosion (Fig. 7), the bolts undergo significant deformation, which is the cause behind the decrease in section pressure force in the joint and, thus, the decrease in friction force. The low final section load capacity value in the joint (determined at a level of approx. 90 kN) and its character (lack of stepwise yielding typical of friction joints) are also influenced by the joint surface condition, which is covered with multiple corrosion products and stone dust. However, the extent of this influence is very difficult to determine

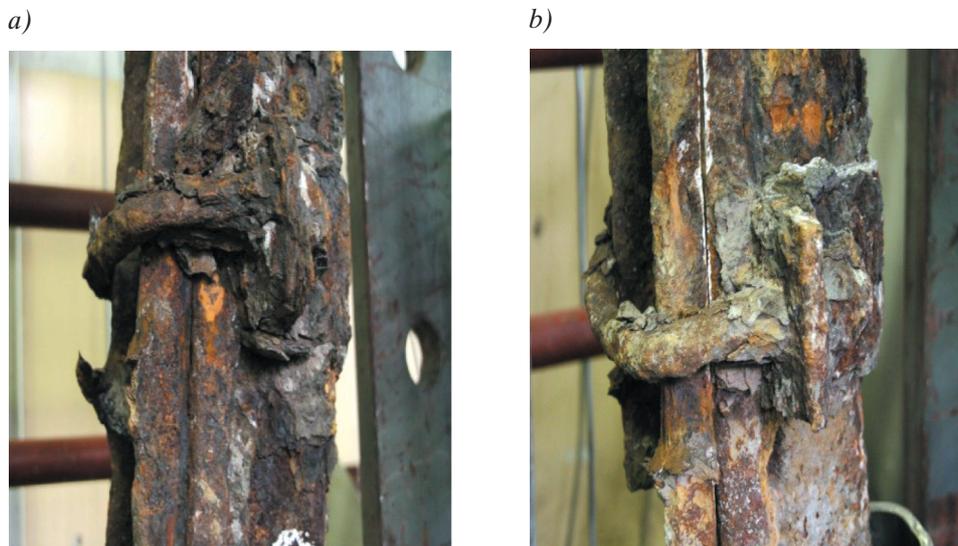
Fig. 8. Friction joint 2 shackles after testing (evident yield)
