SŁAWOMIR STRASZAK
ARTUR WIKTOR

Sheave axles of mine shaft hoists – difficulties and limitations in assessing their technical condition during in-service tests

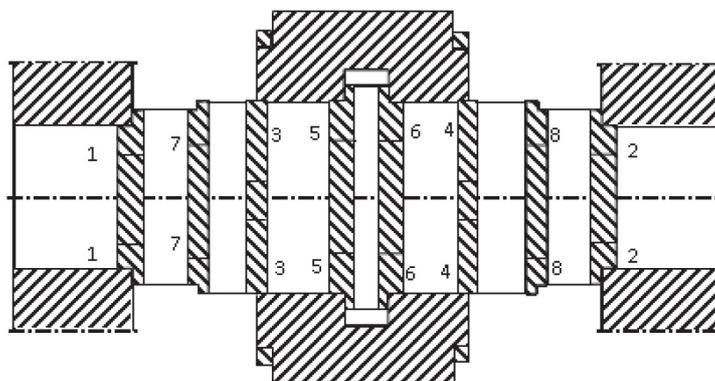
The axles of the sheaves are mainly subjected to alternating bending loads on both sides. Load distribution in the sheave axles is uneven. This is due to the nature of the load and the shape of the axle being adapted to work with sheaves. Therefore, locations more susceptible to cracking can be identified. These areas are called critical locations (Fig. 1) [7]. Critical locations in axles are as follows:

- in the offset area of the bearing journals (1, 2),
- in the area of the sheave seating edge (3, 4, 5, 6),
- in other offsets determined by the mounting design (7, 8).

Fig. 1. Layout of critical locations in the sheave axle

The dimensions of critical locations should be determined according to the diameter of the axle in the critical location zone. For cylindrical profile parts, this dimension is 0.25 of the diameter dimension [7].

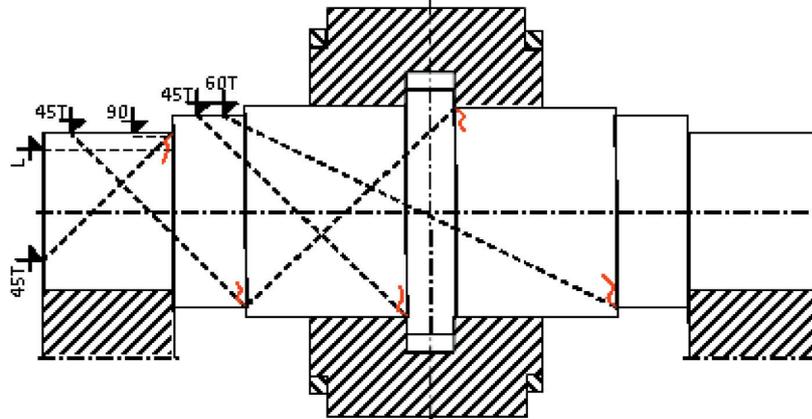
- from both end faces and partially from the side face in the journal areas – the axles mating with the plain bearings (Fig. 2),
- sheave axles with roller bearings from both end faces with complete inaccessibility of the side faces.

For axles with plain bearings, the basic test is the inspection from the lateral surface with transverse wave probes (T) with angles of refraction of 45°, 60° and surface wave probes of 90°. In addition, a test with longitudinal wave normal probes (L) is performed from both faces (Fig. 2). In the case of echoes on the flaw detector screen suggesting the presence of cracks in the axle, the defective areas are subjected to magnetic particle inspection (provided that the places of possible cracks are visible and not covered by structural elements cooperating with the axle) for final verification of indications.

Fig. 2. Ultrasonic testing of sheave axle with plain bearings

beam to be directed into the corner that the hypothetical crack forms with the lateral surface of the axle (Fig. 2).

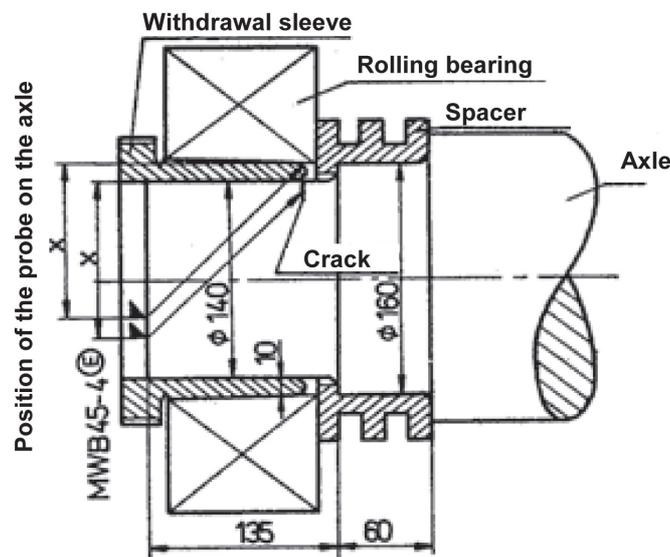
One such case is the distinction of ultrasonic wave reflections originating either from the edge of a rolling bearing withdrawal sleeve or from fatigue cracks originating in the axle under that edge. As a result of the good adhesion of the sleeve to the axle and the

filling of the gap with grease, the ultrasonic waves penetrate the contact surface between the components and are reflected by the edge of the sleeve. The location of the wave reflection is identified by the position of the probe on the axle face (Fig. 3) [8].

Fig. 3. Distinguishing the edge echo of rolling bearing sleeve from the axle fatigue fracture [8]

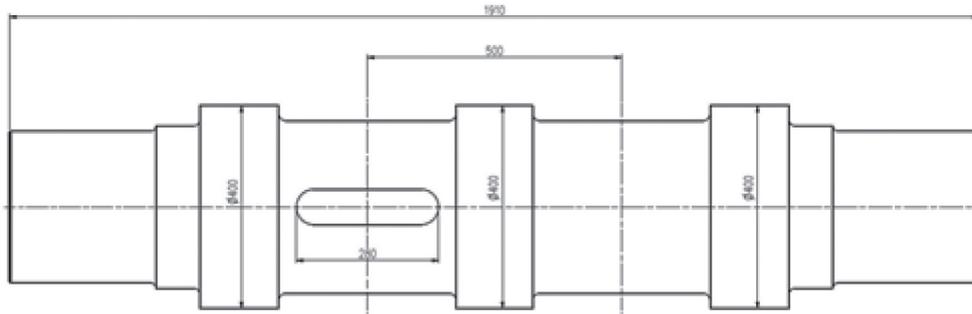
Fig. 4. Example of double-groove sheave axle

A major complication of ultrasonic inspection of sheave axles is the significant variation in their shapes and dimensions (Fig. 4 and 5).

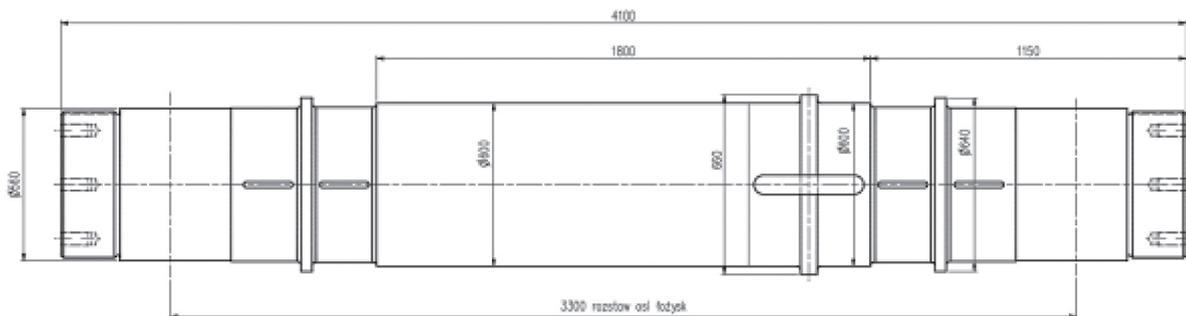
Fig. 5. Example of four-groove sheave axle

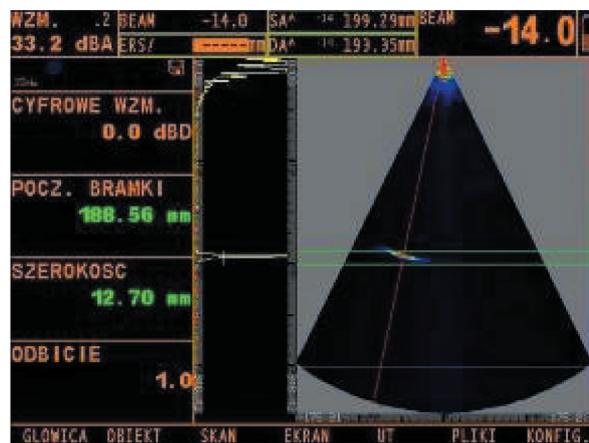
Fig. 6. Phased array imaging of a fatigue crack in the single-groove sheave axle (B2SPA16 16-element 2 MHz probe, $\pm 30^\circ$ maximum crack indication was obtained for beam insertion angle of 14°)

- increases the effectiveness of the test – allows for detection of in-service fatigue cracks in the initial stage of their formation (scanning in the full range of useful angles, and not only a few as in the case of ordinary ultrasound testing),
- allows to shorten the test time – lesser number of probes used (flaw detector settings),
- facilitates the interpretation of the results (easy change of beam introduction angles – it is possible to determine at what angle the signal from a possible crack is the strongest, presentation of the indication e.g. on S-scan) (Fig. 6).

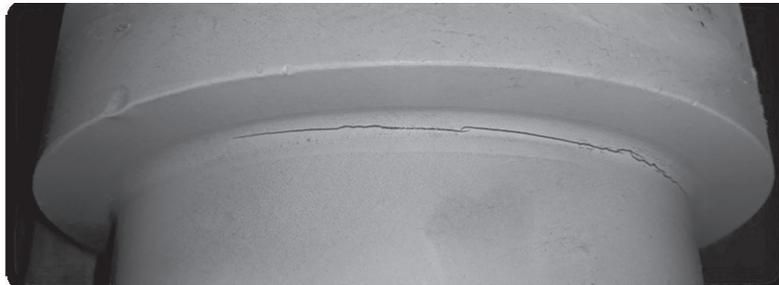
- Fatigue cracks. Usually caused by incorrectly manufactured axles, i.e., too small transition radii between successive offsets, resulting in a notch effect in critical areas of the axles, or too large diameter steps causing excessive stress accumulation in these areas. This is mainly the case for axles in double groove designs (Fig. 6 and 7). Sometimes fatigue cracks are initiated by corrosion pitting, often occurring at the axle-sheave hub contact surface.
- Excessive internal defectivity (i.e., excessive size and severity of defects of metallurgical origin) in critical locations. This mainly concerns the axles of old shaft hoists. These defects do not pose a direct threat to the safe operation of the axles, but under certain circumstances (stress concentration in these areas due to overloading or failure of the hoisting plant) they can cause cracks to appear.

Fig. 7. Fatigue cracks detected during ultrasonic testing of single groove sheave axle (at second offset) – imaging using the magnetic particle testing (MT) method

Axles with fatigue cracks should be replaced with new axles as soon as technically feasible, and until their replacement, crack propagation should be monitored by ultrasonic testing over a sufficiently short period of time. Remaining anomalies require immediate remediation of their causes, and axle damage should be controlled during subsequent non-destructive periodic inspections.

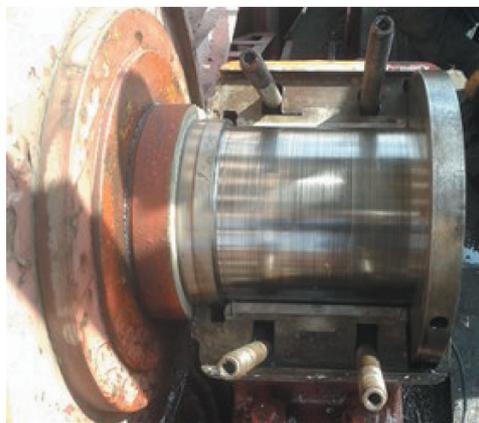
Fig. 8. Circumferential scratches on the axle journal surface

- sharp, deep (up to about 2 mm) circumferential indentation caused by excessive wear of the bottom shell, which results in axle settling and rubbing against the bearing housing (Fig. 8),
- circumferential cracks on the sliding surface of the journals caused by contaminants getting into the oil (Fig. 8),
- corrosion spots and scuffs on the sliding surface of the journals caused by improper lubrication,
- mild, shallow, circumferential abrasion caused by the felt seal on the bearing housings,
- loose grease rings.
