*Wojciech Anigacz **, *Krzysztof Drożdżol **, *Elżbieta Kokocińska-Pakiet **

EXAMINATION OF AN EARTH SLOPE SETTLEMENT

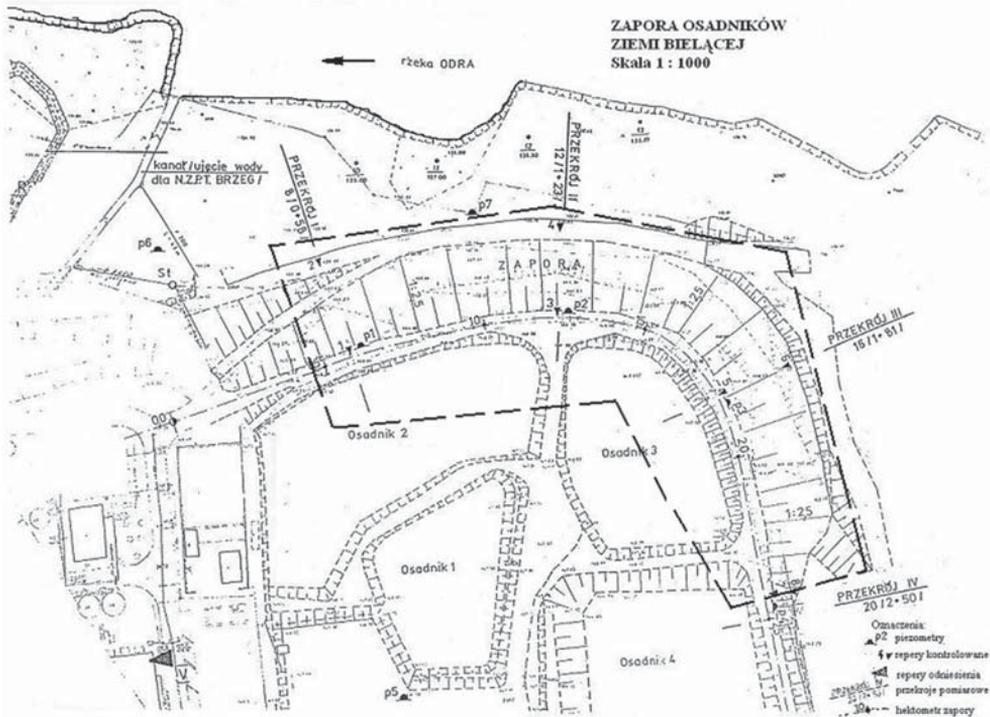
Fig. 3. Location of the embankment dam on site [2]

The main body of the structure was build on the existing base which had not been undermined by Odra river waters. The embankment footing is formed of silt existing at a depth of about 14 m below the embankment base. Above it there is a layer of sandy clay, of a thickness ranging from 5 m below the embankment base to 14m below the soil surcharge. In this part of the soil surcharge there is also an interbedding of medium sand, approximately 2 m thick, at the depth of 10 m below the surface of the top of the embankment. The top layer of the slope is made of a fill of clayey sand. The geological cross section of this has been shown in figure 2 [3, 4]. The layout and the shape of the slope on site has been shown in figure 3 [1].

In the course of long-term observations, the second section appeared to be the most susceptible to settlement and local landslips. During the course of the examination additional measurement points were installed in this section.

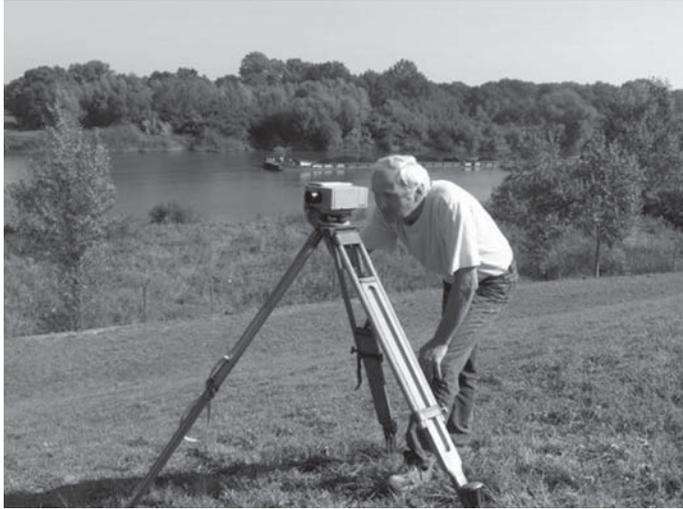
Fig. 4. The precise digital level NA 3003 during use

Vertical checks were carried out using the geometric levelling method of increased accuracy. The typical observation error amounted at ± 0.15 mm. The measurement was carried out with a precise digital level NA 3003 and with the use of precise invar staffs (Fig. 4). Prior to measurement, the level was checked and rectified in accordance with PN-ISO 17123-2:2005. (Optics and optical instruments — Field procedures for testing geodetic and surveying instruments — Part 2: Levels). The Kronsztad vertical system of coordinates was accepted.
