Aleksandra Borecka *

DESCRIPTION AND EVALUATION OF THE LANDSLIDE HAZARD. A CASE STUDY IN A LANDSLIDE IN RADZISZOW

* AGH University of Science and Technology, Faculty of Geology, Geophysics and Environmental Protection, Department of Hydrogeology and Engineering Geology, Krakow

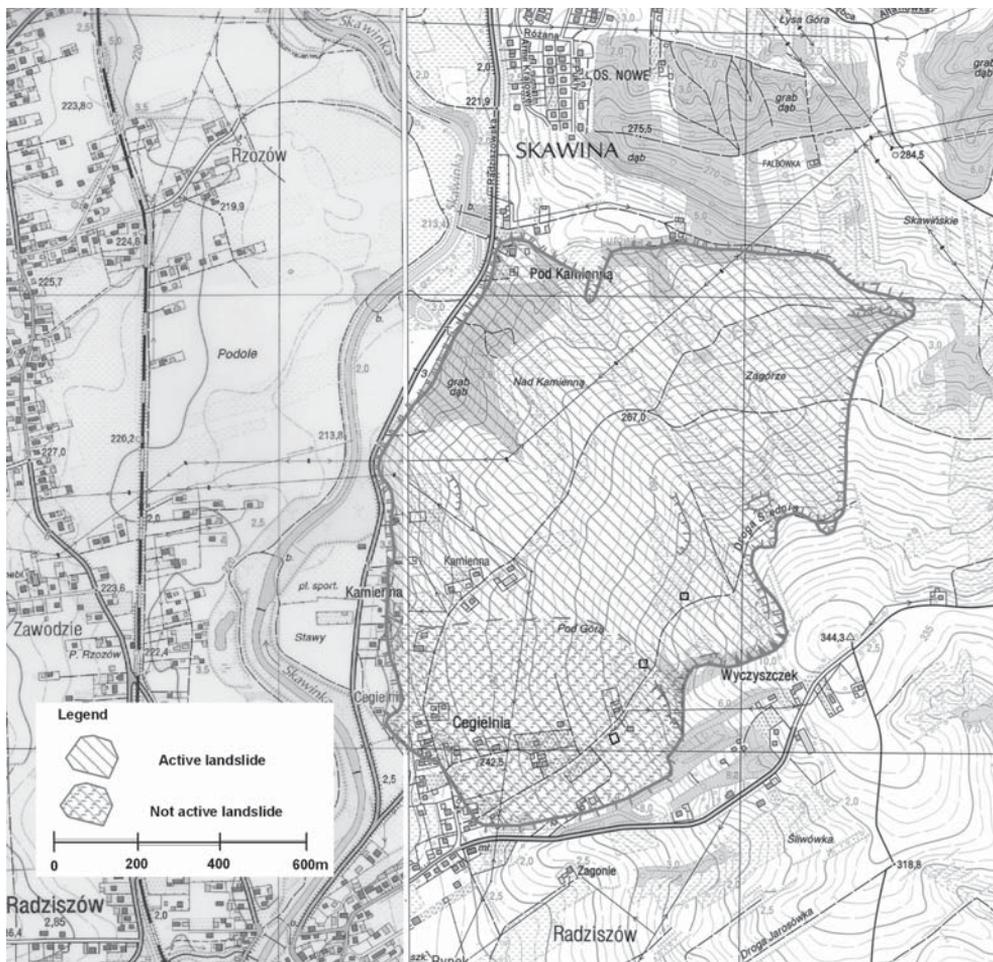
Fig. 1. The location of the landslide in RadziszowM-34-76-B-a-4 (Bukow), M-34-76-B-a-3 (Radziszow) [1]

incline at a considerable angle, which is the reason for the height difference of approximately 2 to 5 metres (Fig. 1.) The study area on the site planning is marked as a terrain for: a single-family and homestead building development (MNR), agricultural area (R), green wastelands areas (ZR) and, a small part, belongs to woodlands (ZL) [14]. The piece of land was heavily exploited as an agricultural area until the 1990s. Currently, it is idle land, covered with grass, bushes and trees. There are about 30 dwelling houses and more than 15 utility buildings in the study area. It is bordered by the valley of the Skawinka river from the west and by Lutowka Creek, which is the right-bank tributary of Skawinka. Its southern side, is adjacent to a valley where a local road from Radziszow to Bukow runs through. On its eastern side, it adjoins another landslide form. Hydrographically, it belongs to the Vistula basin, whose bed is about 5 km away north-westward. The surface runoff flows in a western and north-western direction.
