MAREK PŁACHNO
SŁAWOMIR BARANOWSKI
IRENEUSZ OŚLIŹNIOK

Difficulties related to the renovation of the reinforcement of the V shaft at PGG Oddział KWK Ruda Ruch Bielszowice

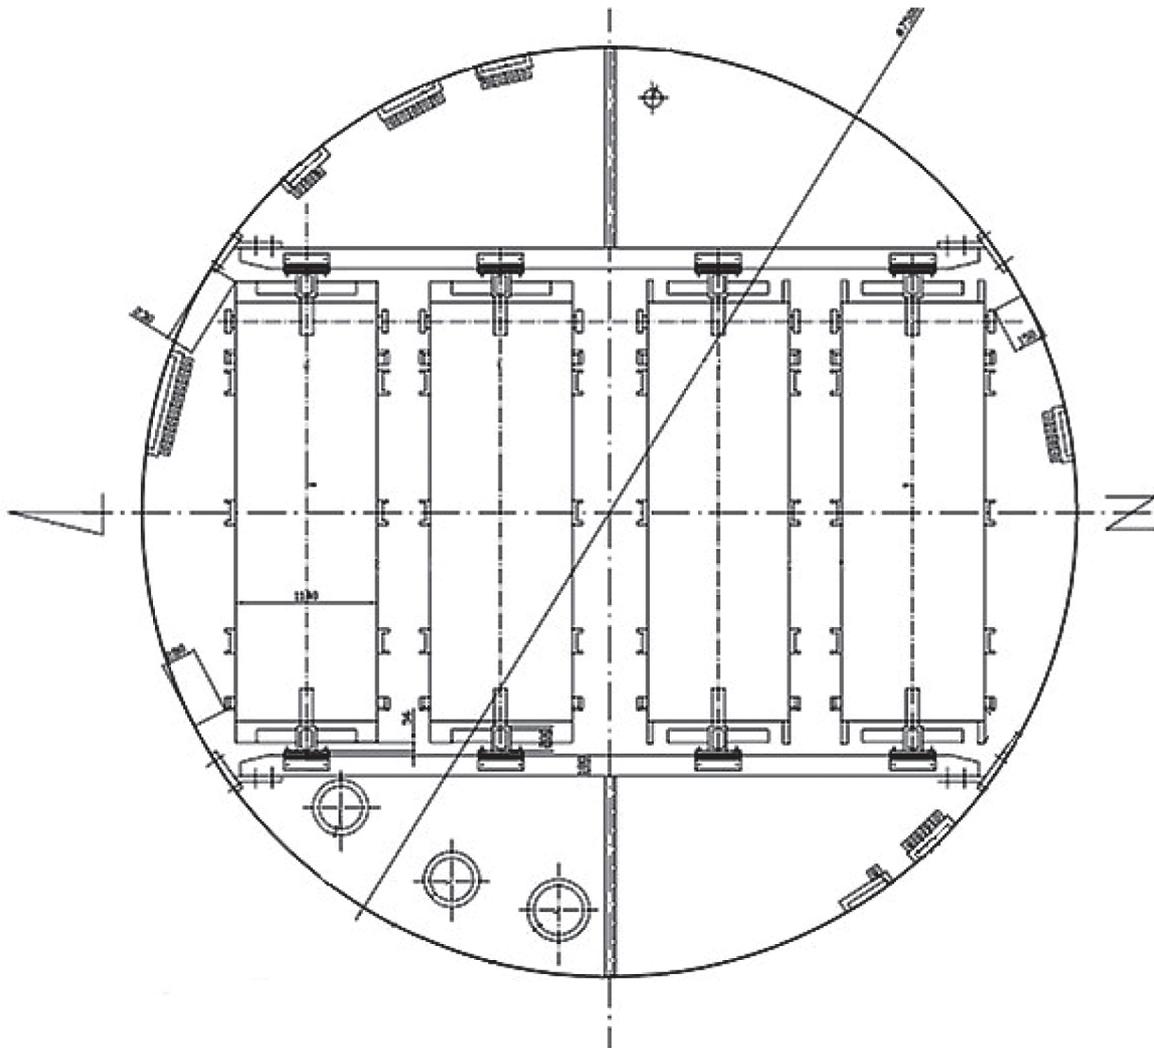
Fig. 1. Structural diagram of the reinforcement system in the V shaft shield at KWK Ruda Ruch Bielszowice

The system of guiding the exhaust vessels in shaft V consists of eight guide tracks. Each of them has a chain of guides formed by nine-meter box-section guides composed of two steel channel sections 200 attached to the main eastern and western girders, respectively. Each of the girders also has a box cross-section, however, it is composed of two steel channel sections 180. The structural diagram of the system for guiding the exhaust vessels in the shaft shield is shown in Figure 1.
