*Roger Abang\**, *Alexander Findeisen\**, *Hans Joachim Krautz\**

## CORROSION BEHAVIOUR OF SELECTED POWER PLANT MATERIALS UNDER OXYFUEL COMBUSTION CONDITIONS

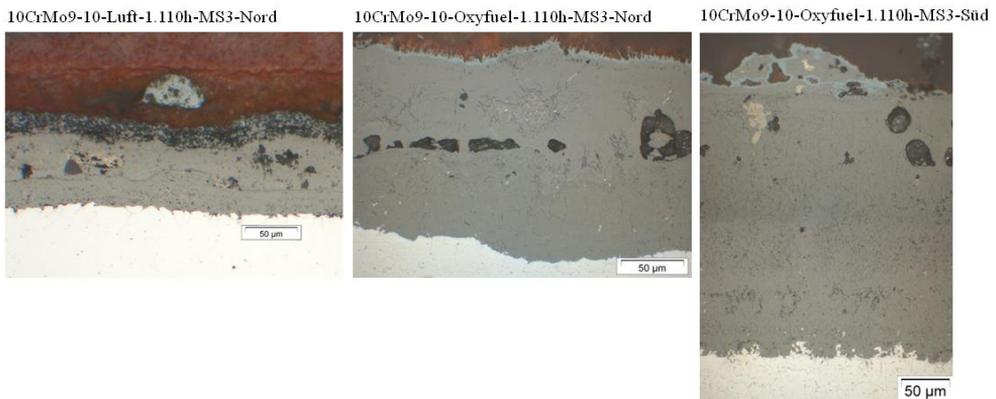
From the light microscopic images in Figure 8, it could be seen that only loosely attached formations of ash with flakes were present on the probes. Under air conditions the underlying corrosion layer was characterised by a few large pores and numerous tiny pores. However, under oxyfuel conditions large pores were evident in the outer corrosion layers while the inner corrosion layers exhibited hardly any pores. The image of the north side under oxyfuel conditions showed a concentration of the large pores on the interface between the outer and inner corrosion zone. The main components of the differentiable surface layers were hematite ( $Fe_2O_3$ ), magnetite ( $Fe_3O_4$ ) as well as a few Fe-Cr spinels. The clearly pronounced, elongated growth of the hematite layer on the north side under oxyfuel conditions was primarily a result of the perfectly functioning gas diffusion within the oxide layer. In addition, it is assumed that under both conditions there is specific formation of iron sulphide within the surface layer (see 1 and 2).

Inspection of layer thickness indicated a significantly lower thickness for probes under air conditions. Furthermore, the oxide layer on the south side under oxyfuel conditions was significantly greater than on the north side. Layer thickness was similar for probes located on the north side under oxyfuel conditions. By contrast layer thickness under oxyfuel conditions on the south side was significantly greater than on the north side. This was due to the existing ash bed and the reactive components contained within it.

Fig. 8. Light microscope image of the material 10CrMo9-10
